Unloading Phenomena Characteristics in Brittle Rock Masses by A Large-Scale Excavation in Dam Foundation

Abstract: Xiaowan Hydropower station's dam located in south west of China is the second highest arch dam in the world ($h = 292$ m), its foundation is based on brittle rocks of biotite granite gneiss and amphibolites plagioclase gneiss. A large-scale excavation around the foundation of the dam was conducted, near to 90 meters horizontal depth excavation and 130 meters vertical depth excavation, so the foundation dam was marked by a significant deformation and a severe damage near the excavation zone, namely excavation distributed zone (EDZ). This damage was caused by the unloading process. According to the *in situ* investigation, the characteristics of unloading rock masses were described. With the acoustic wave velocity monitoring method, the unloading rock masses characteristics of time effect and space distribution are summarized. Usually the unloading process causes fractures in rock masses along two perpendicular directions in the plane of the bank slope, one is parallel to the dam base slope, and the other is parallel to the river with steep-dip angle. Near to the excava

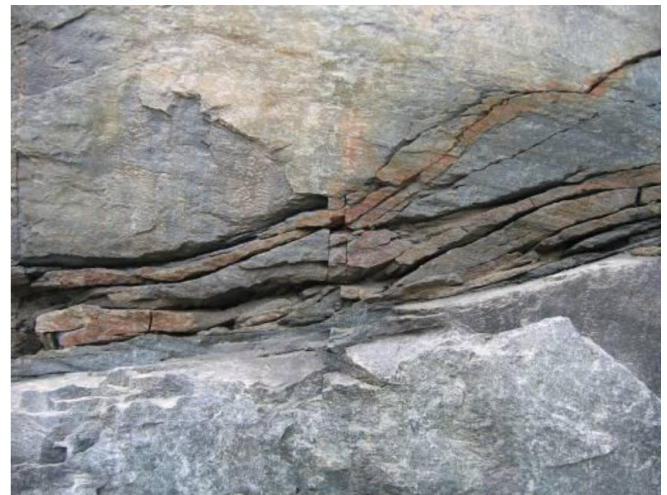
There are two kinds of unloading fractures along the structures with low dip angles. The first one is the unloading fractures growth with sheet like fractures (Fig. (4a)), and the fractures' thickness are from 0.5 cm to 5 cm, most of the unloading fractures appeared on the shallow of the dam foundation. The second one is the unloading fractures opened widely, and some small broken rock fragments remained in the opened cracks (Fig. (4b)), in general, the unloading fractures are no more than 5 m depth.

(a) Amphibolites plagioclase gneiss.

From the Fig (4), the characteristics of unloading fractures are apparently different in different rocks. In amphibolite plagioclase gneiss rock, the unloading fractures are thin sheet, sheet-like, about 0.2~3 cm thickness, generally, developed as a series of unloading fractures, and the width of fractures zone near to 50 cm (see Fig. (4a)); while in biotite granite gneiss, the unloading fractures are narrow, straight and opening so widely near to 5-10 cm, many broken rocks in the opening cracks.

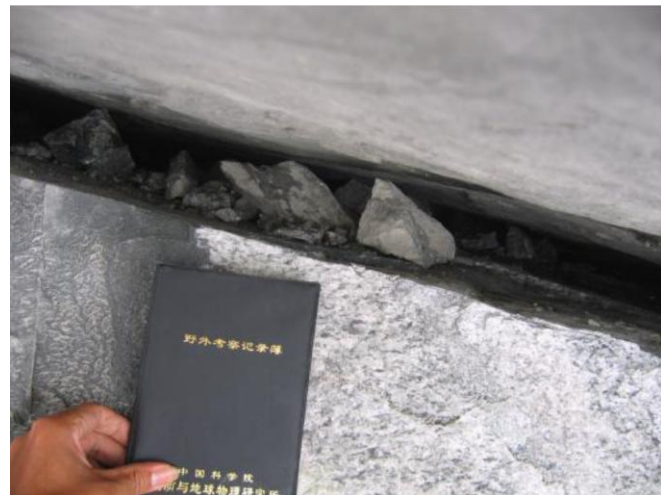
(b) Biotite granite gneiss.

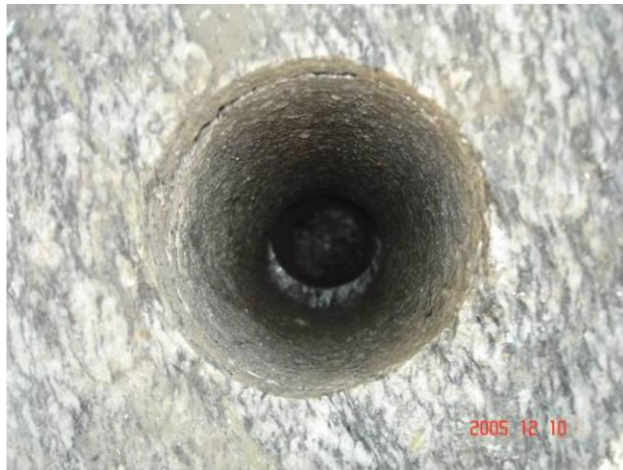
shearing along the structure which strikes to river with low dip angles see Figs. (5 and 6). Due to unloading, the cracks can rebound and in a way as shearing along low dip angle structure and tension along steep angle structure. Usually, the opening is apparently in the zone approaching to the excavation surface and decrease along with the depth (Fig. 7).

Fig. (5). Bored internal dislocation.

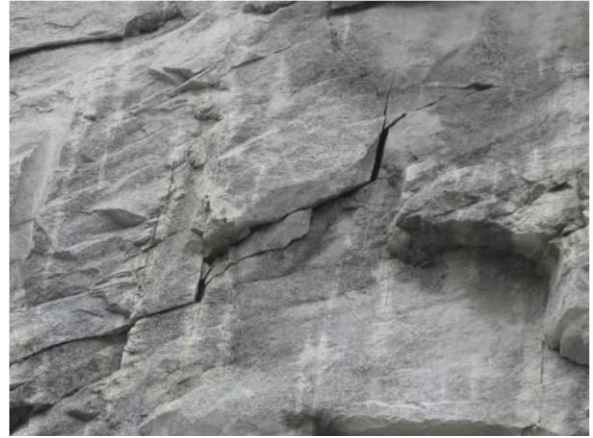
Fig. (7). Shearing along low-dip angle crack and tension along steep-angle crack.

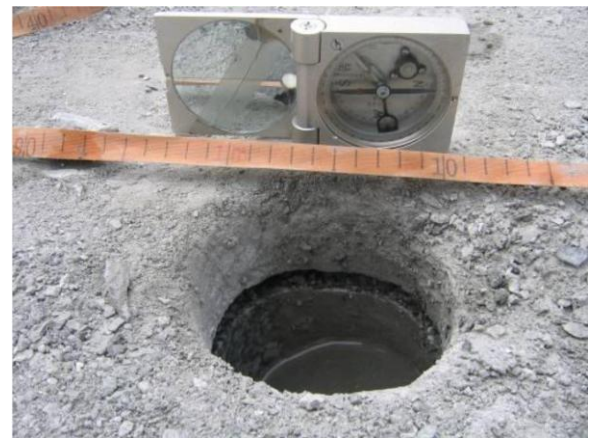
(a) New fracture in drilling hole

Fig. (8). New fractures in intact rock.

Usually, the low-angle cracks appear as discontinuous closed micro-cracks before excavation, while the foundation being excavated, the rock rebounded and caused deformation along with the cracks being stress redistributed, then the discontinued micro-cracks were mostly coherent as a macro fracture which opened near to 20 mm. Fig (8) shows the excavation damage zone situation at the bottom foundation of left bank (Level 954 m). it has been found that the most roughness direction of the unloading fractures were dipping to the river (Fig. 9).

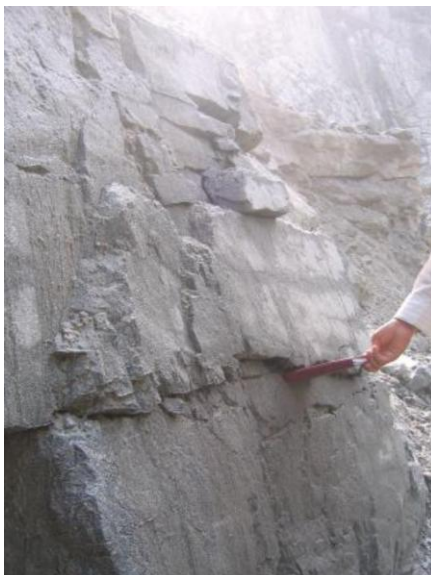
Fig. (6). Steep rock wall dislocation.

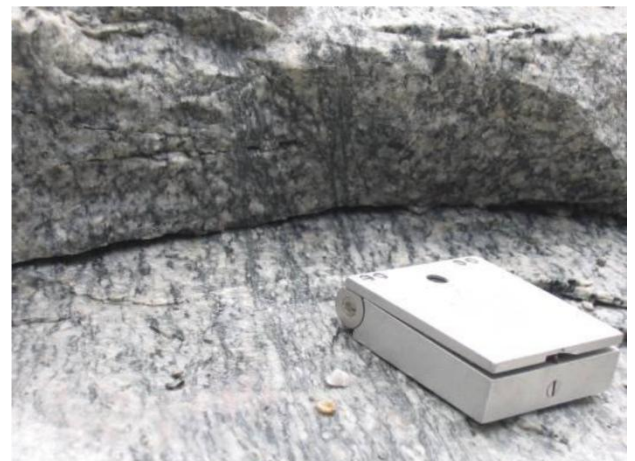
(b) New fracture in low elevation dam session.

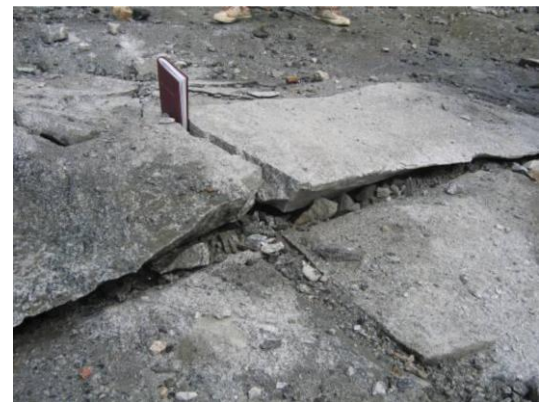
In addition to the above mentioned moderate unloading deformation, there is also very severe destroyed mode, namely rock burst. The stress is concentrated in the area of the valley at the bottom of the river bed due to the topography, and the rock burst were seen at this place after dam base excavation, it has been found that the rock burst remains at the right bank of the foundation surface elevation 962 m (see Fig. 10).

Fig. (10). Arciform broken-off by rock burst.

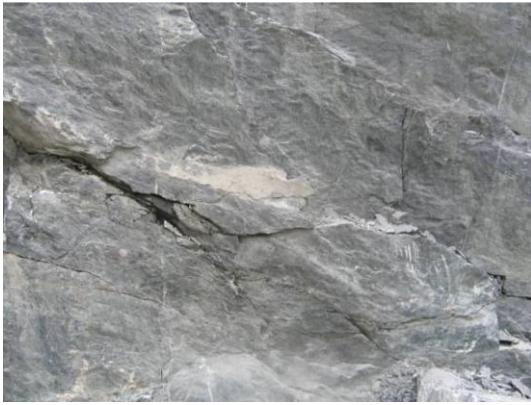
The first characteristic of unloading fracture is that the low-dip fracture is parallel to the slope of construction excavation surface, and the angle also varied with the excavation surface. The second one is that the low-dip angle unloading fractures are tending to each other and tending to the valley, shown in Fig. (11). The last one is that the unloading fractures are often subjected to in the control of steep-dip angle and low-dip angle fractures in the high-elevation area, and the destroyed surface appears ladder-like or ring-shear sharp (Fig. 12), it is shearing along with the structure surface, while in the low-elevation area, the destroyed surface are subject to in the control of the low-dip angle structural surfaces and mostly rebounded like-slab due to the stress concentration, shown in Fig. (13).

Fig. (12). Fractures like diamond ring shape.

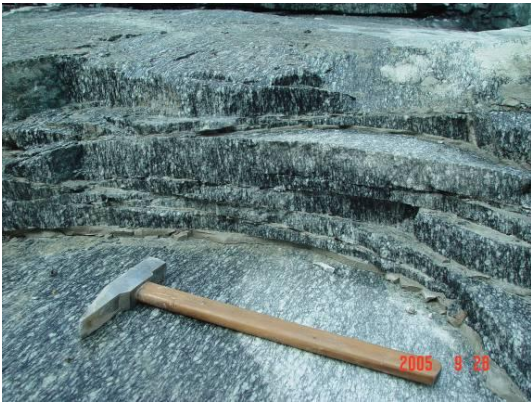
Fig. (13). Thin-tabulate fractures.
