# The Collapse Accident Analysis for Steel Structure of Waste-heat Boiler in a Cement Plant

**Abstract:** By means of on-site investigation, inspection, interior experiments, theoretical analysis and calculation, a detailed analysis is carried out on the cause of the partial collapse accident about a waste-heat boiler steel structure in a cement plant of Hunan province of China. The results of inspection and analysis show that: as a key part of load transfer, the connection weld of long thin steel plate is poor in quality, meanwhile, the detail of beam-column connection can not meet the requirement of rigid joint stipulated by the design, which are the main causes for the collapse accident of boiler steel structure. Based on the analysis of accident cause, some problems worthy of consideration are put forward to the design and construction of this kind of structure, such as the weld procedure and quality control of long thin steel plate connection weld, etc.

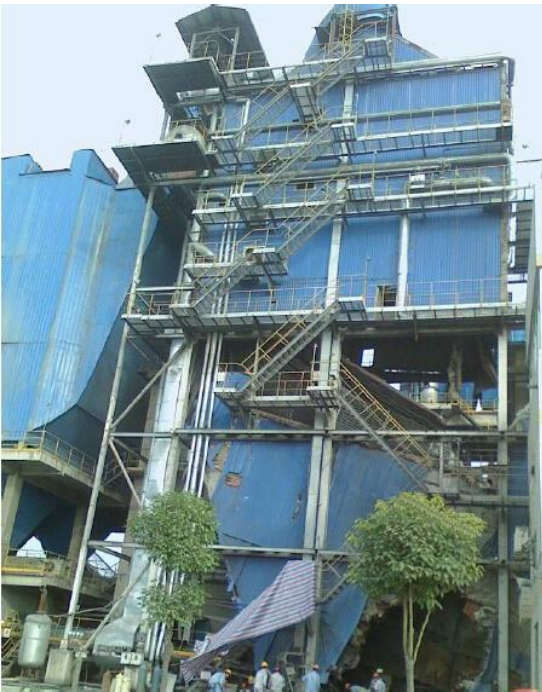
About 13:40 p.m., July 16, 2012, the combination of dust-settling compartment and super-heater tube chamber suddenly collapsed. Fig. (2) shows the main scene of the accident situation. The dust-settling compartment has fallen to the ground inclined and formed an angle, east high and west low (Fig. 3). The eastern end of the super-heater tube chamber of high pressure period was still suspended on the steel beam, while western end has sunk into the dust-settling compartment completely (Fig. 4), and parts of the connection welds between the dust-settling compartment and super-heater tube chamber were torn open completely (Fig. 5). At the same time, the bearing beams of third floor have been distorted seriously, and the damage of beam-column joints was obvious (Figs. 6, 7).

**Fig. (2).** The main scene of the accident.

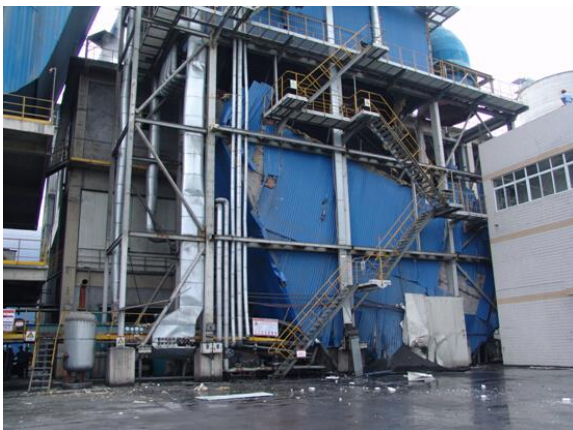
**Fig. (3).** Collapse of dust-settling compartment.

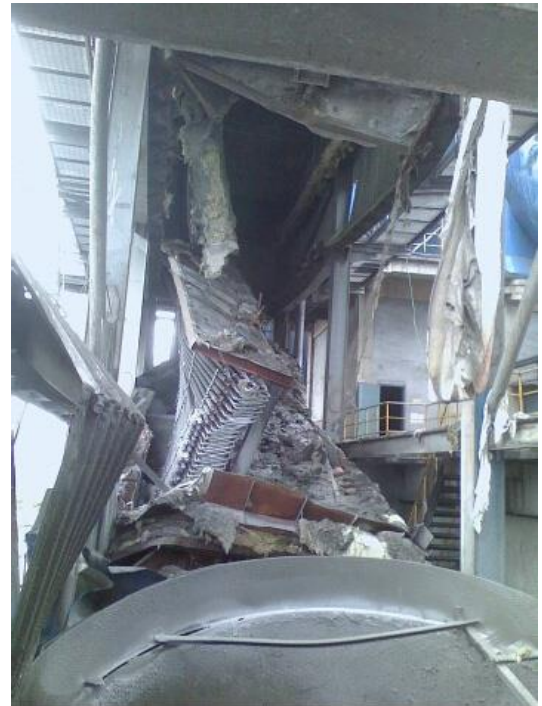
**Fig. (4).** Collapse of super-heater tube chamber.

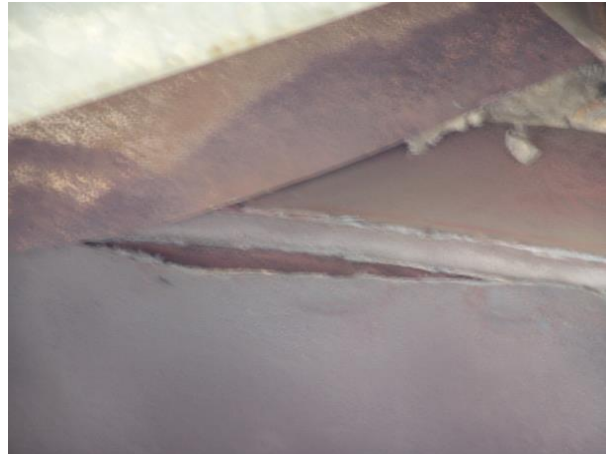
**Fig. (5).** Tearing seam between the attachment weld.

According to the design check, the connection weld between dust-settling compartment and super-heater tube chamber should be safe under the existing load. But the weld was found to fail in several places. The poor weld quality is the root cause for the failure of connection weld. The wall thickness of dust-settling compartment is only 4 mm, and the requirement of welding is quite high. However, most of the welds were actually discontinuous and the sizes of welds are uneven. When the local peak stress is caused by the weld defect exceeds the weld strength, the weld crack will appear. Under the action of long-time load, the weld crack continuously develops, and eventually the whole weld tears damage, causing the appearance of collapse accident.

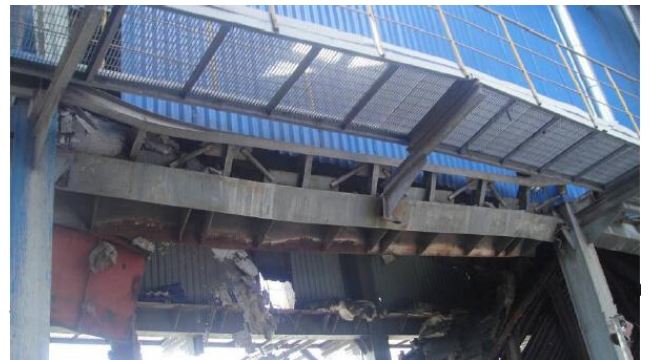
**Fig. (6).** Distortion of bearing beam.

site of accident, we can see that the bearing beams twisted seriously while the columns have little damage. So, it is necessary to re-check the carrying capacity of bearing beam.

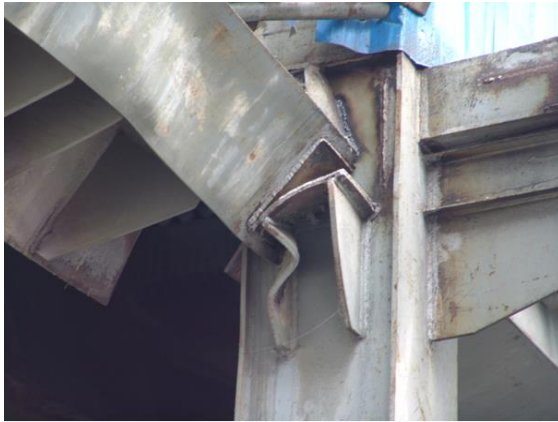
Fig. (7). Damage of beam-column joint.

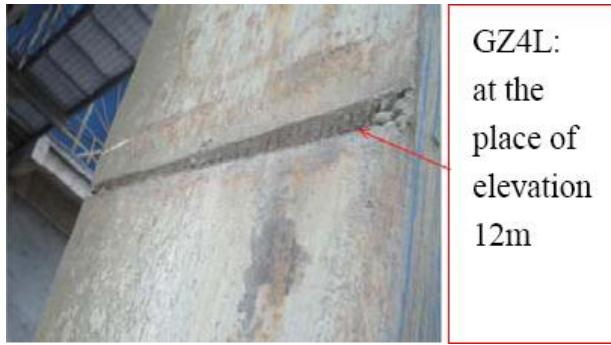
GZ4L:  
at the  
place of  
elevation  
12m

The column of this boiler steel structure adopted box-section. Vertical splice of column section is butt weld connection. Fig. (10) illuminates the splice detail of column section. Ultrasonic detection was adopted to evaluate the welding quality, and a total of 36 segments of butt weld seam was inspected. The result shows that for all of inspected weld, 35 segments were qualified and there was only one weld omitted (See Fig. 9a).

(a) Column flange butt-weld leakage solder

V. With the exception of the omitted weld (Fig. 9a), the construction quality of the butt weld for the steel column splice meets the requirements of grade II weld according to the stipulation of JG/T 203-2007(Method for ultrasonic testing and classification for steel structures) [7].

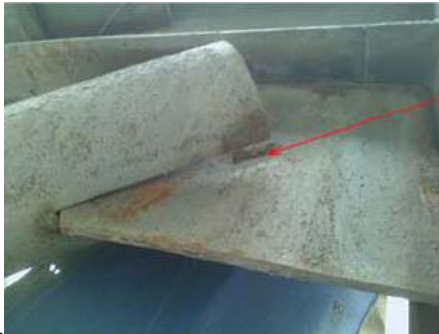
axis A  
/axis 4-5  
in  
second  
storey

The appearance quality inspection of the main connection welds in the structure was conducted. The inspection results indicated that there were numerous deficiencies about the connection weld of the structure, mainly including the several types as follows (See Fig. 9): (a) leakage solder, (b) insufficient weld length, (c) poor visual quality, (d) serious corrosion.

(b) Insufficient weld length in tube-gusset plate connections

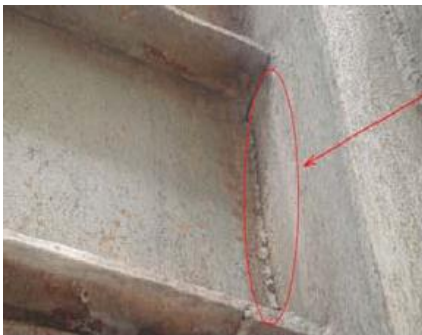
GZ5R:  
beam-  
column  
connection  
in second  
storey

(c) Poor visual quality about fillet weld

IV. The quality of fillet weld of this boiler steel structure is poor, the detail of beam-column connection for the collapsed parts of the structure does not meet the requirements of design drawing, which are the key factors to induce the accident.

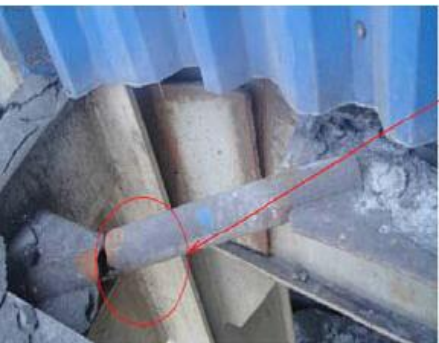
axis B  
/axis 3-4  
in third  
storey

(d) Serious corrosion leading to breakage of horizontal bracing Fig. (9). Appearance defects of the connection weld.

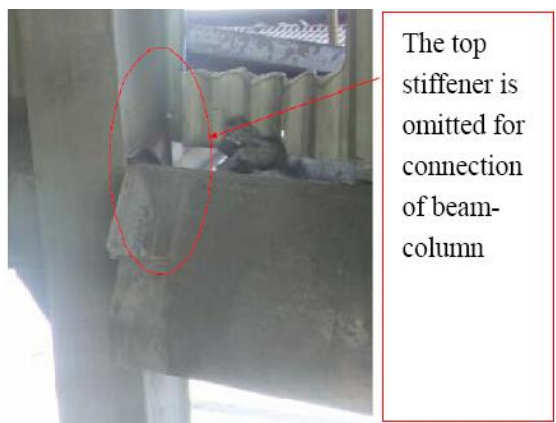
we found that the actual detail of beam-column was shown in Fig. (16). Obviously, it doesn't meet the requirements of rigid assumptions.

**Fig. (16).** The actual details of beam-column.

III. The problem of beam-column details: Compared to the main components such as beam and column, the connection of beam-column seems to be important, but the details of beam-column affect the analysis model of structure and component directly. Random changes to the details of beam-column should be banned during the construction process.

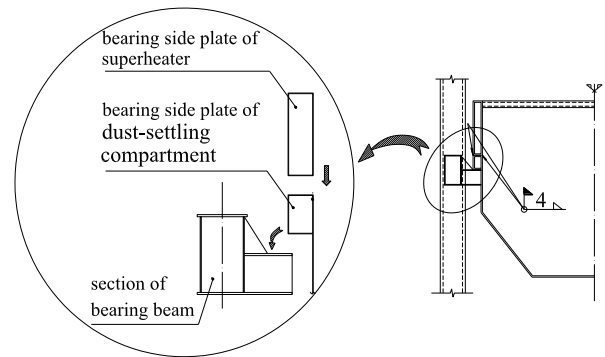
Fig. (17). A improved detail for the connection of dust-settling compartment and super-heater tube chamber.

II. The problem of connection detail for dust-settling compartment and super-heater tube chamber: Considering the difficulty of weld for such a kind of long thin plate, a more convenient and reliable way of connection should be considered during the design process. The assembly method showed in Fig. (17) should be a better way suitable for such a situation.
