Experimental Behavior of Mechanical In-Flange Connectors

Abstract: Prestressed double-Tee beams are used in multi-level parking structures and in some states' bridges. Steel brackets, called in-flange connectors, are embedded in the flanges of the beams and are welded together on-site to facilitate system behavior. To date, placement, i.e. spacing, of these connectors has been based primarily on engineering judgment although some guidelines are available. This paper summarizes the results of seventy (70) monotonic and twenty-three (23) reversed-cyclic tests on double-Tee in-flange connectors in an effort to provide comprehensive information on the relative performance of several different available connectors. Test results are reported for six different connectors manufactured by two different companies using seven different test protocols described herein. Each connector was imbedded in a 965x914x102 mm (38x36x4 in) concrete slab designed to be representative of the overhanging portion of the flange of a concrete double-Tee beam. The connectors were also tested using a slow reversed-cyclic displacement control protocol and the ability of each connector to dissipate/absorb energy

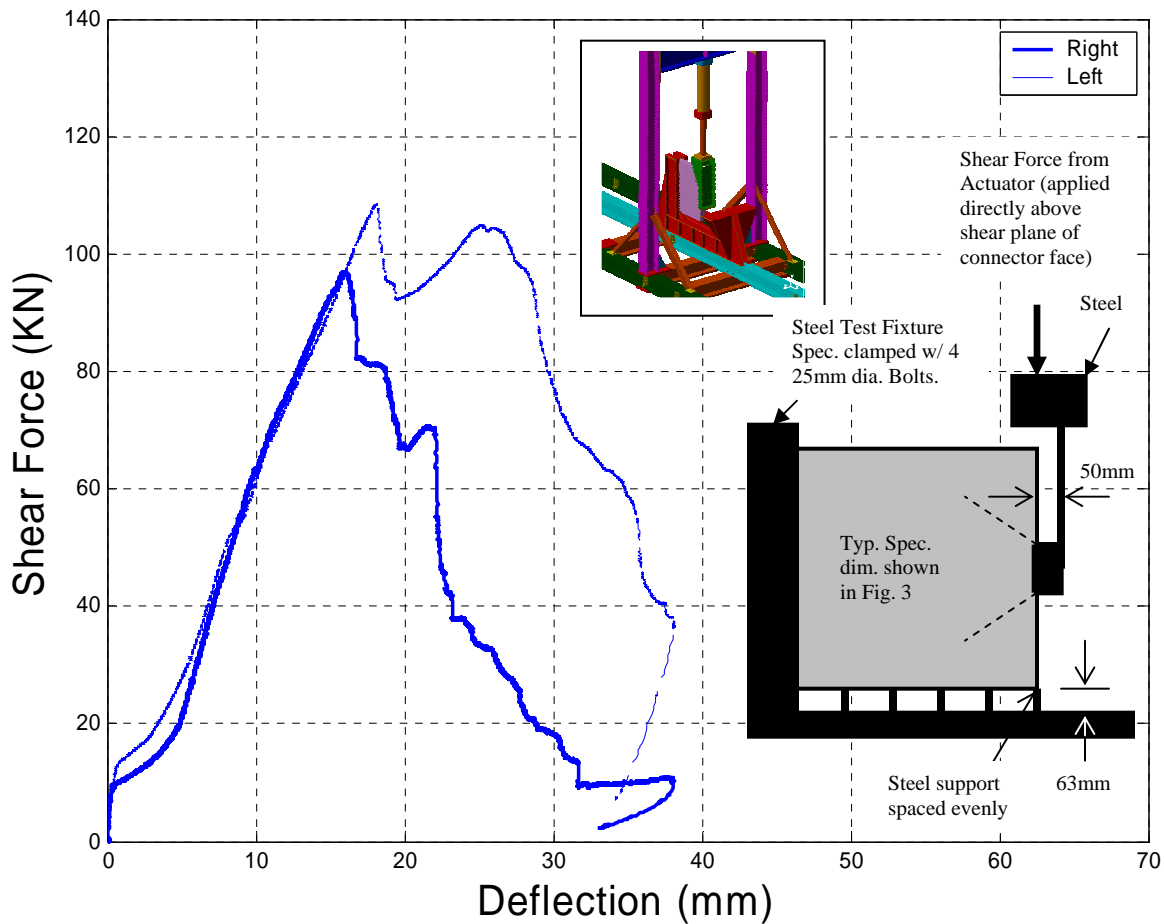
Fig. (3). Load-deflection relationship for a typical horizontal shear test. Schematic showing tests setup with boundary conditions for horizontal shear tests.

welded to the flat face of the steel connector. The test protocol for the both of these tests was also a linear displacement control test procedure. The actuator was displaced a total of 38.1mm (1.5in) in 180 seconds, producing a constant deformation rate of 0.212 mm/sec (0.00833 in/sec). Fig. 3 presents the load displacement results for a typical connector for shear right and shear left, with a schematic in the corner showing the boundary conditions during this type of test.

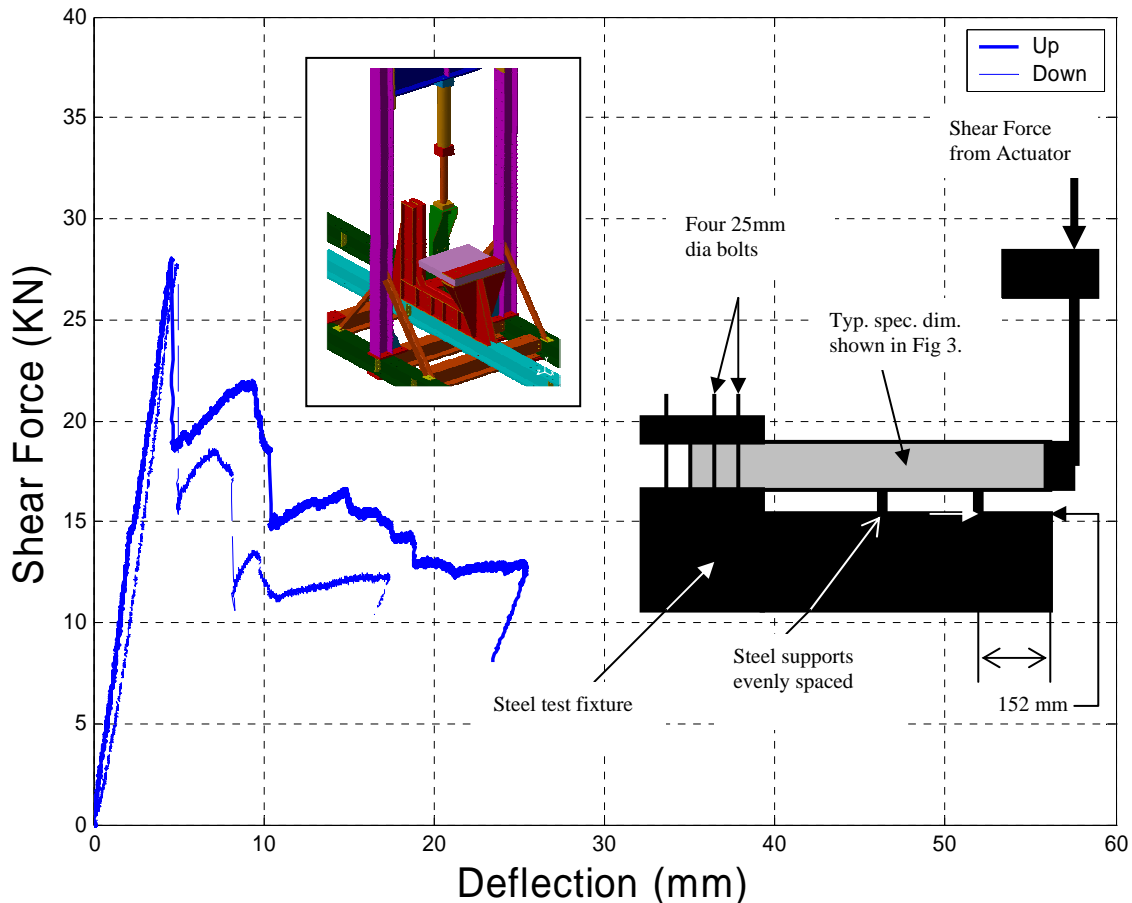
Fig. (4). Load-deflection relationship for typical vertical shear test. Schematic showing tests setup with boundary conditions for vertical shear tests.

The test protocol for the vertical shear up and vertical shear down was also a linear displacement control procedure. The actuator was displaced a total of 25.4mm (1 in) in 120 seconds. The load-deformation plots for a typical vertical shear up and vertical shear down test is presented in Fig. 4. As with the other test types, within that plot is a schematic showing the boundary conditions for the specimens tested in

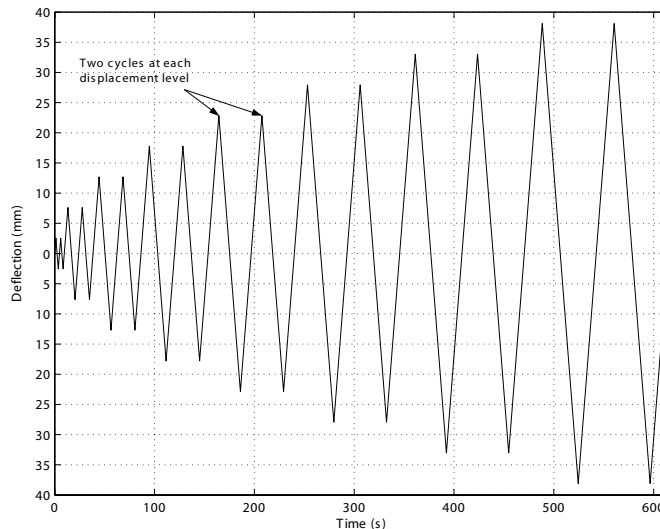
Fig. (6). Horizontal reversed-cyclic test protocol used in this study connectors tested using this protocol. Note that the boundary conditions were identical to those presented in the monotonic tests.

plicate using the reversed-cyclic displacement protocol presented in Fig. 6. As indicated on the figure, two full cycles at each displacement level were used. Of course, there are numerous reversed-cyclic test protocols in existence, however it was felt that two however it was felt that two cycles at each level would provide sufficient information regarding stiffness, strength degradation, and energy dissipation, for the objectives of this study. Due to many similarities in hysteresis shape among the various connectors, as well as to space limitations, only several of the reversed-cyclic test results are presented graphically. As mentioned previously, graphical results for all the connectors tested can be found in [7]. Table 3 presents additional results for all the

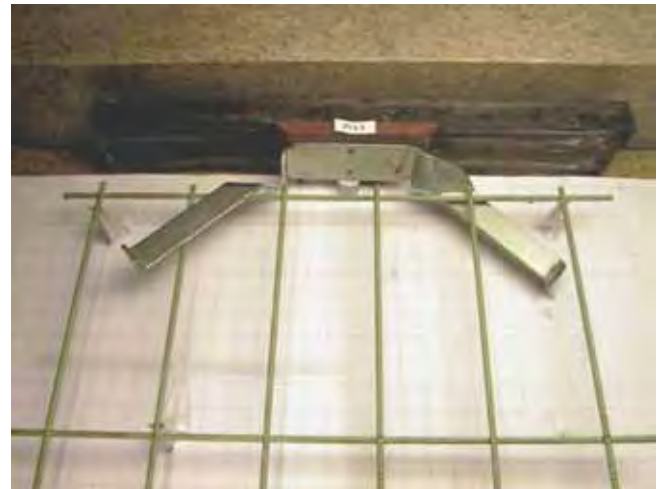
Fig. (11). Picture showing orientation with respect to steel reinforcing mesh for connectors with offset legs (as indicated in Table 1).

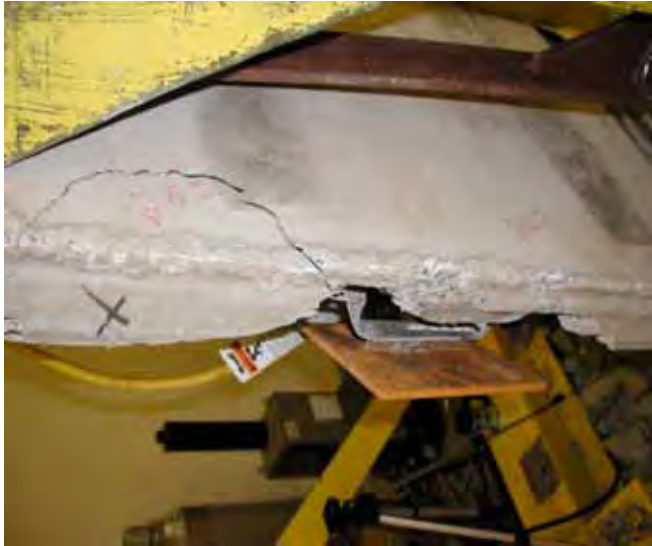
Fig. (12a). Concrete slab damage sustained as a result of testing Connector B in horizontal reversed cyclic shear.

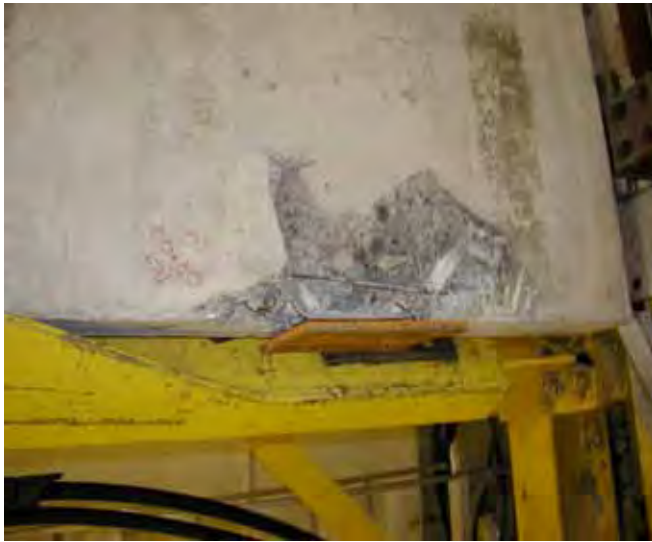
Fig. (12b). Concrete slab damage sustained as a result of testing Connector C in horizontal reversed cyclic shear.

last cycle. However, in Fig. 12b, the steel reinforcing mesh is partially exposed and the connector is visible within the slab. A large amount of concrete spalled during this test. The mild steel connector, connector D, only resulted in some moderate damage to the concrete slab as shown in Fig. 12c. Recall that the vertical reversed-cyclic protocol called for a final displacement cycle of almost 28mm (1.1in). In contrast

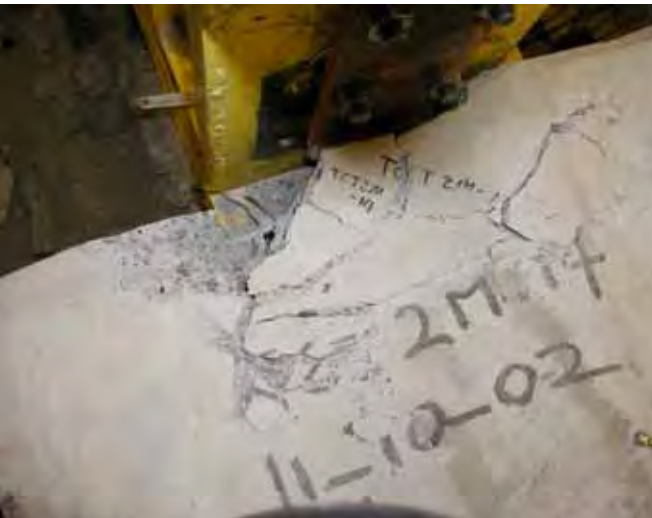
Fig. (12c). Concrete slab damage sustained as a result of testing Connector D in vertical reversed cyclic shear.

to Fig. 12c is the damage sustained by the slab as a result of the vertical reversed cyclic test on connector C. Although this specimen dissipated the most energy, one can see from Fig. 12d that the slab is significantly damaged; although it is still held together by the mesh reinforcement. Overall, for the twenty-three (23) specimens tested under reversed-cyclic displacement protocol, the pattern was similar.

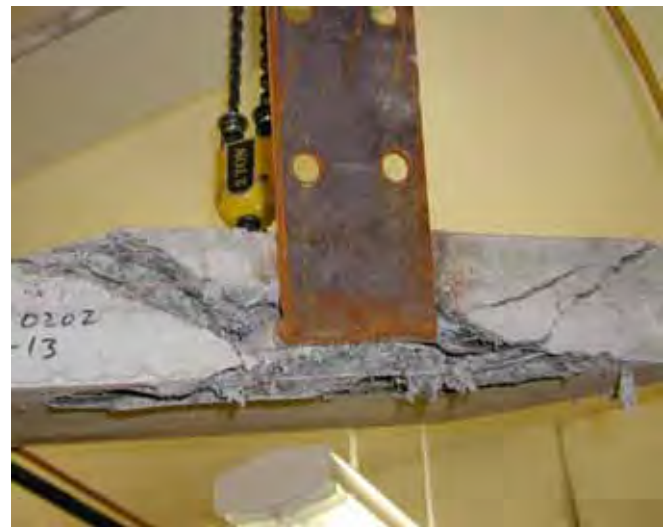
Fig. (12d). Concrete slab damage sustained as a result of testing Connector C in vertical reversed cyclic shear.
