The Open Civil Engineering Journal

Historic City Centers After Destructive Seismic Events, The Case of Finale Emilia During the 2012 Emilia-Romagna Earthquake: Advanced Numerical Modelling on Four Case Studies

Simone Tiberti* and Gabriele Milani

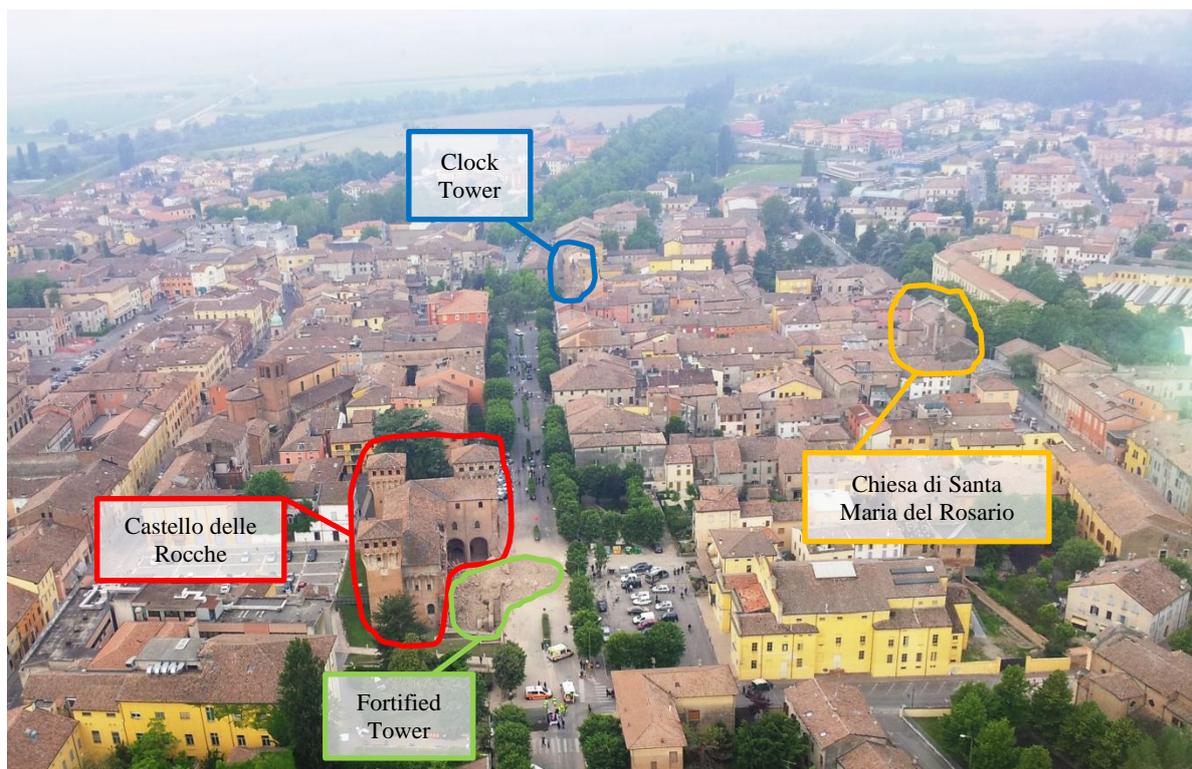
Fig. (1). Aerial view of the city center of Finale Emilia, highlighting the location of the case studies.

which presented for the first time a complete analytical investigation on a masonry castle; the two towers were originally investigated in [13]. The last example – whose results are presented here for the first time – deals with one of the masonry churches of Finale Emilia (“Chiesa di Santa Maria del Rosario”), a medium-sized building severely damaged by the seismic events along with its bell tower. The location of all the case studied investigated in this paper is shown in Fig. (1).

The two towers were coeval and built within 400 meters one each other – as shown in Fig. (1) – hence they were supposed to share the same material, with low values of the mechanical properties typical for historical masonry in that region (Table 5). The value of cohesion here adopted is consistent with the value suggested by [18] if thin mortar joints and good transversal connection along the wall thickness are assumed for the masonry.

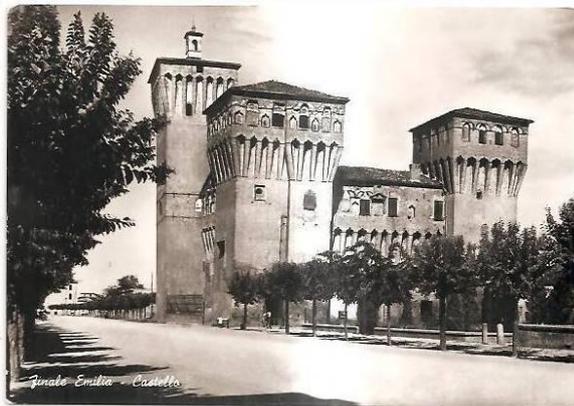
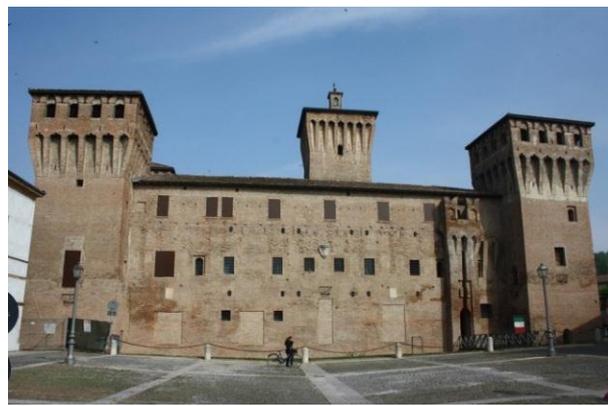
Fig. (2). Castello delle Rocche.

(a) Overall view

(b) Main façade refurbished

The Castle had been plagued by structural problems on the roofing system since shortly after its construction. Moreover, the proximity of the river had caused constant decay to the structure, which worsened starting from mid-18th century after some spaces were used for storing salt. In 1947 the Castle was so deteriorated that it had to be abandoned; hence, extensive renovation works were carried out throughout the 1960s, which greatly improved its overall conditions and static behavior. Further interventions were executed in the 1990s, and in 2009 the main façade was completely refurbished and strengthened. The final outcome of the latter intervention is shown in Fig. (2).

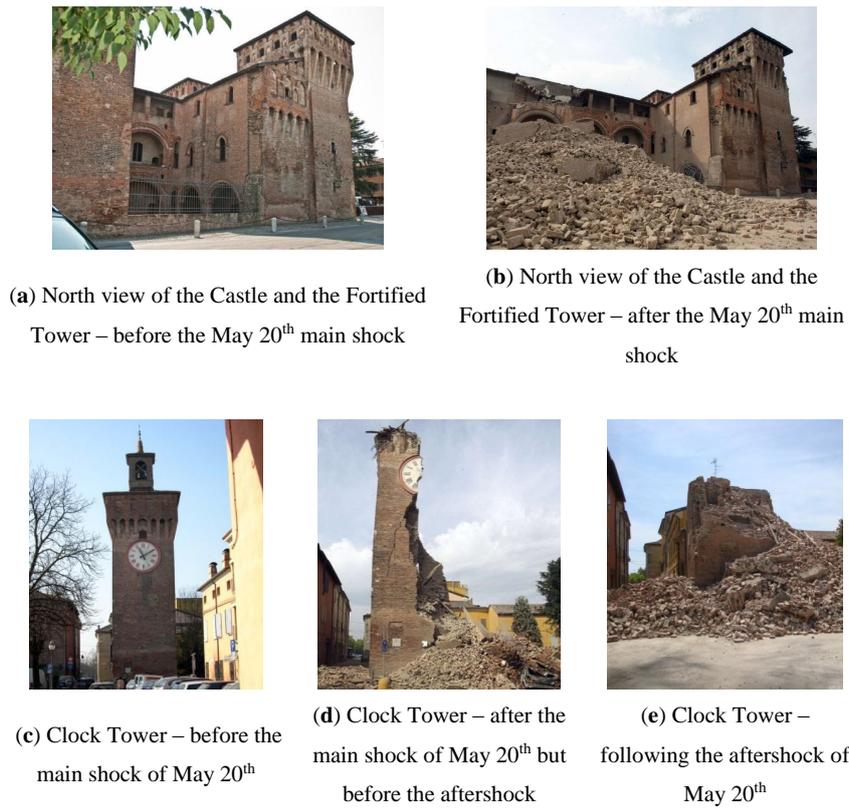
Fig. (3). Comparison between the outlooks of the castle, the Fortified Tower and the Clock Tower before and after the events of May 20th.

Finale Emilia was at the very heart of the area struck by the 2012 seismic sequence. On May 20th at 4.03 am (local time), an earthquake hit the village with a magnitude of 5.9, causing the complete destruction of the Fortified Tower, the partial collapse of the Clock Tower and widespread damages on the upper parts of the Castle (namely, the crown of its three towers). Following some minor aftershocks – mostly occurred during the night – a major one struck at 3.18 pm (local time) with a magnitude of 5.1, which obliterated the remaining part of the Clock Tower and generated further damages to the Castle. Fig. (3) shows meaningful images of the damages displayed by the Castle and of the collapse of the towers.

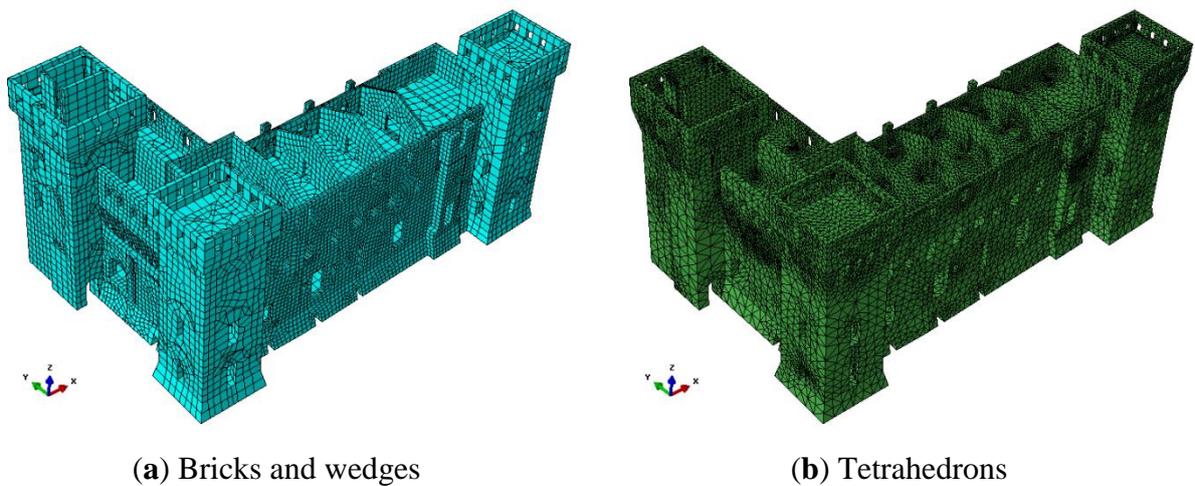
Fig. (4). FE meshes used for the computational analyses of the Castle.

The first mesh consisted mainly of brick elements, with a few wedge elements near the openings. The geometric parts were independently and directly imported from Rhinoceros in Abaqus, where the corresponding mechanical properties were assigned to each part. The different structural elements were then meshed and subsequently assembled, imposing tie constraints at the contact interface to secure continuity of displacements. This mesh was used when performing nonlinear static analyses.

The second mesh was more refined and consisted only of tetrahedrons. However, in this case the geometric model was first imported into Strand7, where it was meshed and used for carrying out modal analyses. Then, the meshed model was written into a Nastran code and imported in Abaqus, where again each part received its own mechanical properties. This second mesh was used when performing nonlinear dynamic analyses.

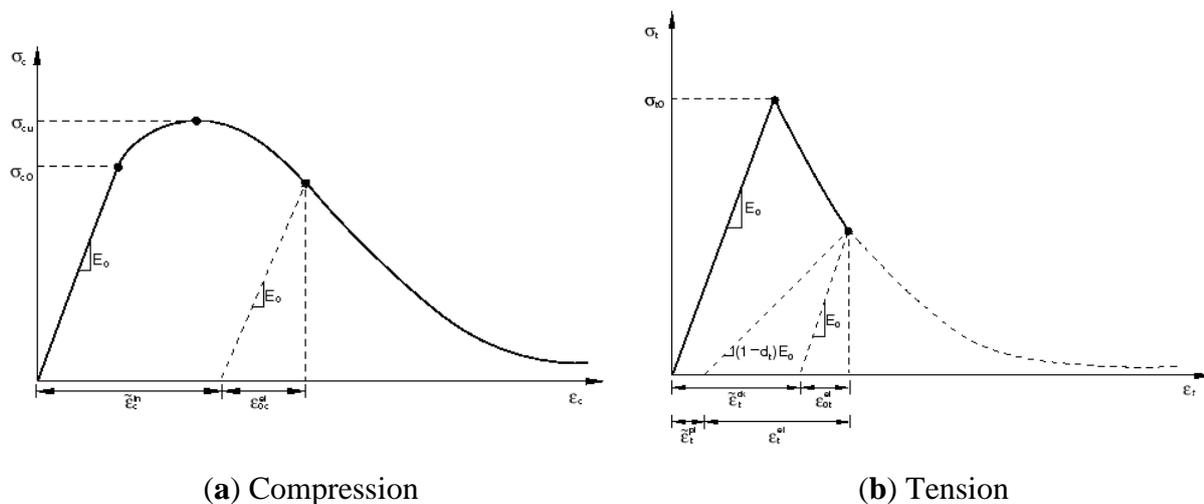
Fig. (5). Inelastic curves employed in the CDP model.

A material model named “concrete damaged plasticity” (CDP) was employed for characterizing the mechanical behavior of masonry. As the name suggests, this model was originally developed for describing the behavior of concrete taking into account plasticity and damage, with the possibility to define distinct constitutive laws and damage parameters in tension and compression. However, the formulation of this model is general, so it can be employed for describing other materials, including masonry. The inelastic curves in tension and compression are shown in Fig. (5), while the values of the constitutive laws in tension and compression along with the damage parameter in tension are summarized in Table 2. Other parameters are needed for the complete definition of this material model, and they are listed in Table 3. Further considerations on the adopted mechanical model are given in [12], where the reader is again referred to.

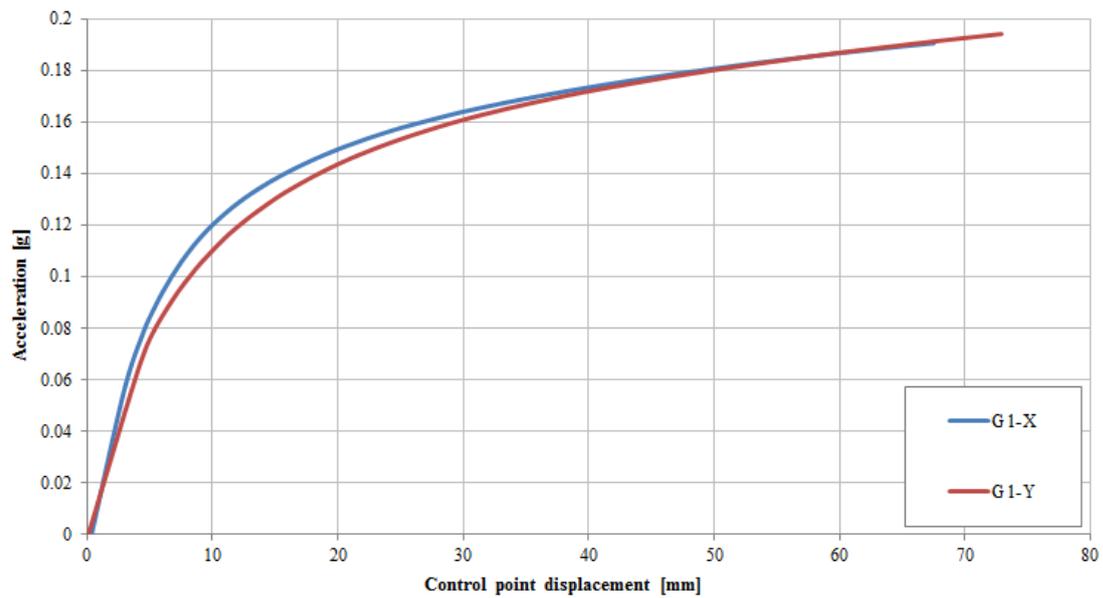
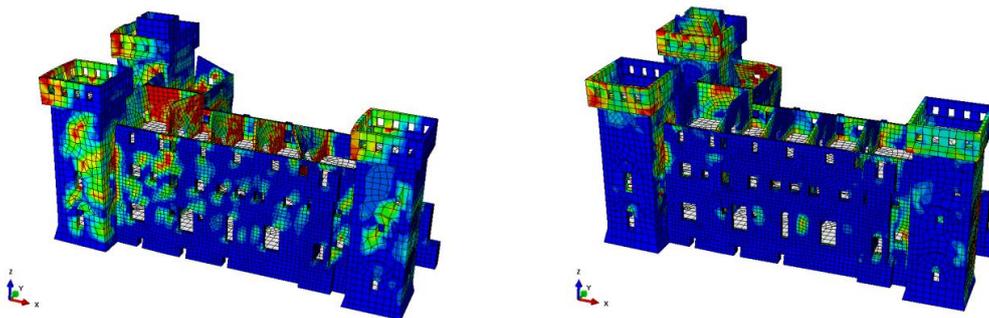
Fig. (6). Results of the pushover analyses.

(a) Capacity curves

(b) Damage map for the G1–X distribution

(c) Damage map for the G1–Y distribution

The capacity curves and the damage maps for the aforementioned distributions are presented in Fig. (6). In the former, the vertical axis displays the resultant of the static seismic load applied to the model divided by the total mass of the structure. This is a non-dimensional horizontal acceleration expressed as a fraction of the gravitational acceleration g . Such a representation allows the determination of the collapse acceleration for the structure in a very straightforward manner, taking into account all the numerical and theoretical assumptions done. Moreover, the value of collapse acceleration can be directly compared with the spectral acceleration provided by [14].

As the figure shows, the capacity curves are quite similar in the two directions and, since the restoration intervention occurred only on the wall of the façade – aligned along axis X, thus works well under shear for the G1–X distribution – the results seem surprising, highlighting once again that the behavior of a castle is probably global and the improved mechanical properties of a single wall, albeit with important dimensions, does not affect in an appreciable manner the global behavior of a large structure. The G1–X distribution originated widespread damages also in the restored façade, more severe than those coming from the other distribution, which may look counterintuitive but could be explained due to the interaction between the towers and the façade.

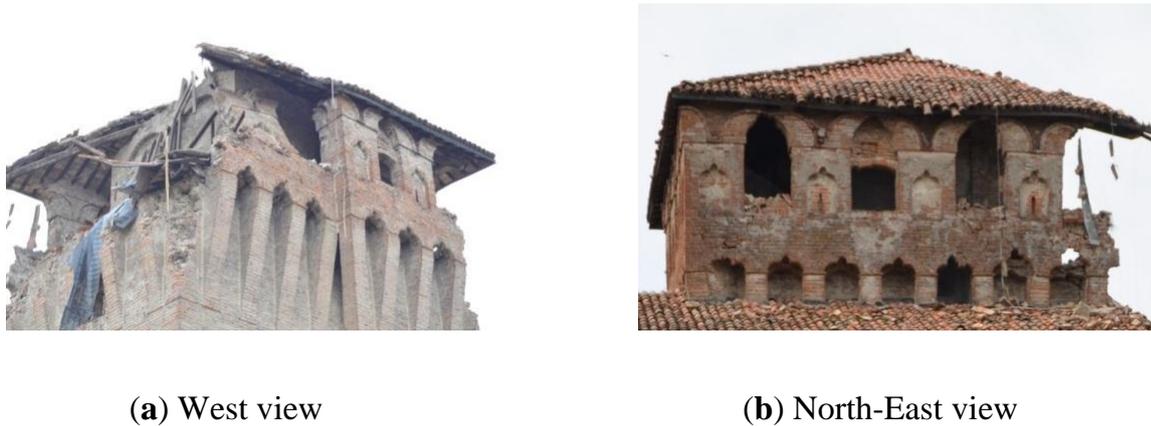
Fig. (7). Damages on the West tower crown, where partial collapses were observed.

As mentioned in a previous section of this paper, the earthquake caused widespread damages on the crown of the three towers of the castle, especially the one facing the West direction – see pictures in Fig. (7).

For this reason, limit analyses is carried out on the crown of the towers, considering three possible failure mechanisms: simple, composite and corner out-of-plane overturning. Table 4 presents the comparison between the rocking failure collapse acceleration (related to a specific mechanism) and the peak and mean accelerations of the May 20th main shock. The results clearly show that all three mechanisms were activated on the West tower, as occurred in reality in different portions of the crown, whereas no mechanism activated for the other two towers, which were indeed less damaged.

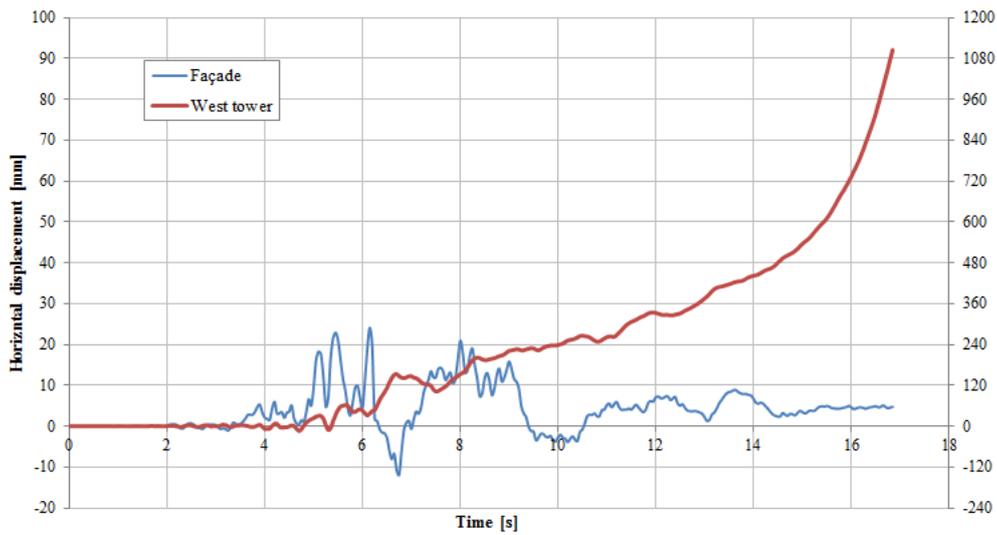
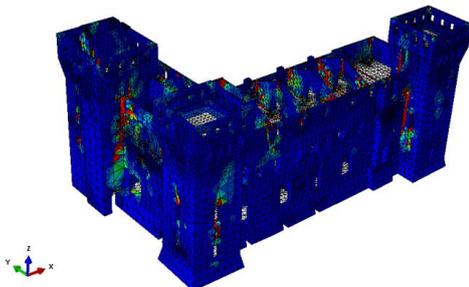
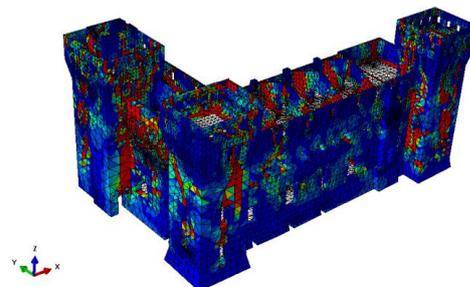
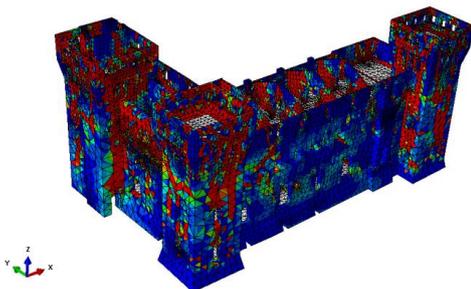
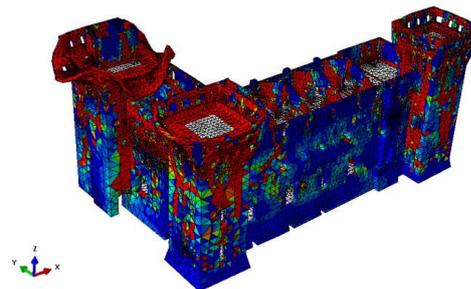
Fig. (8). Results of the nonlinear dynamic analysis.

(a) Comparison of horizontal displacement histories

(b) Damage map at the absolute peak acceleration in X

(c) Damage map at the absolute peak acceleration in Y

(d) Damage map at half-time of the accelerogram

(e) Damage map at the practical end of the accelerogram

The time-displacement diagrams of two control points and the evolution of the damage map over time are provided in Fig. (8). The displacement history for the control point on the façade (axis on the left in Fig. (8a)) displays small oscillations and a low value of residual displacement (equal to 5 mm), meaning that the restoration had beneficial effects. Conversely, for the point on the West tower (axis on the right), the displacement grows exponentially, with a value of residual displacement greater than 1 m, which is certainly consistent with the actual activation of collapse mechanisms on the crown.

The evolution of the damage map over time suggests the development of widespread damages (red zones in the map) on the upper part of the Castle and especially of its three towers. In particular, the damage map depicted in Fig. (8e) clearly indicates the activation of collapse mechanisms on the crown of the West tower, mirroring again the real outcome.

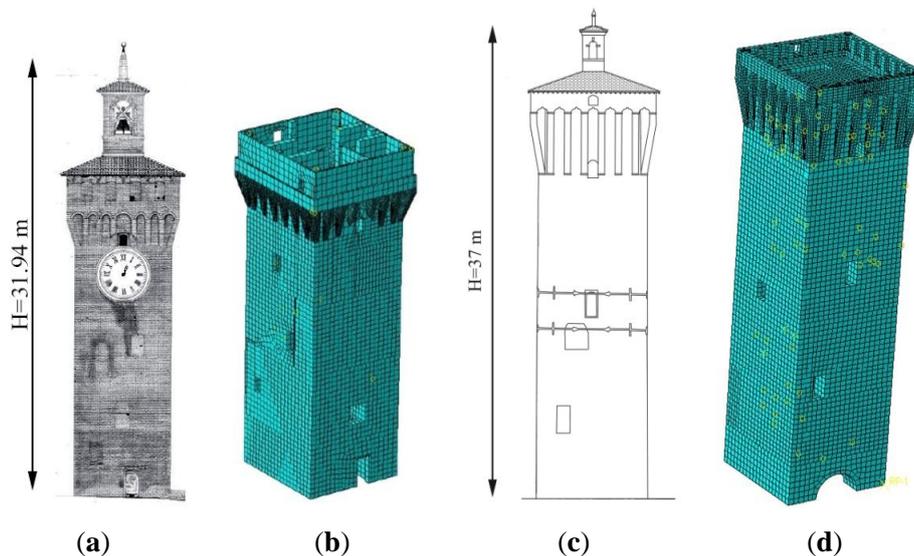
Fig. (9). Geometry and FE meshes of the Clock Tower (a and b) and the Fortified Tower (c and d).

For the two towers, investigated also in [13] and here critically re-analyzed, all the computational analyses were carried out in Abaqus. The finite element meshes were created after importing the geometrical models of each tower from Rhinoceros, and both consisted of only brick elements. They are shown in Fig. (9).

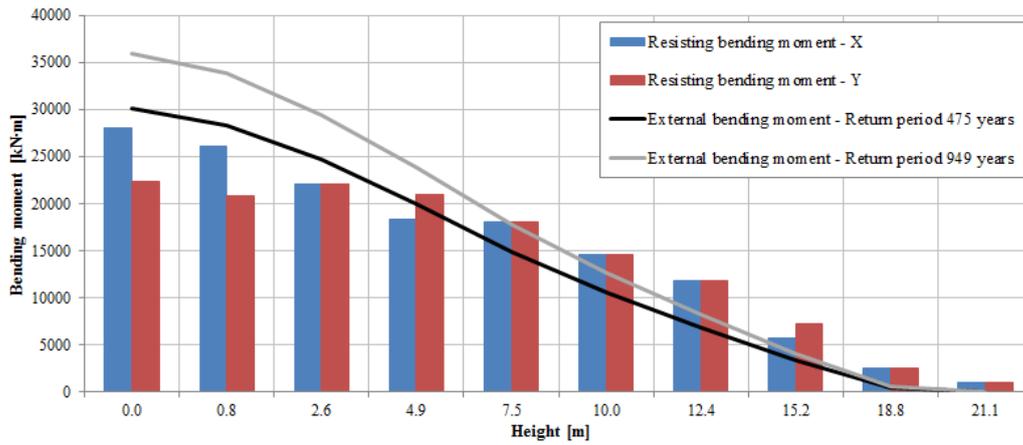
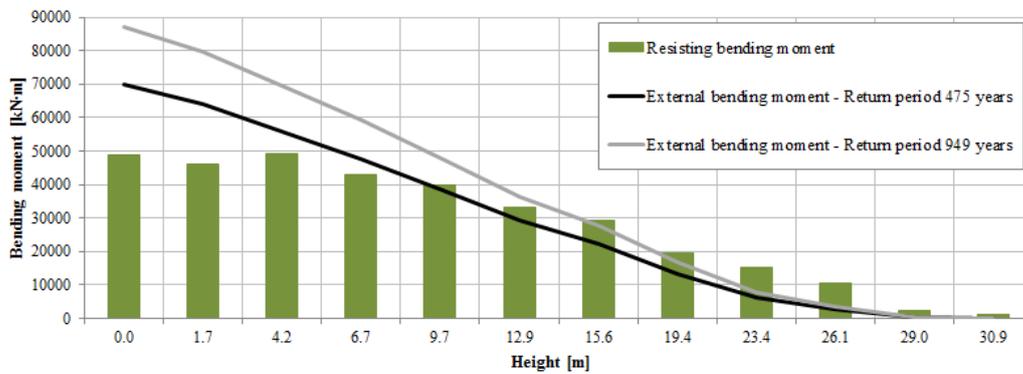
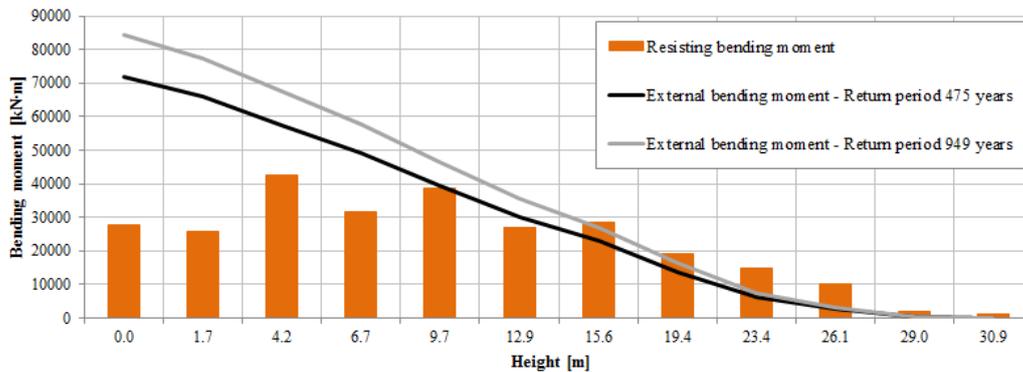
Fig. (10). Comparison between resisting and external bending moments.

(a) Clock Tower

(b) Fortified Tower - X

(c) Fortified Tower - Y

The aforementioned simplified approach was used for both the Clock and Fortified Towers, and the results are synoptically reported in Fig. (10). The equivalent static analyses were extensively commented in [13], where the reader is referred to also for further details regarding the evaluation of the so-called seismic safety index and acceleration factor, which [2] deems useful for seismic assessments. Here it is worth noting that, using a cantilever beam approach and exception made for towers with huge irregularities, collapse systematically occurs due to the formation of a plastic hinge induced by bending near the base, where the resisting bending moment is usually lower than the external one (see Fig. (10)). This outcome appears rather unrealistic compared to the actual behavior observed during an earthquake. Indeed, for such occurrence almost all the towers experience either the formation of vertical cracks or full collapse

caused by the formation of a mixed shear-bending hinge. Therefore, more sophisticated analyses (*e.g.* nonlinear dynamic analyses) should be conducted to have a more realistic insight into the behavior under horizontal loads of such structures.

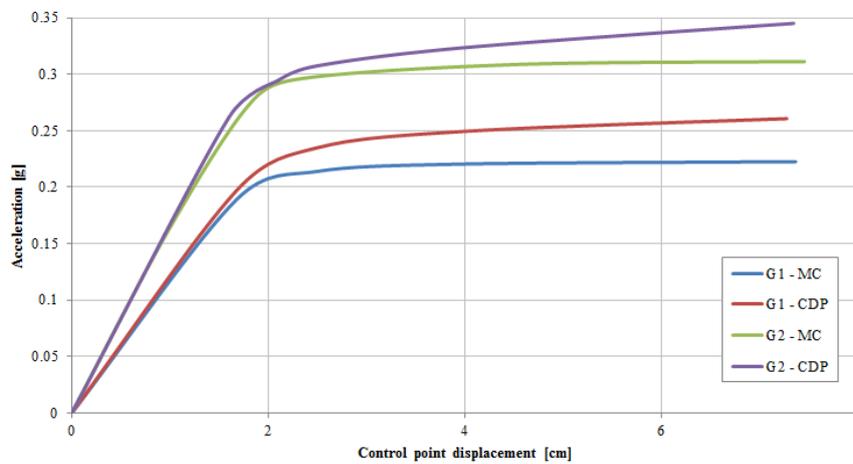
Fig. (11). Comparison among capacity curves for the Clock Tower obtained with different material models and load distributions.

The pushover analyses were carried out in agreement with [14]. Two different load distributions were applied to the numerical models: one was the G1 previously described, whereas the other was only dependent on the masses and uniformly distributed along the height – consistent with the Group 2 (G2) as defined in [14]. The capacity curves for both towers are shown in Fig. (11), and they were evaluated for each material model and load distribution here considered. The results showed that the CDP and MC materials gave similar responses, demonstrating a good correspondence between the two models and hence implicitly validating the use of an elastic-perfectly plastic model for the analysis of such structures in the nonlinear range. As expected, the G1 distribution produced more conservative results than the G2 one, thus it should be preferred when choosing the distribution to apply in nonlinear static analyses.

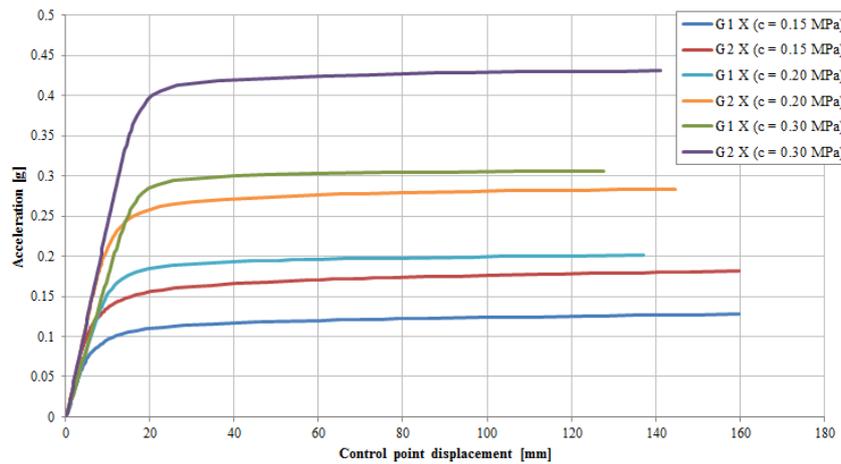
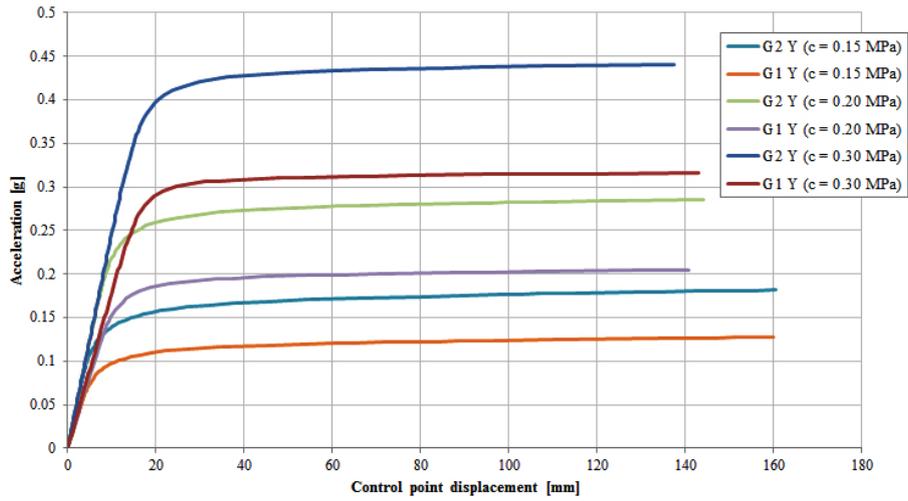
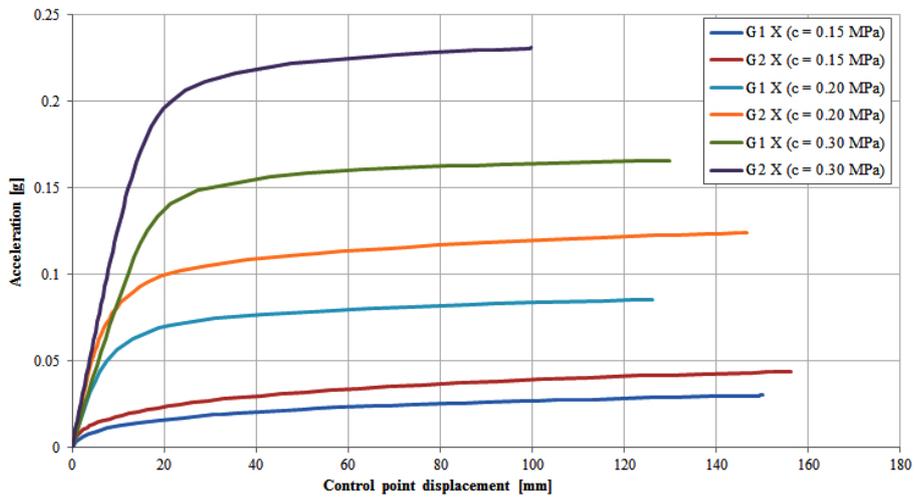
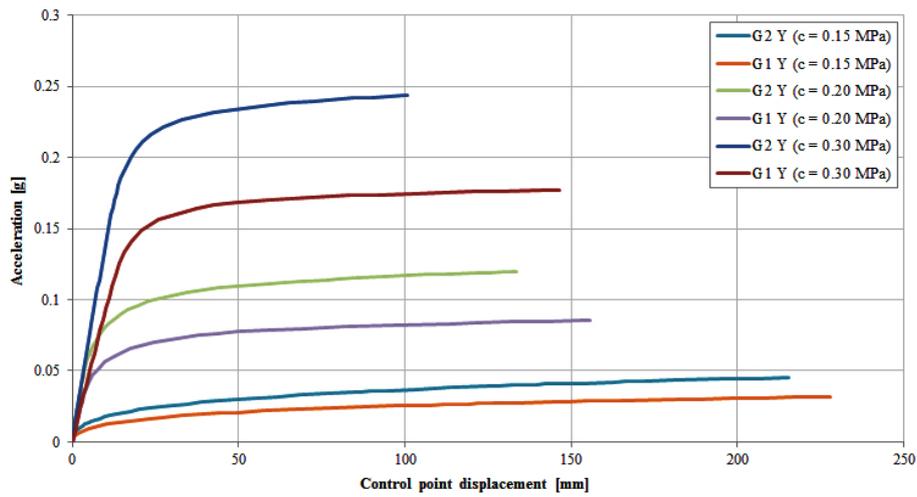
Fig. (12). Capacity curves over a range of cohesion values.

(a) Clock Tower - X

(b) Clock Tower – Y

(c) Fortified Tower – X

(d) Fortified Tower – Y

Pushover analyses are then repeated varying the cohesion value over a wide range (0.15, 0.20 and 0.30 MPa respectively) for both towers and the two load distributions. The capacity curves for all the cases are depicted in Fig. (12). It can be noted that cohesion plays a crucial role on the peak load value, because failure occurs for the formation of a mixed shear and bending hinge near the base.

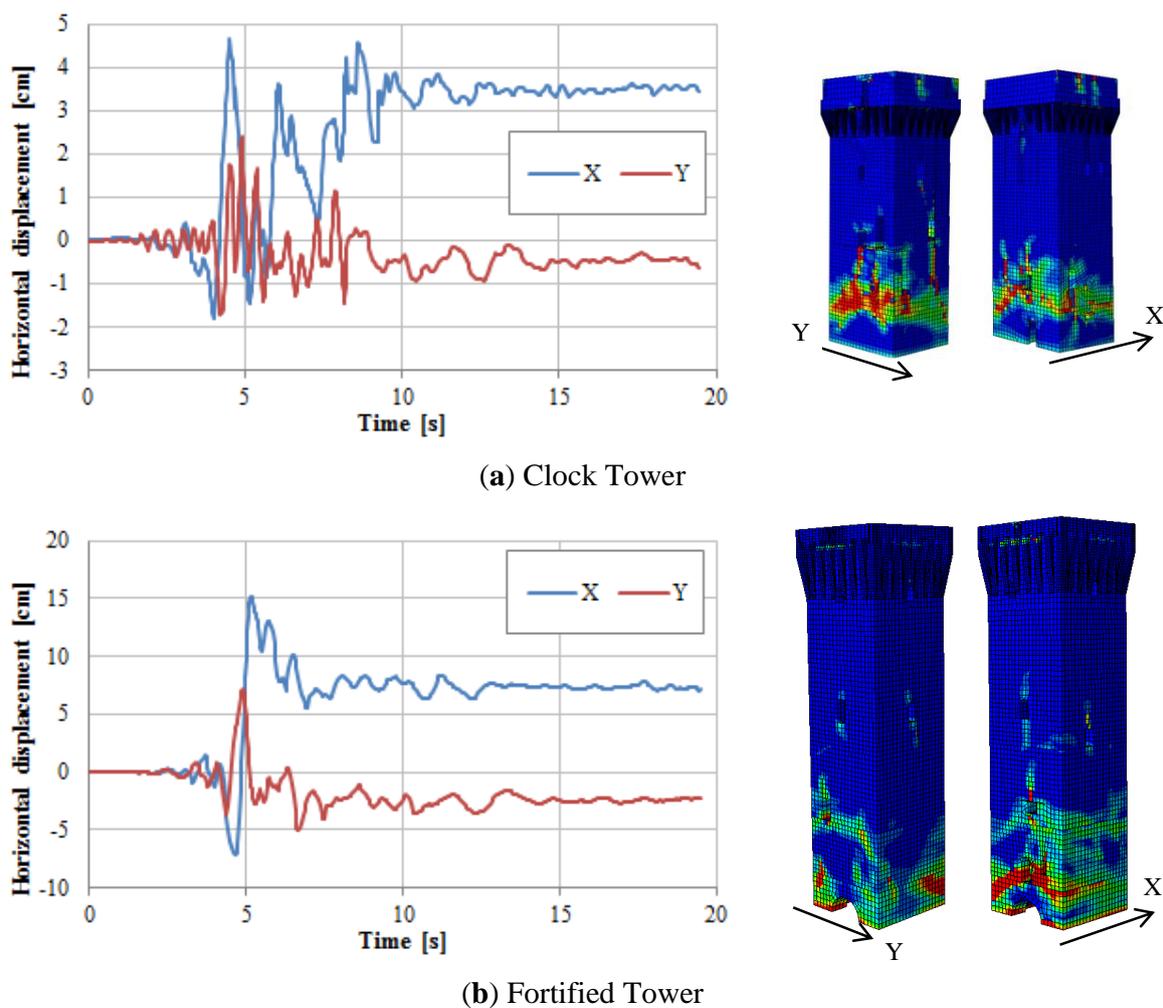
Fig. (13). Horizontal displacement histories of the reference points and damage maps at the end of simulation.

Fig. (13) presents the results obtained in terms of time-displacement diagrams and damage maps at the end of the simulation. The horizontal displacement of each tower was extracted in reference points located at the very top of the computational models. The maps showed widespread damages at the base of the towers, suggesting that failure occurred due to the formation of an inclined plane of weakness – a shear plane; moreover, vertical cracks appeared close to the openings, in a good representation of the real outcome. The horizontal displacement histories showed residual displacements compatible with the collapse of the towers (about 3.5 and 7.5 cm for the Clock and Fortified Towers, respectively).

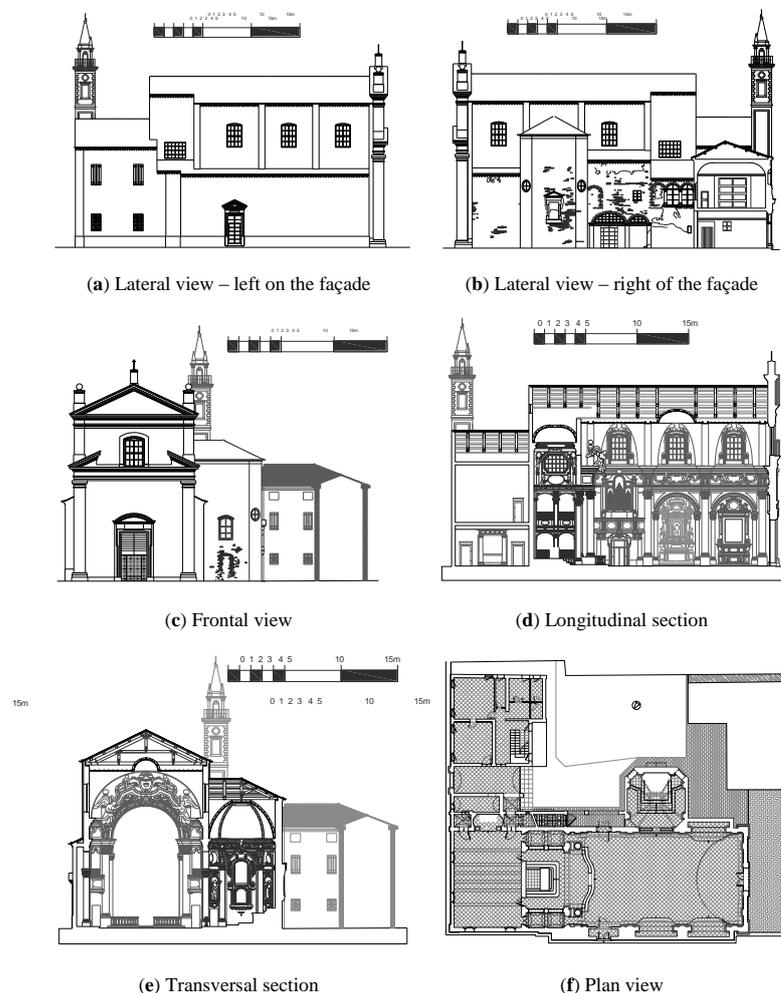
Fig. (14). Geometrical details of the Rosario church.

The so-called Chiesa di Santa Maria del Rosario (from now on labelled “Rosario church”) is a historical, unreinforced brick masonry structure located at the Northern boundary of Finale Emilia (Fig. (1)). Geometrically, the structure presents a rectangular plan with dimensions approximately equal to 32x13 m. It is constituted by a large single nave (roughly 20 m long and 13 m wide) and a rectangular presbytery with dimensions equal to 7x13 m. The average thickness of the walls is 50 cm. The height of the façade is about 17 m, and a two-story building (whose height is 13 m) is directly connected to the back of the apse. The interior walls are supported by semicircular arches and columns. The bell tower is about 20 m high and is partially linked to the main building at one of its corner. Fig. (14) shows geometric details of the Rosario church.

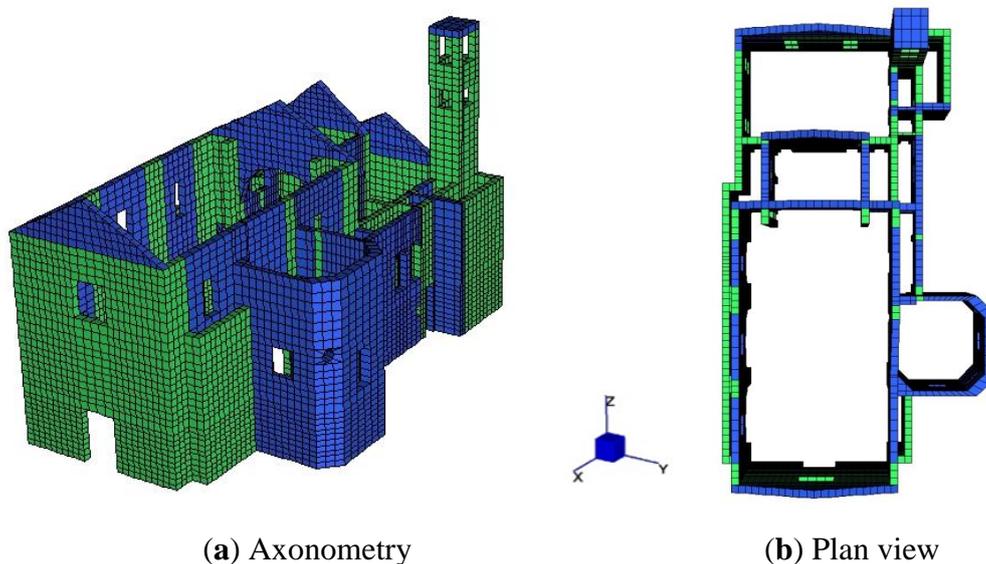
Fig. (15). Numerical model of the Rosario church.

The numerical analyses were performed using the commercial code Strand7. The computational model of the Rosario church presented a finite element mesh consisting mainly of brick elements with the addition of some wedge elements, for a total of 19275 nodes and 9076 elements as shown in Fig. (15). Non-structural wooden elements like

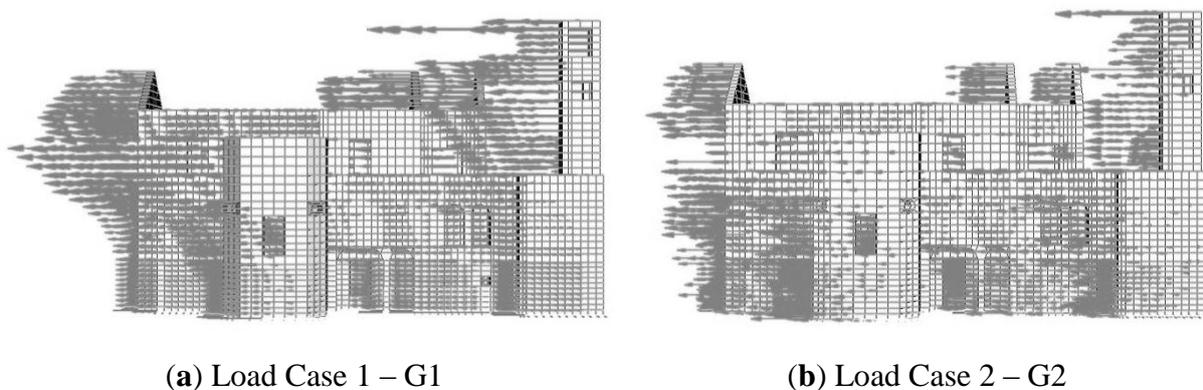
Fig. (16). Distribution of nodal loads along the positive direction of the local X axis.

The nonlinear static analyses were again performed according to [5]. The horizontal loads applied to the numerical model were consistent with the G1 and G2 distributions previously described, and they are respectively labeled Load Case 1 and Load Case 2 in the analytical computations reported hereafter. Both distributions were applied along the positive and negative directions of the local axes chosen for the Rosario church (namely, X is the longitudinal axis and Y is the transversal one). As an example, Fig. (16) shows the two distributions along the local axis X.

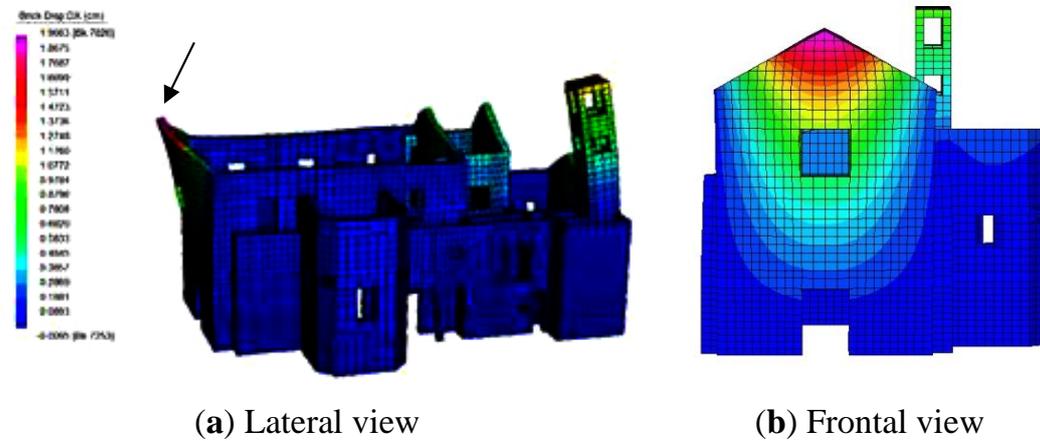
Fig. (17). Load Case 1 applied along the positive X direction: deformed shape at collapse and contour plot of displacements.

Fig. (17) shows the deformed shape at the last iteration of the pushover analysis performed with the load distribution presented in Fig. (16a).

The results clearly show the formation of a failure mechanism that involves the overturning of the façade in its upper part, the failure of the bell tower, and damage in the lateral walls of the central nave. The general state of inelastic deformation and the active failure mechanisms appear in satisfactory agreement with the state of damage occurred in reality.

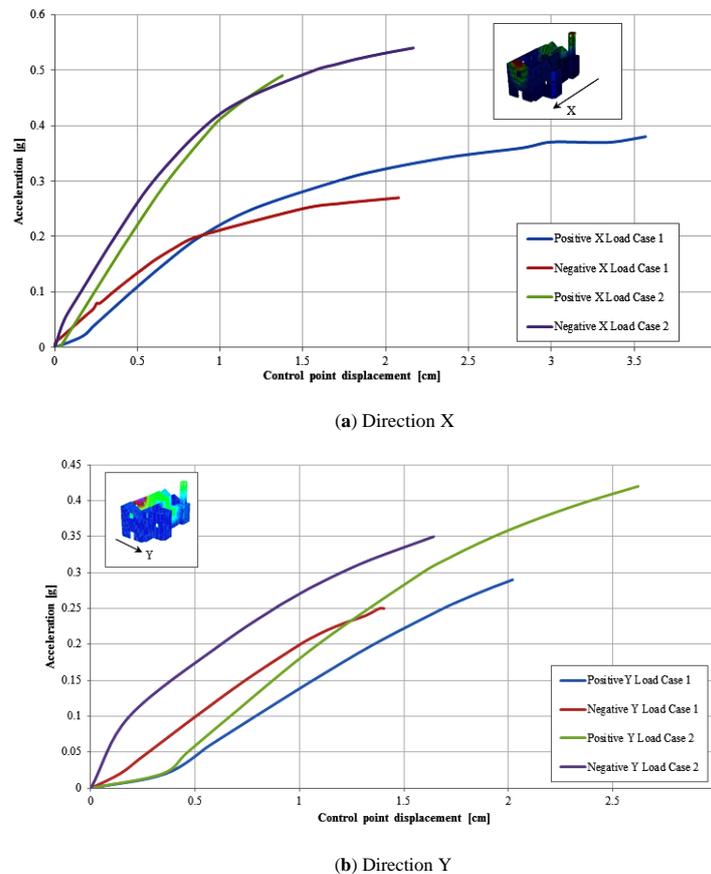
Fig. (18). Capacity curves for the Rosario church with cohesion equal to 0.15 MPa.

The capacity curves obtained for both load cases are displayed in Fig. (18).

High values of the collapse accelerations are obtained from the capacity curves, even for the Load Case 1. Such results do not completely justify the state of damage induced by the earthquake, and the discrepancy is mainly linked to the cohesion value assumed for masonry.

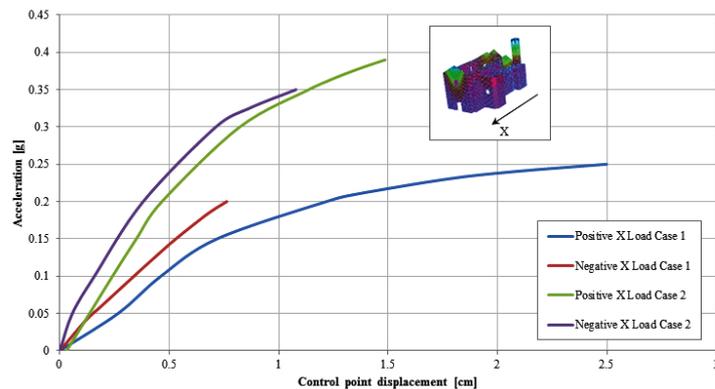
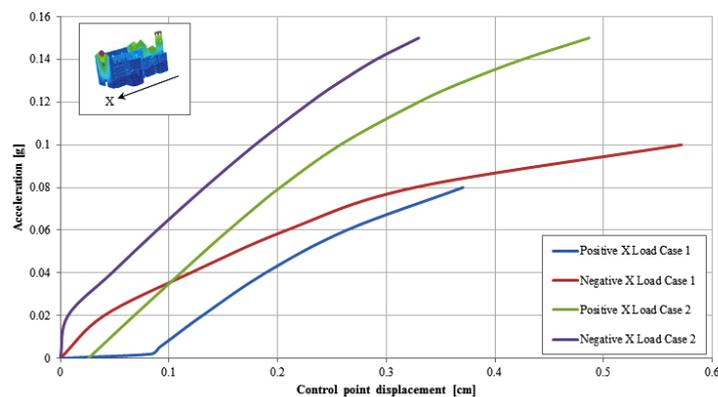
Fig. (19). Capacity curves for the Rosario church with lower values of cohesion, along the X direction.

(a) Cohesion equal to 0.1 MPa

(b) Cohesion equal to 0.05 MPa

In order to investigate the role of cohesion, a sensitivity analysis was carried out by considering two lower values for the parameter, namely 0.1 MPa and 0.05 MPa. It was expected that the capacity curves would be more realistic for decreasing values of cohesion, which well approximates the situation of a no-tension material. Fig. (19) shows the capacity curves for cohesion equal to 0.1 MPa and 0.05 MPa, respectively, along the X direction.

The results show that the failure mechanisms activating on the church do not considerably change when compared to those obtained for a higher cohesion value. Conversely, the values of collapse acceleration are sensibly reduced. In particular, a gradual reduction in the displacement capacity of the structure is observed for decreasing values of cohesion. Moreover, for the case where the cohesion was set equal to 0.05 MPa, the results show that an acceleration lower than 0.1g is responsible for the collapse of the structure, which appears reasonable in light of the experience collected with damages induced by the seismic sequence and the knowledge about the characteristics of the accelerograms. Visible inelastic shear deformations may be also noticed on the façade, a result which appears consistent with the actual outcome.
