Cultural Heritage and Earthquake: The Case Study of “*Santa Maria Della Carità*” in Ascoli Piceno

Francesco Clementi*, Enrico Quagliarini, Francesco Monni, Ersilia Giordano and Stefano Lenci

Department of Civil and Building Engineering, and Architecture (DICEA) Polytechnic University of Marche, Ancona Italy

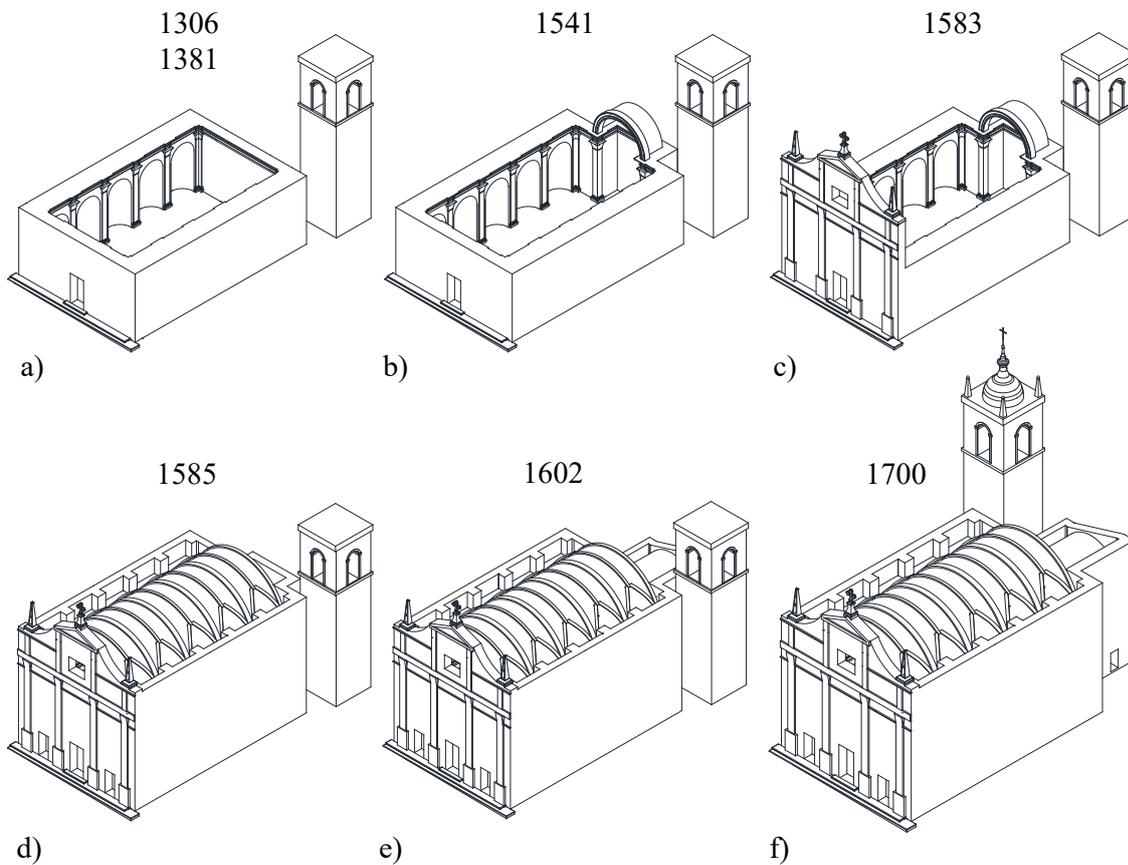
Fig. (2). *Santa Maria della Carità* (Ascoli Piceno, Marche, Centre of Italy) evolution through ages.

The period of its construction is unknown, but the first proof of the existence of a little church, dating back to 1306, can be found in a parchment. On the Northside of the Church, there is an annex that was built in 1196 and that hosted a hospital; this hospital, in particular, was managed by the same fraternity that took care of the church. The old church was very different from the actual one (2a-2b). Later, from the early years of the 16th century up to 1583, the building was partially demolished and re-built in various phases and in the same place, with the modification of the facade by raising the tympanum and by opening the doors on the front facade Fig. (2c). Further to this intervention, the nave was covered with a masonry vault and connected to the apse through a triumphal arch. Therefore, iconographical documents attest the presence of a pre-existing bell-tower on the opposite side by comparison to the actual one Figs. (2d-2e). So the triumphal arch was built during the 16th century, but the actual bell-tower was built only at the end of the 17th century, after almost one hundred years (Fig. 2f) [24, 25].

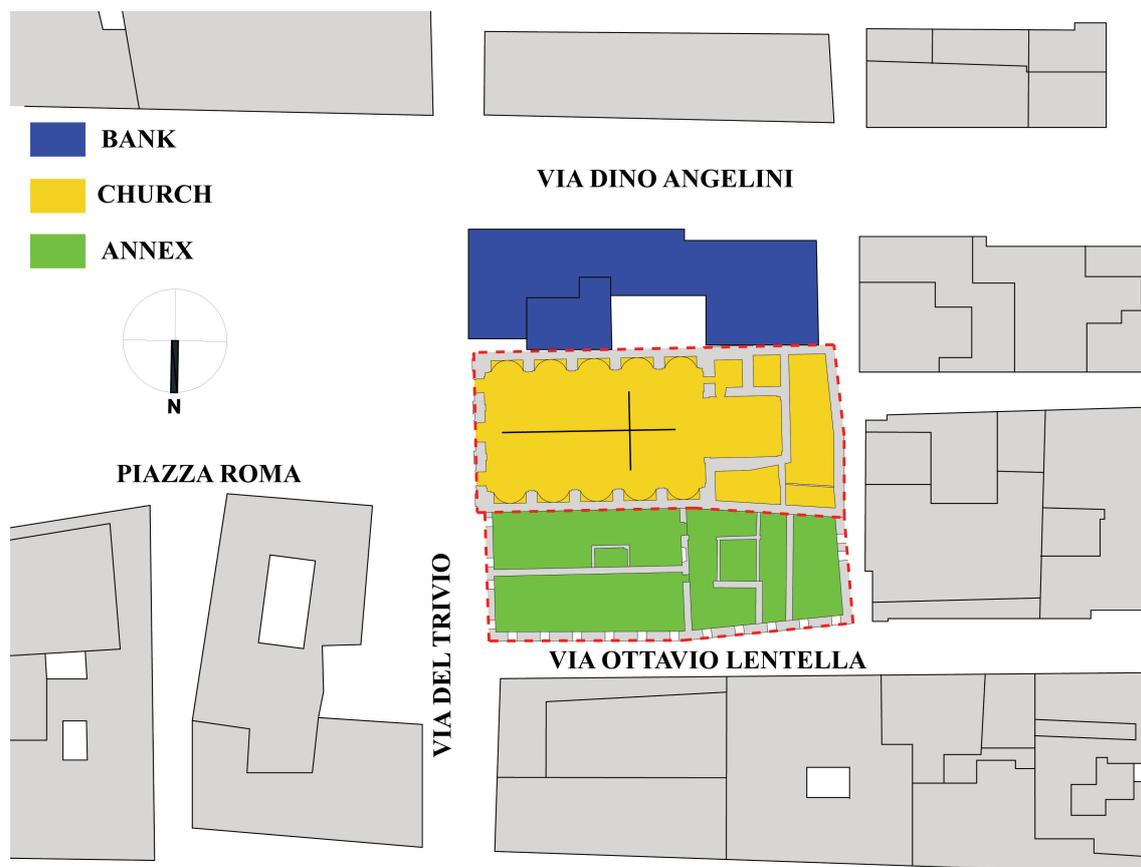
Fig. (3). The church and the annex.

Between 1930 and 1932 Fig. (3) the south allay of the church was closed after the edification of a building that features a concrete frame that is totally disconnected to the church. This very building now hosts a bank.

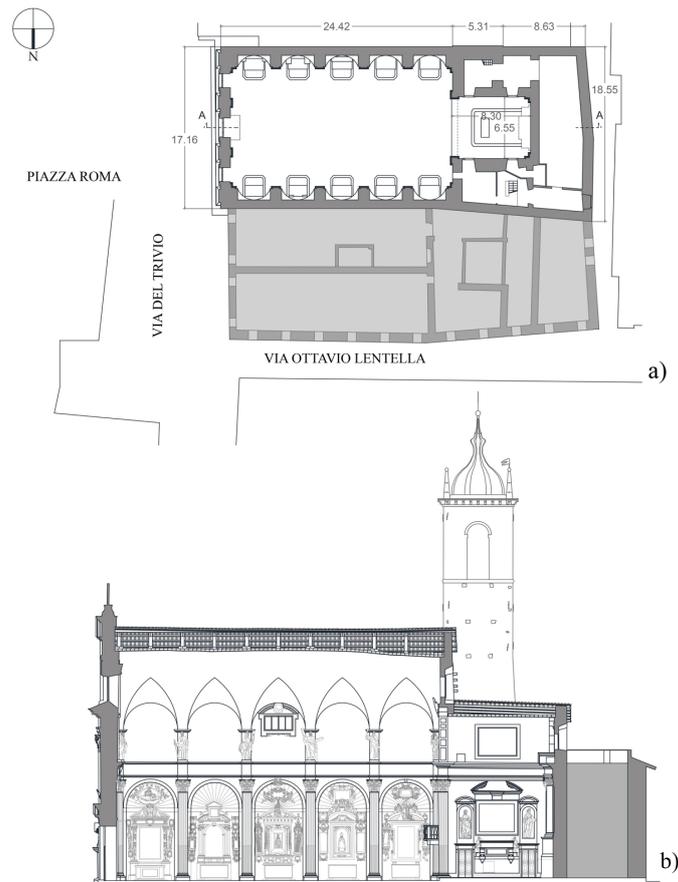
Fig. (4). Actual planning and section of the church.

The church has a unique nave of 12.93 m wide, 23.15 m long and has a maximum height of 16.5 m; it ends with a rectangular apse of 6.55 m wide, 8.30 m long and with a height of 11.95 m Fig. (4). The apse is inside the sacristy, that counts two floors and has a maximum height of 15.90 m. In the sacristy, there is also the bell-tower: it has a square shape with side of 4.31 m and a maximum height of 27.80 m. The thickness of the walls ranges between 2.21 m (the piers of the nave) and 0.91 m (the walls of the nave). The bearing structure is made of stone masonry; the main façade, characterized by three front doors, has ornaments with classical patterns (columns, tympanum, cornice) and the masonry layer is constituted by white travertine; the nave is covered by a brick elliptic vault (like the apse zone) with lunettes that create small ornamented niches that are joint to the internal columns. Also in *Santa Maria della Carità*, like many other Italian churches, the triumphal arch separates the nave area from the apse. The arch is inserted in a masonry panel, with an elliptically shaped opening that is about 1.2 m thick.

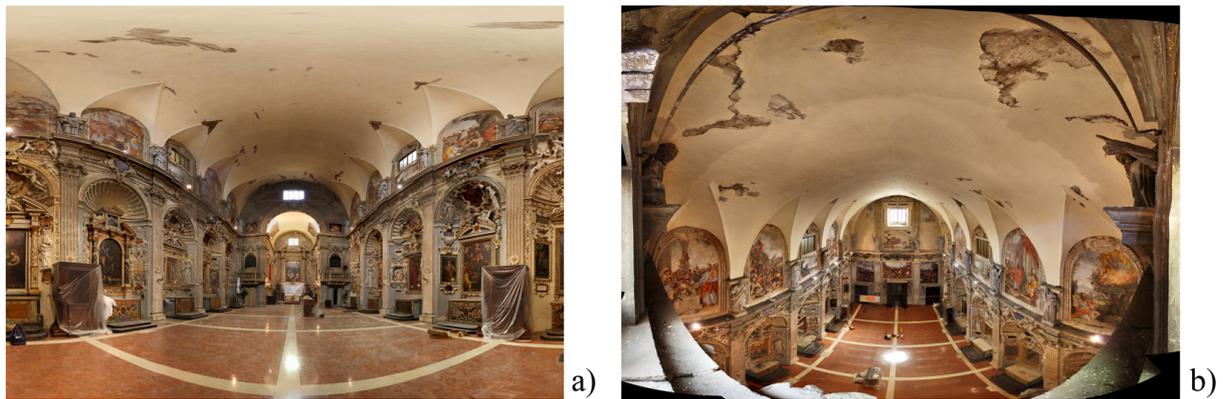
Fig. (5). Visible damage after L'Aquila earthquake (2009) in the triumphal arch area (a) in the façade area (b).

After L'Aquila earthquake in 2009, the church was closed due to several cracks on the triumphal arch (Fig. 5) and on the vault of the nave. Other damages were visible in the non-structural elements inside the church. Moreover, a possible activation of the overturning mechanism of the facade was observed; in fact, there were cracks on the connection with the vault.

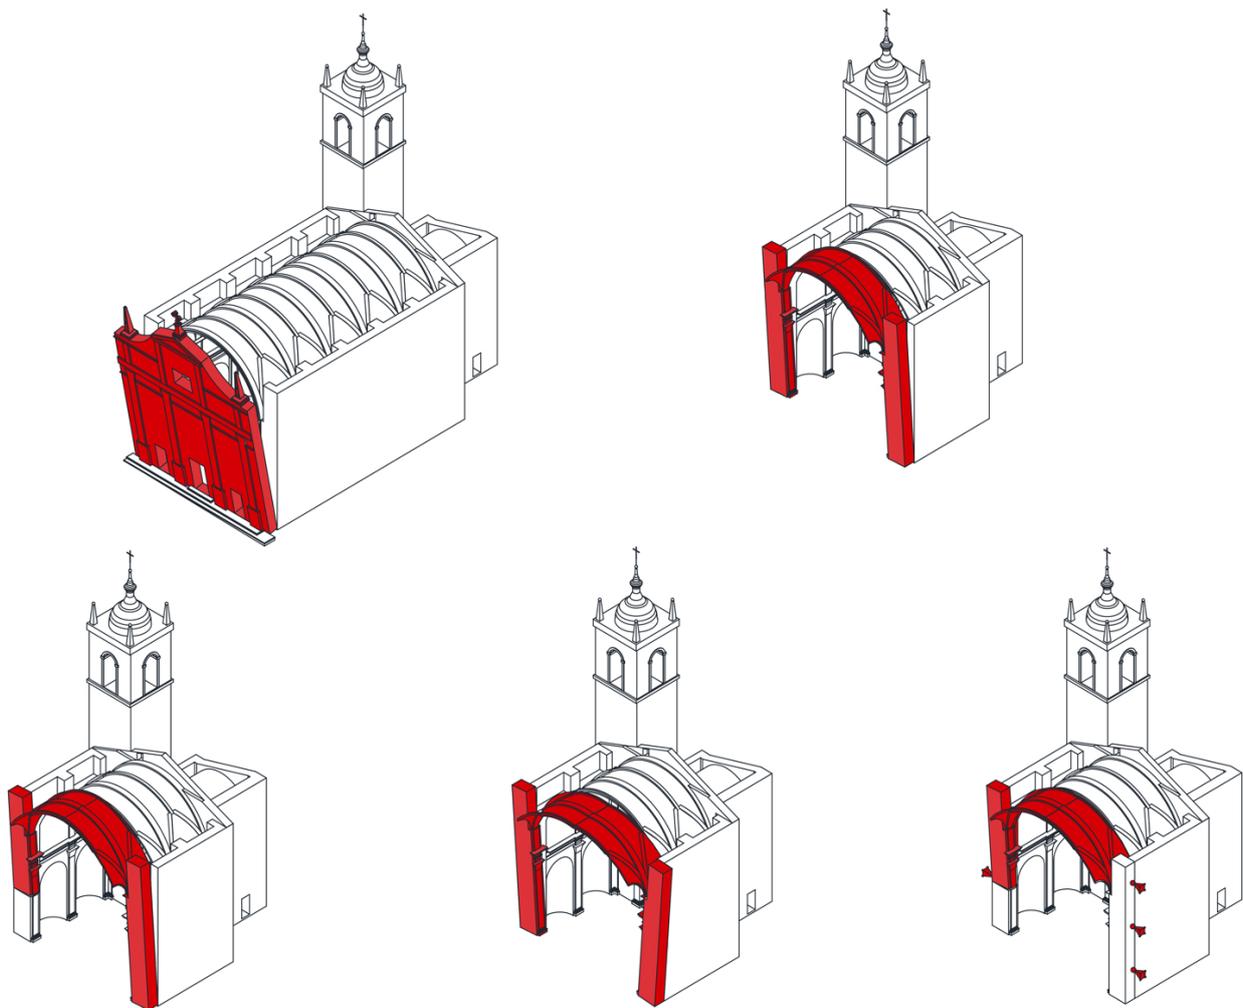
Fig. (6). Main mechanisms analysed for *Santa Maria della Carità* church.

For the *Santa Maria della Carità* church, the linear kinematic procedure was implemented in order to analyse the possible activation chosen from the twenty-eight failure mechanisms contained in [10]. Actually, the following overturning mechanisms depicted in Fig. (6), can be activated:

- Out-of-plane overturning mechanism of the facade;
- Out-of-plane overturning mechanism of the wall of the nave;
- In-plane damage mechanism of the vault of the nave.

The acceleration of the activation of the mechanism has been computed by following the Italian standards [26, 27]. To prevent the activation of these mechanisms, some interventions have been designed.

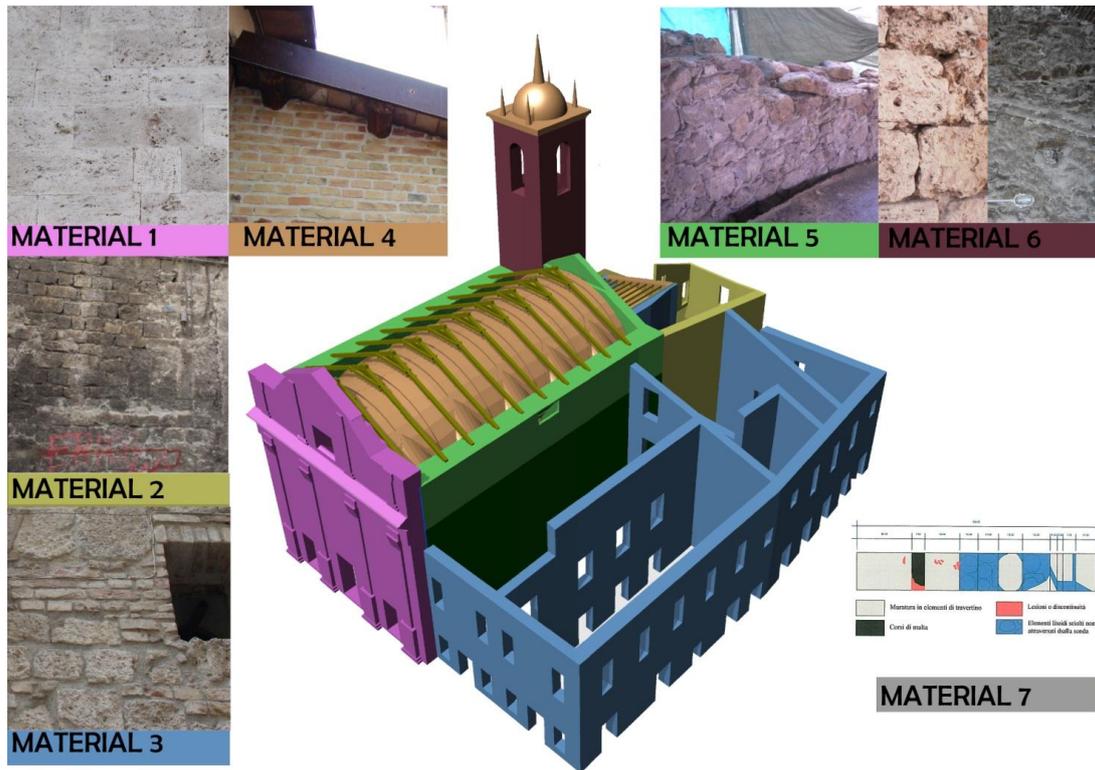
Fig. (7). Material characterisation of the *Santa Maria della Carità* church.

The masonry was not completely visible, and for this reason, a lot of surveys were performed (Fig. 7), in order to accurately recognize the masonry type and to confirm the wall thickness. To complete some missing data from in-situ tests, the Italian Codes for existing masonry buildings [26, 27] have been consulted.

Table 1. Mechanical characteristics of the main elements (see also Fig. 7).

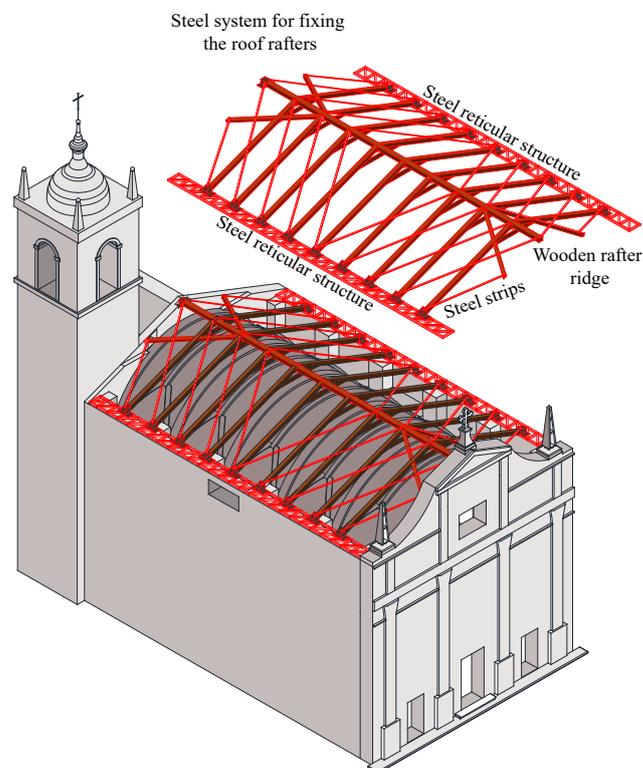
Fig. (8). The reticular system for the retrofitting of *Santa Maria della Carità*: a 3D view.

Hence, it has been suggested that the roof slabs should be stiffened in their plane in order to be considered as rigid diaphragms and new timber beams, replacing the deteriorated existing ones, should be anchored to the bearing walls. The interventions consisted of making a reticular beam system on the plan of a pitched roof. The reticular beam system is composed of metal bands that act as strings, wood stands that serve as rafter, ridgepole, and framework curb, which serve respectively as (higher) tense and (lower) compressed truss (Fig. 8).

The retrofitting system is able to (i) contrast the out-of-plan collapse of façade, (ii) contrast out-of-plan collapse of the tympanum on the triumph arch, (iii) balance the thrust of the vault on the walls nave, (iv) stiffen the gabled roof. The post intervention is evaluated, again, with the linear kinematic analysis. This intervention permits to verify all the mechanisms. In order to limit the cracking on the nave vault, and on the triumph arch, carbon FRP strips were inserted to the extrados of these elements.

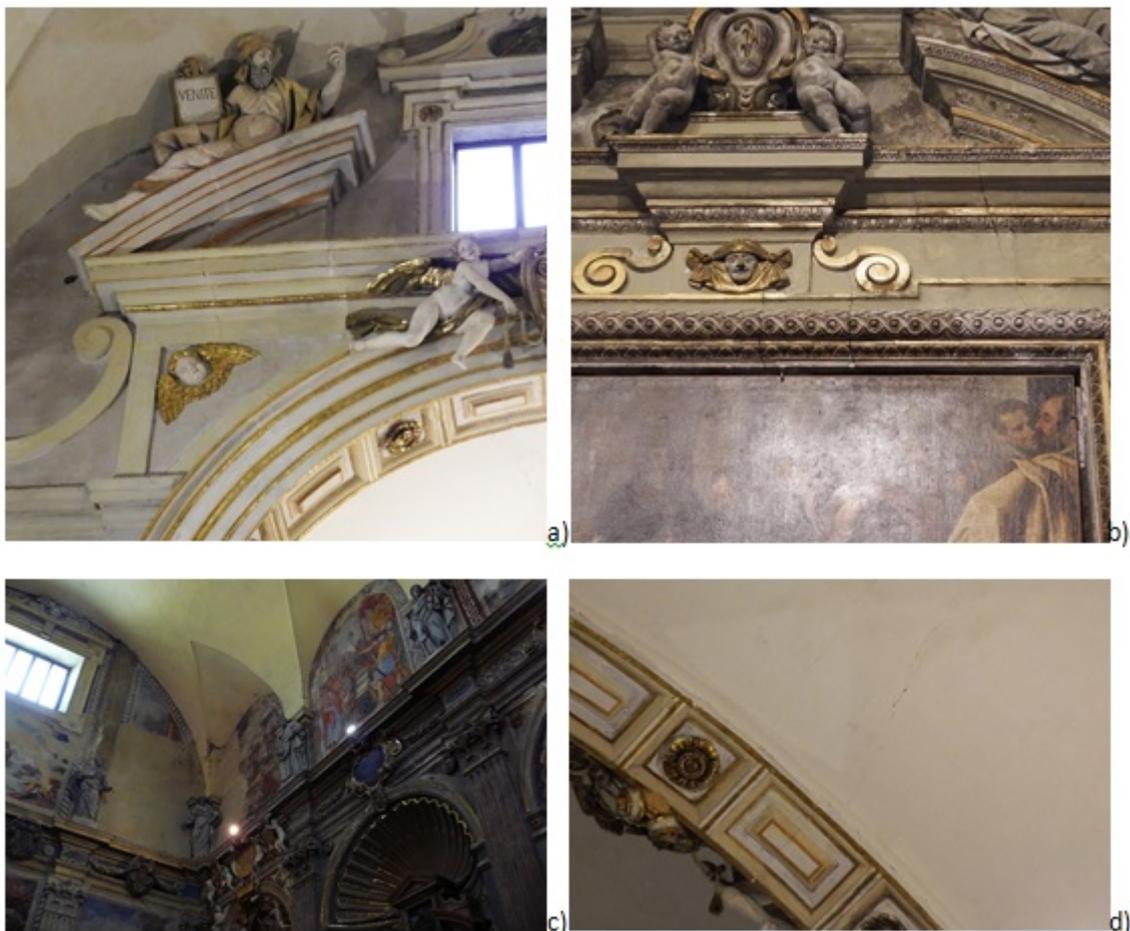
Fig. (9). Cracking after the seismic events of 2016 in *Santa Maria della Carità*: stuccos on the triumphal arch (a), stuccos on the walls of the main naves (b), horizontal micro-cracking on the lunette (c), micro-cracking on the vault of the presbytery (d).

After the seismic event in October 30th, only a few cracks have appeared on the stuccos of the triumphal arch and of the walls of the nave (Fig. 9a and 9b), confirming that the main mechanisms (as pointed out in chapter 3) did not activate as in the previous seismic event in 2009, consequently, this represents the first in-situ test of the intervention. The recurring observable damage (see Figs. 5b and 9c) between the two earthquakes is the horizontal cracking on the lunette near the façade. Differently, new micro-cracking appears on the vault of the presbytery near the triumphal arch (Fig. 9d).

belfry are located. In Y-Direction, the cracking distribution is more uniform and limited with respect to X-Direction, but, when the load is increased, the tower becomes more damaged especially on the connection with the church walls and less damage is associated to the top of the belfry. Finally, comparing the real damages reported in Fig. (9) with those of NMs in Figs. (25 and 26) when the load act in Y-Direction, a diffuse micro-cracking is observable in the middle height of the nave walls, where lunettes with some stuccos are located. Furthermore, the cracking on the presbytery vault near the connection with the triumphal arch is always visible (see Fig. 9d) in all NMs. This confirms the reliability of the proposed NMs.

Also in this case, comparing the real damages reported in Fig. (9) with those of NMs in Fig. (29) when the load act in Y-Direction, a diffuse micro-cracking is visible in the middle height of the nave walls, where some stuccos are present. Actually, this represents a specific vulnerability of this church. Differently, in both directions, a micro-cracking is visible in the presbytery vault near the connection with the triumphal arch, as reported in Fig. (9d) where the last real damage is reported.

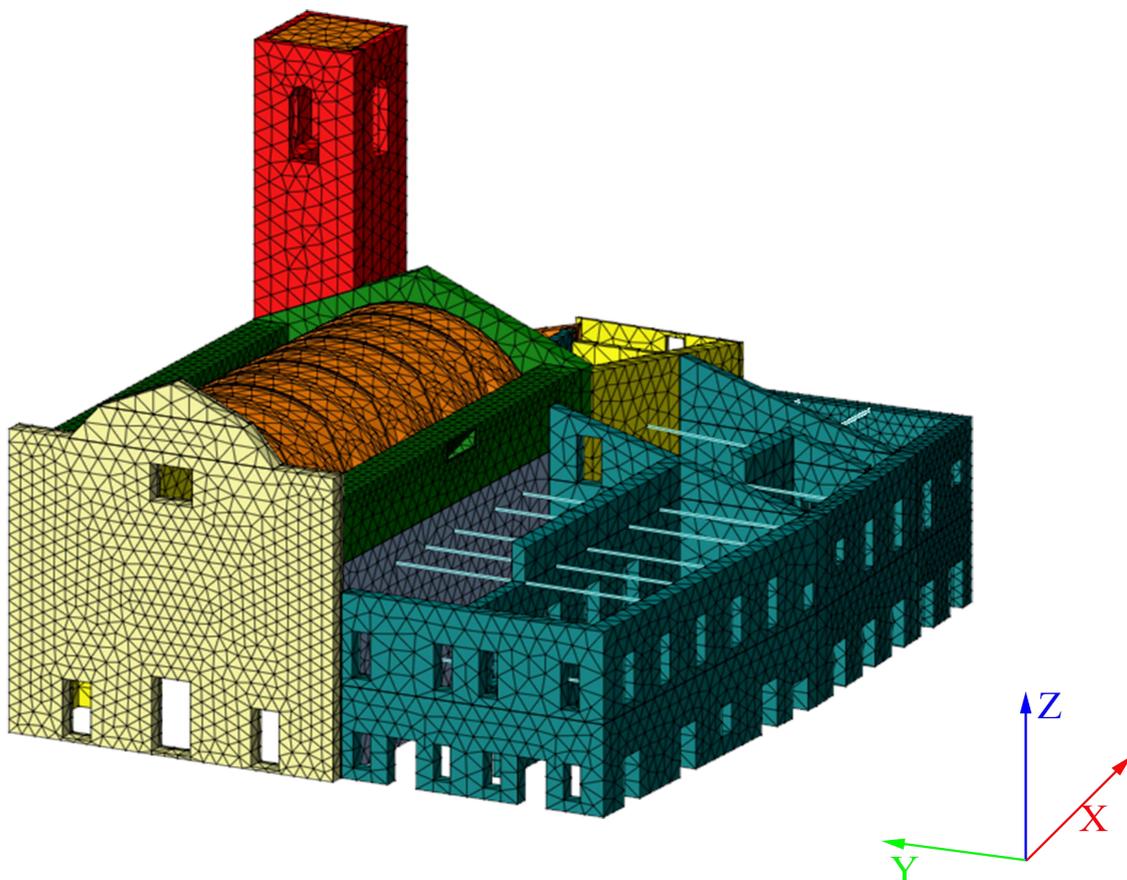
Fig. (10). Finite element model of the complex of *Santa Maria della Carità* church in Ascoli Piceno.

The panels were modelled with solid tetrahedron elements with 4 nodes [37], and optimised regular mesh (see Fig. 10) was used for discretization. The nonlinear behavior of the masonry panels of the historical complex is represented by a Total Strain Crack Model based on fixed stress–strain law concepts available in Midas FEA[®]. In this way, the cracks are fixed in the direction of the principal strain vectors that remain unchanged during the loading of the structure.

The compression behavior of the masonry was modelled by a constitutive law comprising a parabolic hardening rule and a parabolic softening branch after the peak of resistance Fig. (11a); the tension behavior was characterised by a linear hardening branch followed by a nonlinear softening branch Fig. (11b). The fracture energies in compression (G_c) and tension (G_f) are reported in Table 1, and h is the mean dimension of the mesh Fig. (10).

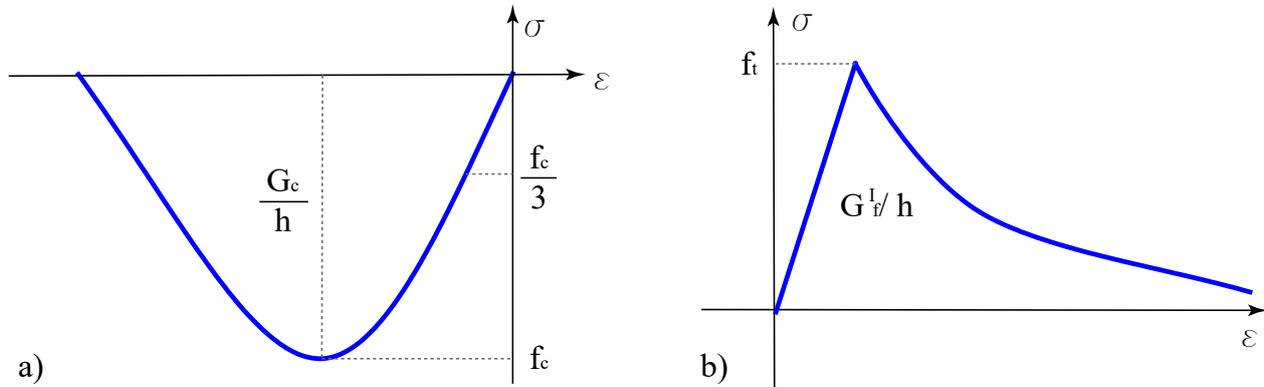
Fig. (11). Stress–strain constitutive relations used for the simulation: a) masonry uniaxial compression; b) masonry uniaxial tension.

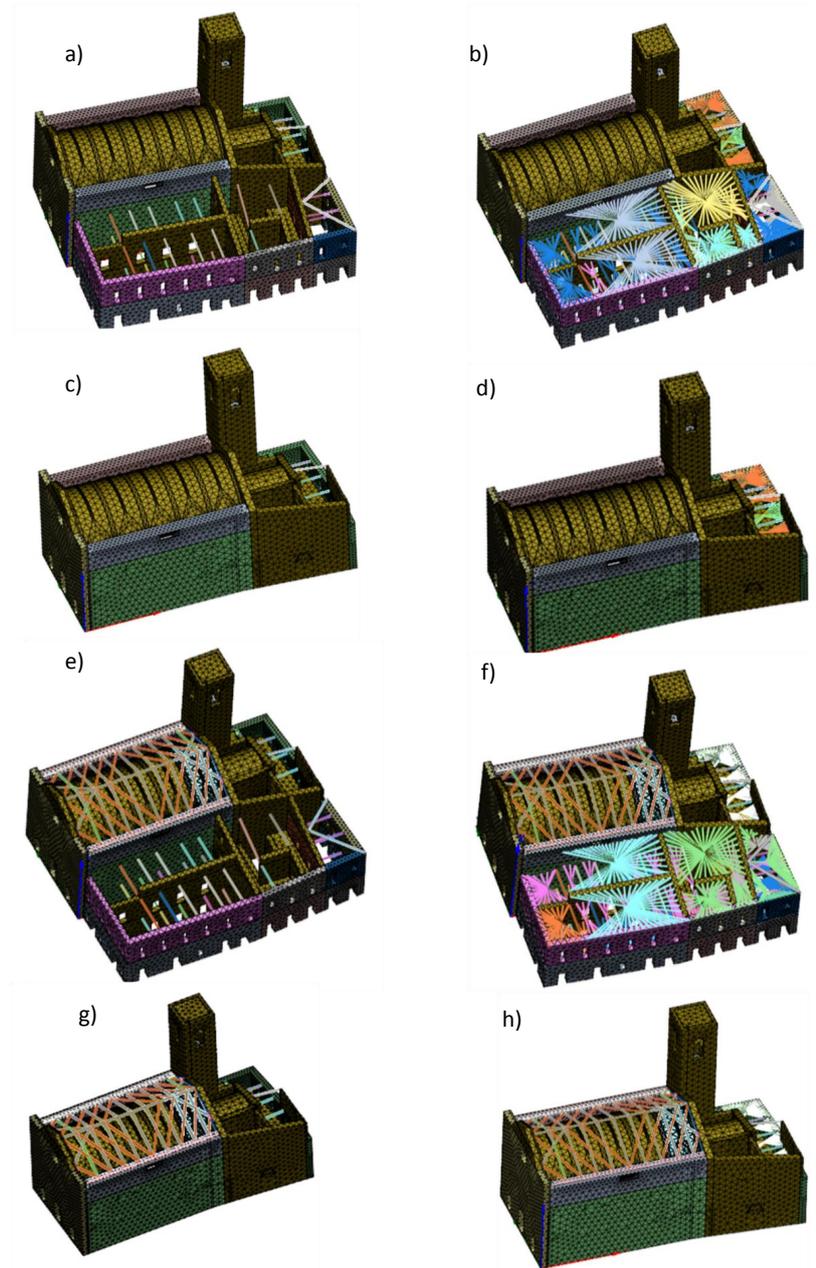
Fig. (12). Numerical Models: a) the church and the annex with flexible floors in a pre-intervention phase; b) the church and the annex with rigid floors in a pre-intervention phase; c) only the church with flexible floor in a pre-intervention phase; d) only the church with rigid floor in a pre-intervention phase; e) church and annex with flexible floors in a post-intervention phase; f) church and annex with rigid floors in a post-intervention phase; g) only the church with flexible floor in a post-intervention phase; h) only the church with rigid floor in a pre-intervention phase.

- The Church and the Annex with Deformable floors Without Intervention (C+A+D+Wi) – Fig. (12a).
- The Church and the Annex with Rigid floors Without Intervention (C+A+R+Wi) – Fig. (12b).
- The Church with Deformable floors Without Intervention (C+D+Wi) – Fig. (12c).
- The Church with Rigid floors Without Intervention (C+R+Wi) – Fig. (12d).
- The Church and the Annex with Deformable floors Post-Intervention (C+A+D+P) – Fig. (12e)
- The Church and the Annex with Rigid floors Post-Intervention (C+A+R+P) – Fig. (12f)
- The Church with Deformable floors Post-Intervention (C+D+P) – Fig. (12g)
- The Church with Rigid floors Post-intervention (C+R+P) – Fig. (12h)

In order to detect the vulnerability of the isolated church, the NMs were simplified deleting the annex and obtaining (C+D+Wi), (C+R+Wi), (C+D+P) and (C+R+P) (see Figs. 12c-d-g-h). The main capacity curves are reported in Fig. (27).

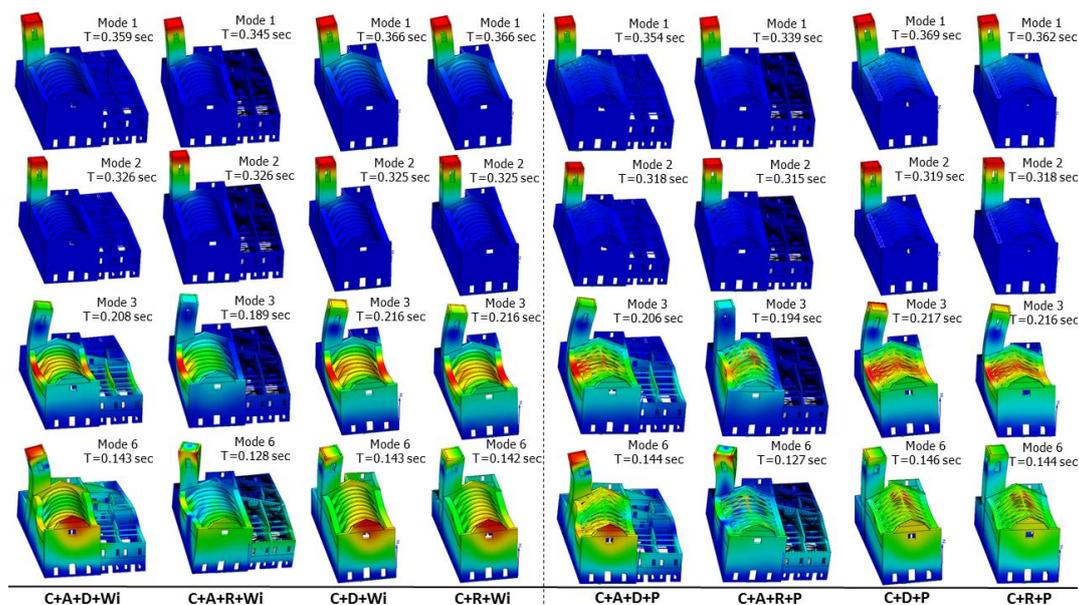
Fig. (13). Modal analysis results for the eight 3D NMs.

The 3D NMs have been used, in first place, to assess the (linear) dynamic behavior of the eight chosen configurations of Church and Annex. To calculate the modal shapes, considering the large number of d.o.f., the Block Lanczos method has been used. Generally, the first 50 modal shapes for all the models have been evaluated with the aim to assure that the total effective modal mass activated is at least 80% (Table 3) of the total. The main modes for the eight models are shown in Fig. (13).

Observing the outcomes of the mode shapes resulting from the analysis component is interesting to observe the back wall of the apse and the façade: in the model (C+A+R+Wi) these walls have a completely different behavior from the configurations without the annex (C+R+Wi) which show the out-of-plane displacement and also a shift in the plane due to the additional lateral mass (Fig. 13).

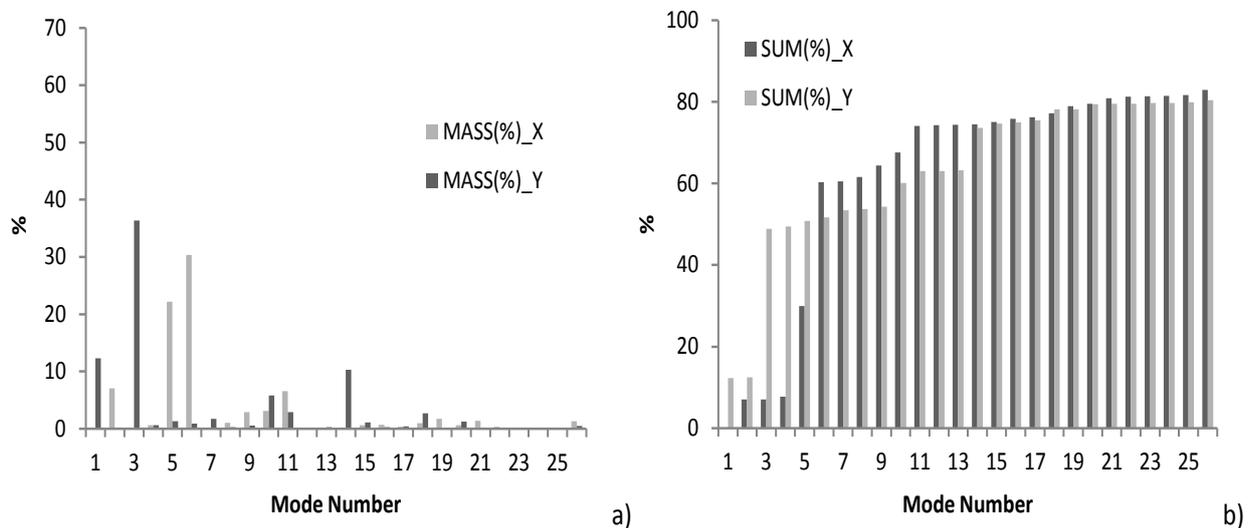
Fig. (14). Modal analysis results for the 3D model (C+A+D+Wi): a) for each mode, b) with respect to the total mass.

In the NMs without interventions, namely (C+A+D+Wi) (C+A+R+Wi) (C+D+Wi) (C+R+Wi), the effective and cumulative masses of each vibration modes, in the gable (transversal) and in the main nave wall (longitudinal) directions, are reported in Figs. (14, 15, 16, and 17). In all cases, the 1st and 2nd modal shapes are associated to the bell-tower, and this confirms that the tower is the most vulnerable element of the structure. For all the models, the main modal forms are the 3rd, for the transversal direction, the 6th and the 4th, for the longitudinal direction, and they are respectively associated to the out-of-plane of the walls of the nave and of the gable.

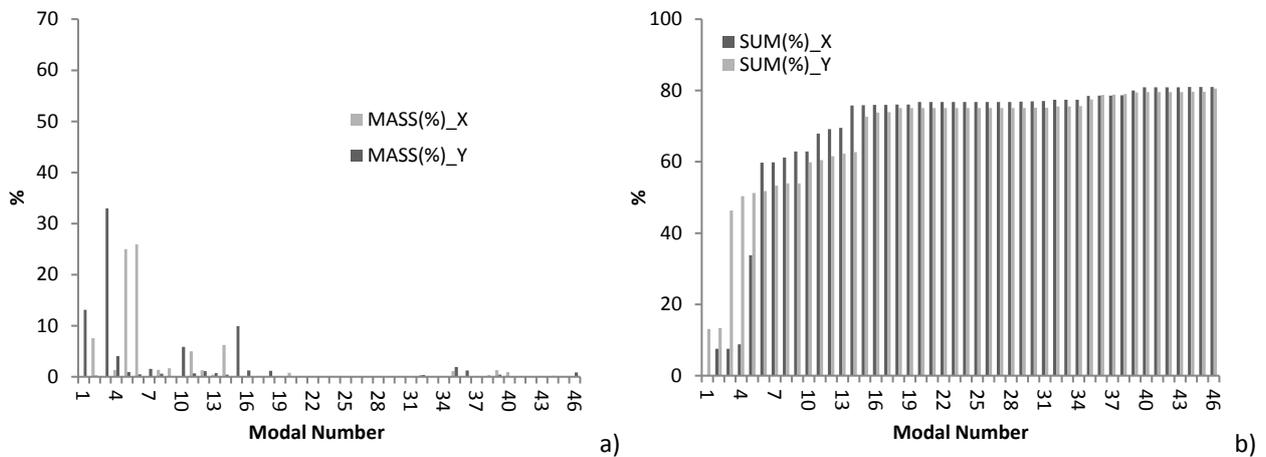
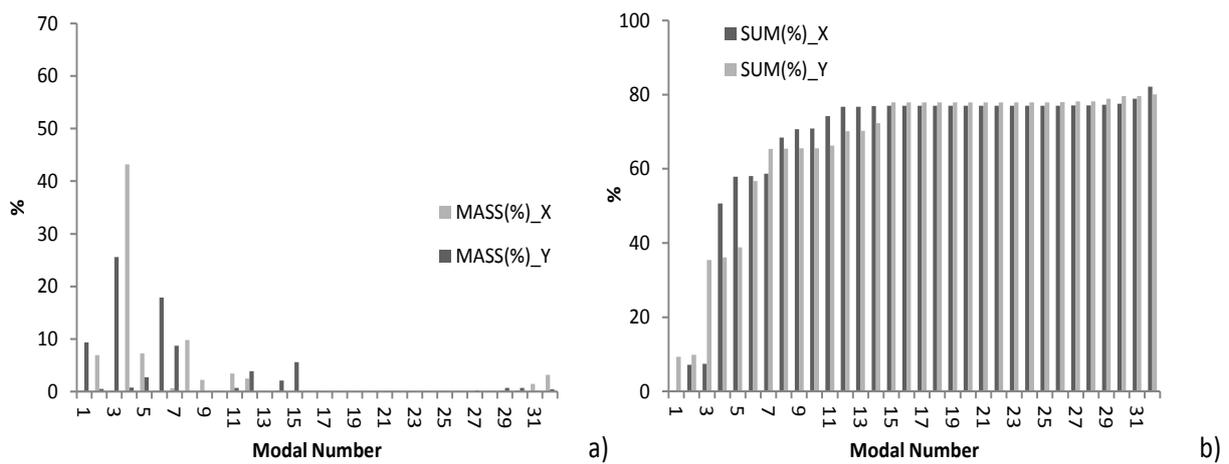
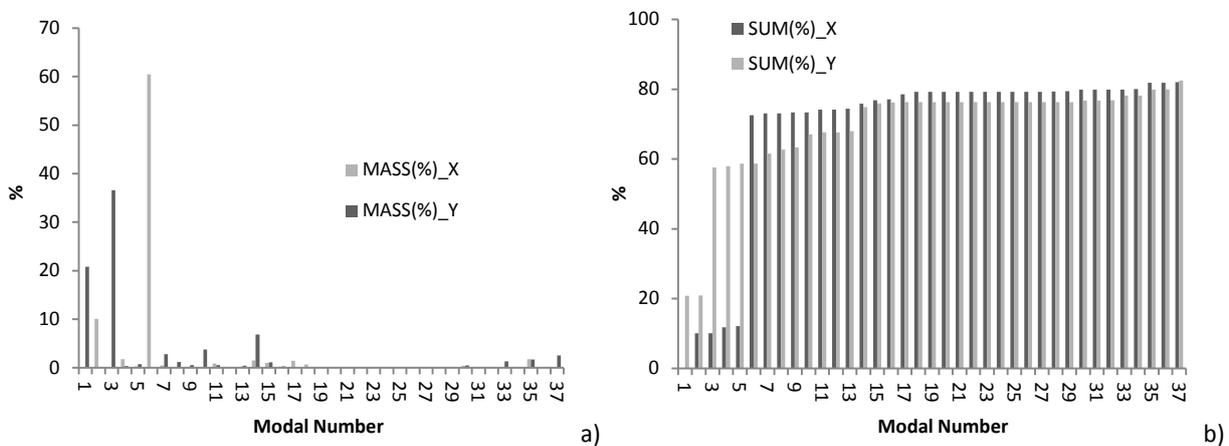
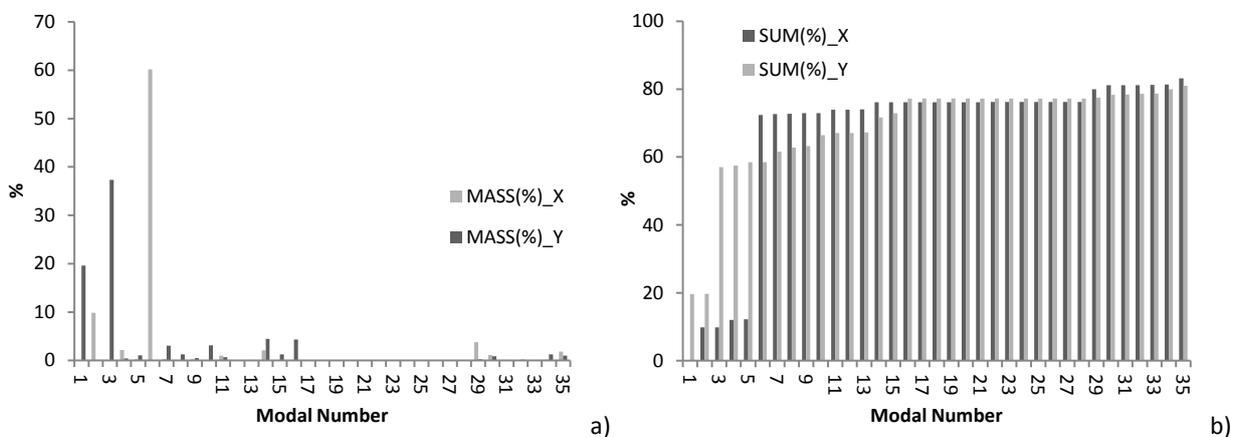
In the NMs where the intervention on the roof of the church is implemented, namely (C+A+D+P) (C+A+R+P) (C+D+P) (C+R+P), in order to have the 80% of the excited modal masses, more frequencies than the previous cases should be considered, due to the presence of local mode in the roof beams.

In these NMs the main mode shapes are associated with low modal mass (Figs. 18-21), due to the roof beams. Also in these NMs, the 1st and 2nd modal shapes are connected to the bell-tower. As in the case of pre-interventions, the subsequent (main) shapes are associated with out-of-plane movements of the nave walls and of the gable (the 3rd for Y-direction, the 4th and 6th for X-direction).

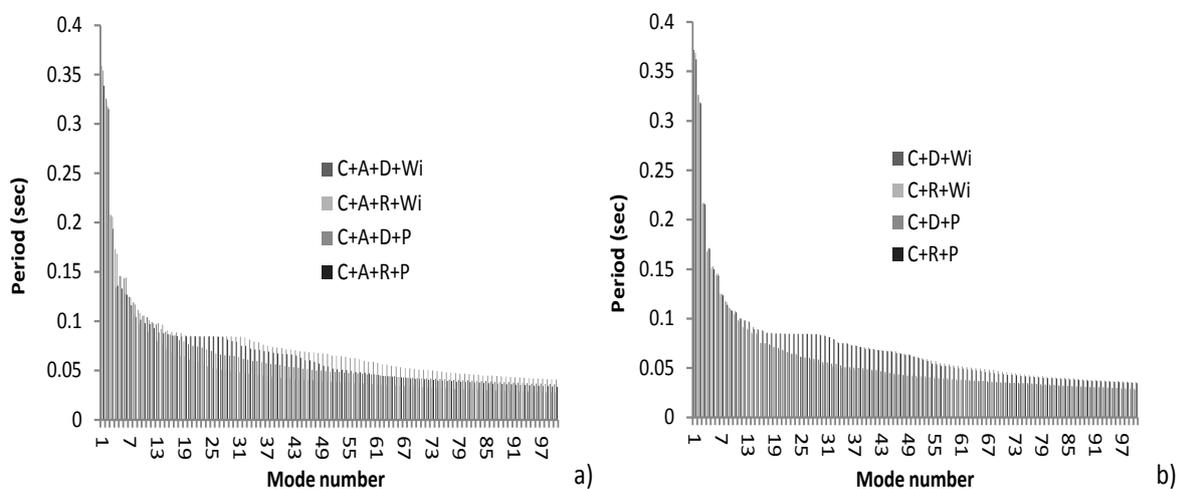
Fig. (22). Main frequencies for the first 100 modes for NMs: with the annex (a) without the annex (b).

In Fig. (22) the first 100 frequencies are reported to compare the different dynamic behavior in the presence and in the absence either of the annex and the retrofitting. The main conclusion is that the presence of the annex reduces the period of oscillation; differently, the retrofitting of the roof limits the out-of-plane deformation of the walls of the nave that occurs out of the geometric plan of the walls but the period is quite invariant with respect to the previous case, confirming the non-invasiveness of the retrofitting intervention.

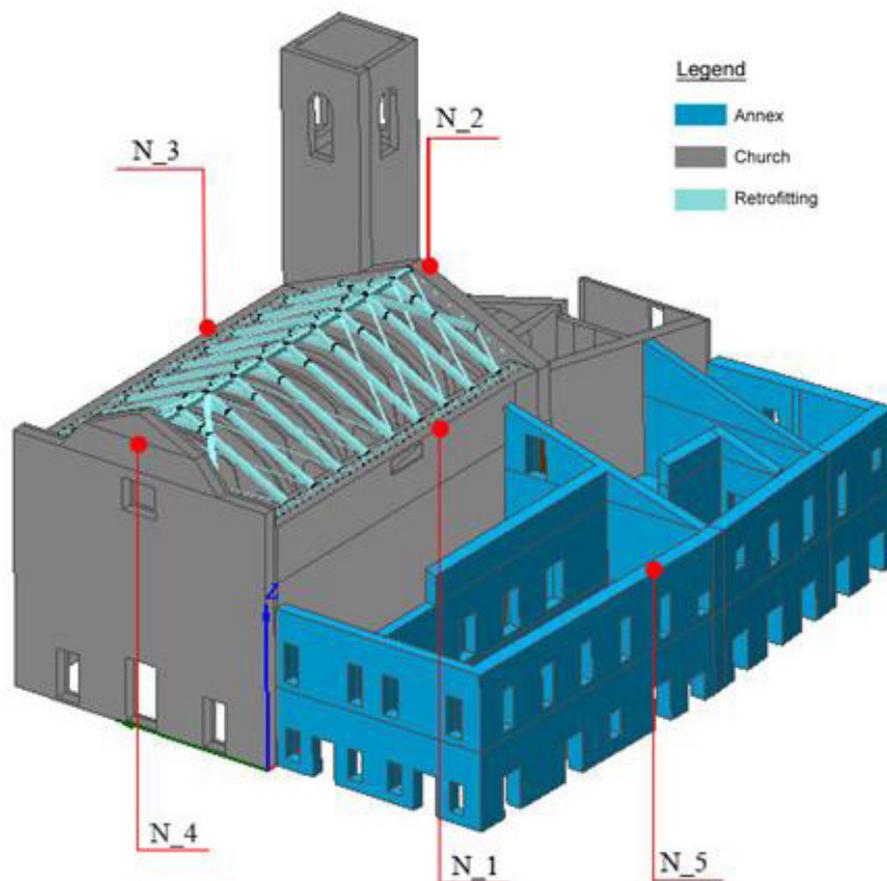
Fig. (23). Control points of the Eight models.

Due to a significant extension of the building, the nonlinear behavior is analysed at the varying of the selected control point. The same control points (see Fig. 23) are used in all the models, so it is possible to capture the variation in the seismic response by changing the floors stiffness, the influence of annex and of retrofitting.

Generally, the critical load distribution for the complex is in the longitudinal direction parallel to the main nave development. The behavior on the X-direction for all the models is brittle, whereas on Y-direction there is a more ductile behavior (see Fig. 24). As already shown in the real damage survey (see Section 3), also in the NMs the major cracks involved the connection between the façade and the side walls nave, and the central vault. For this reason, the global displacements of these points were investigated (Fig. 23).

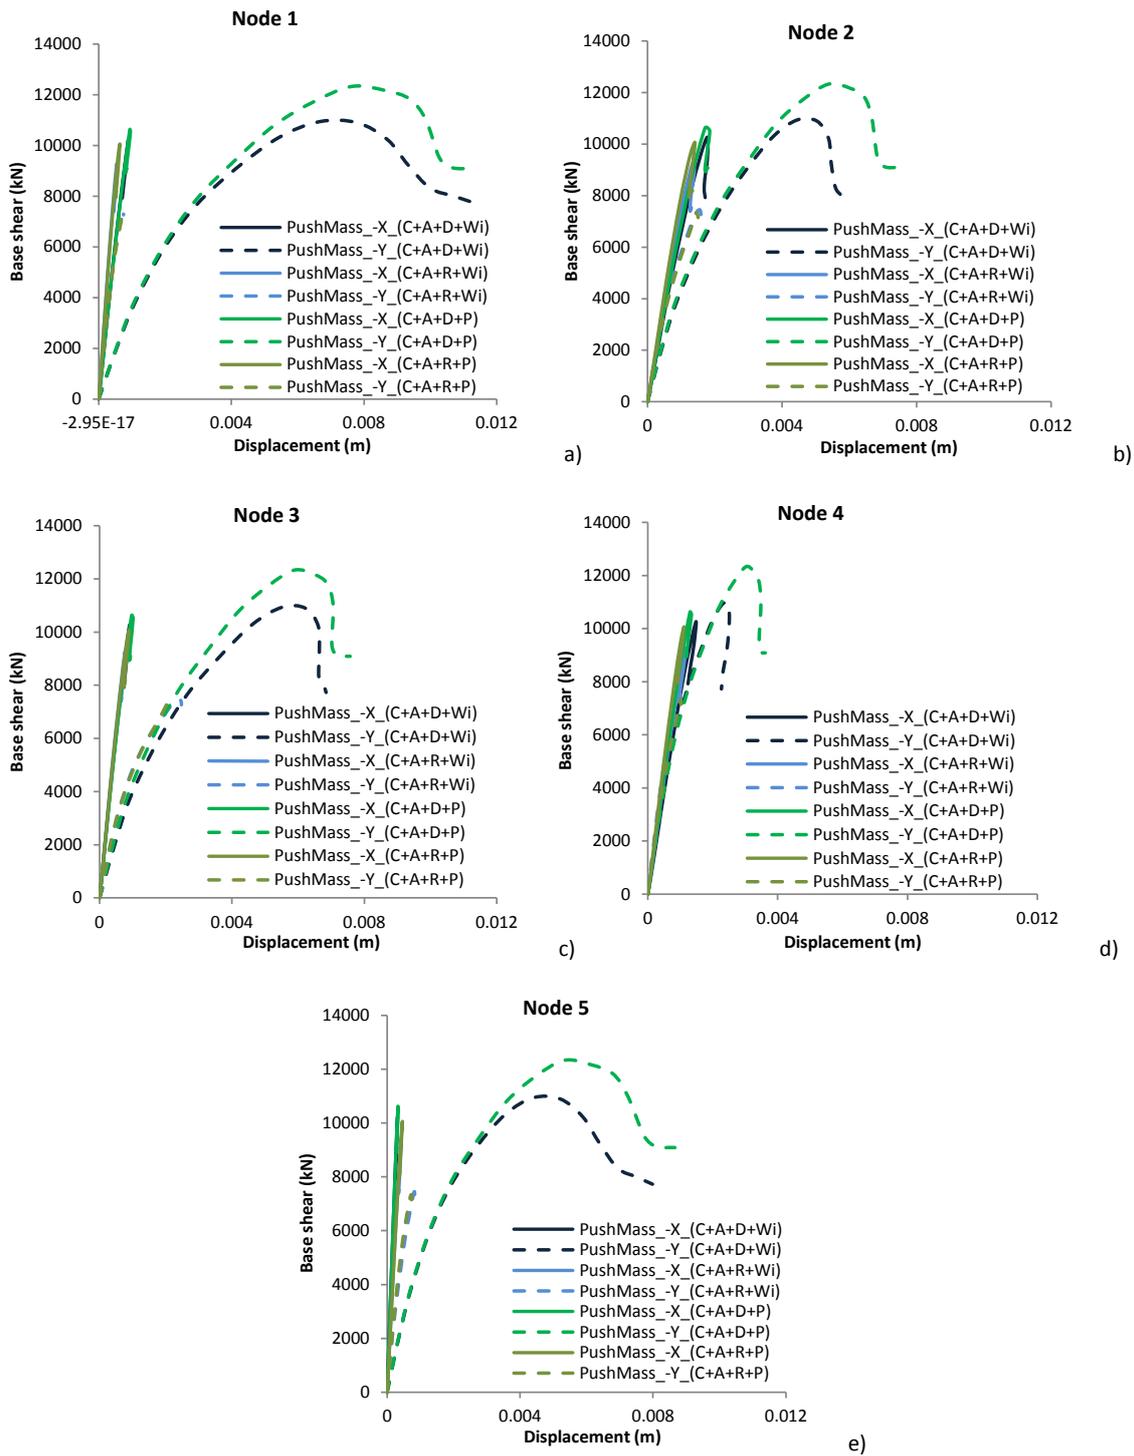
Comparing, ante-intervention NMs with post intervention NMs *i.e.* (C+A+D+Wi) with (C+A+D+P) and (C+A+R+Wi) with (C+A+R+P), an increment in terms of displacements and forces in both directions is evident. Likewise, in these models, it is also possible to see that the presence of rigid floors reduced the displacements but increased the lateral stiffness. In Figs. (25 and 26) the development of the cracking in the four NMs, due to horizontal loads in the -X-Direction and -Y- Direction, are shown.

Fig. (24). Capacity curves at varying of the control points for the 3D NMs: (C+A+D+Wi), (C+A+R+Wi), (C+A+D+P) and (C+A+R+P).

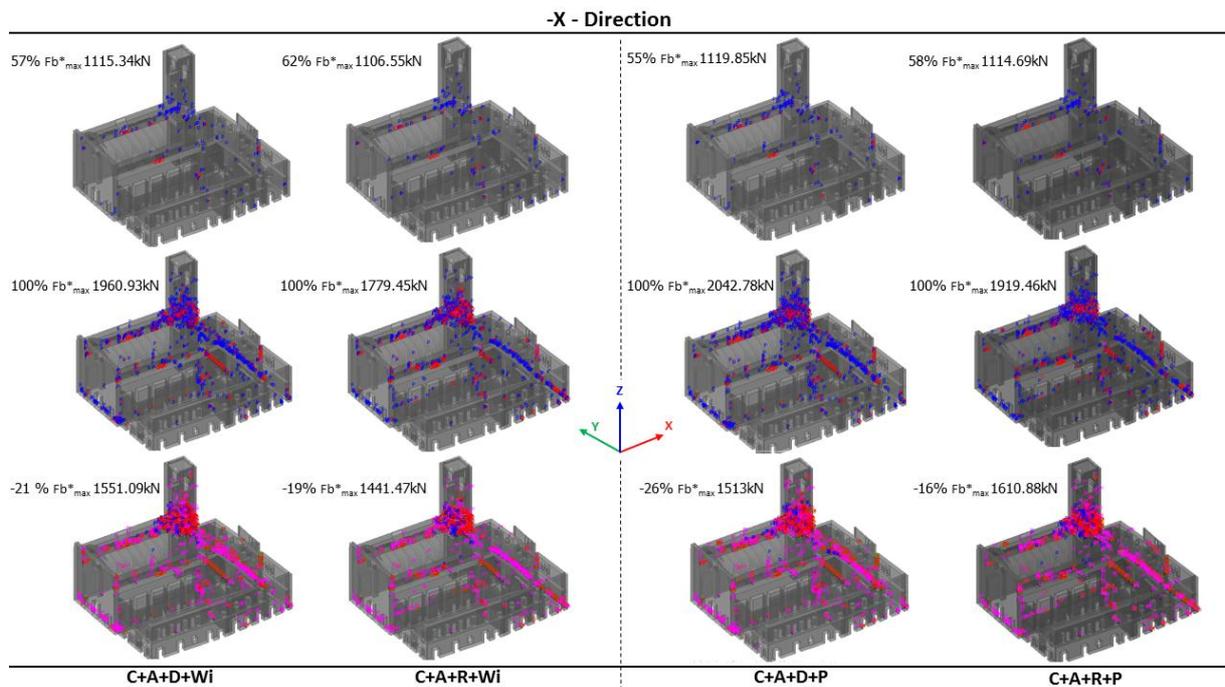
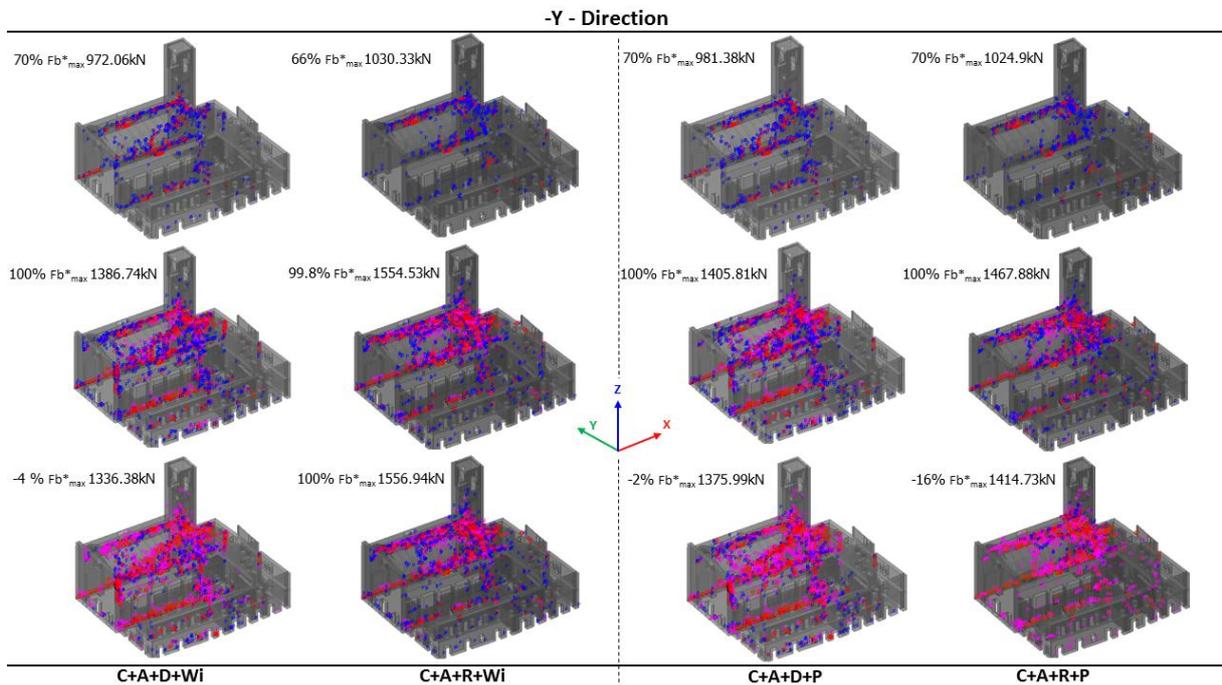
Fig. (25). Pushover: uniform load -X direction. Cracking patterns for (C+A+D+Wi), (C+A+R+Wi), (C+A+D+P) and (C+A+R+P) NMs.

Fig. (26). Pushover: uniform load -Y direction. Cracking patterns for (C+A+D+Wi), (C+A+R+Wi), (C+A+D+P) and (C+A+R+P) NMs.

In both directions, the first crack appears on the barrel vault of the nave, and these macro-elements represent the brittle elements of the structure.

Furthermore, in X-Direction some cracking appears on the triumphal arch under the bell-tower; when the transversal load is increased, then the damages extend up to the bell tower until reaching the upper zone where the arches of the
