Cultural Heritage and Earthquake: The Case Study of “*Santa Maria Della Carità*” in Ascoli Piceno

Francesco Clementi*, Enrico Quagliarini, Francesco Monni, Ersilia Giordano and Stefano Lenci

Department of Civil and Building Engineering, and Architecture (DICEA) Polytechnic University of Marche, Ancona Italy

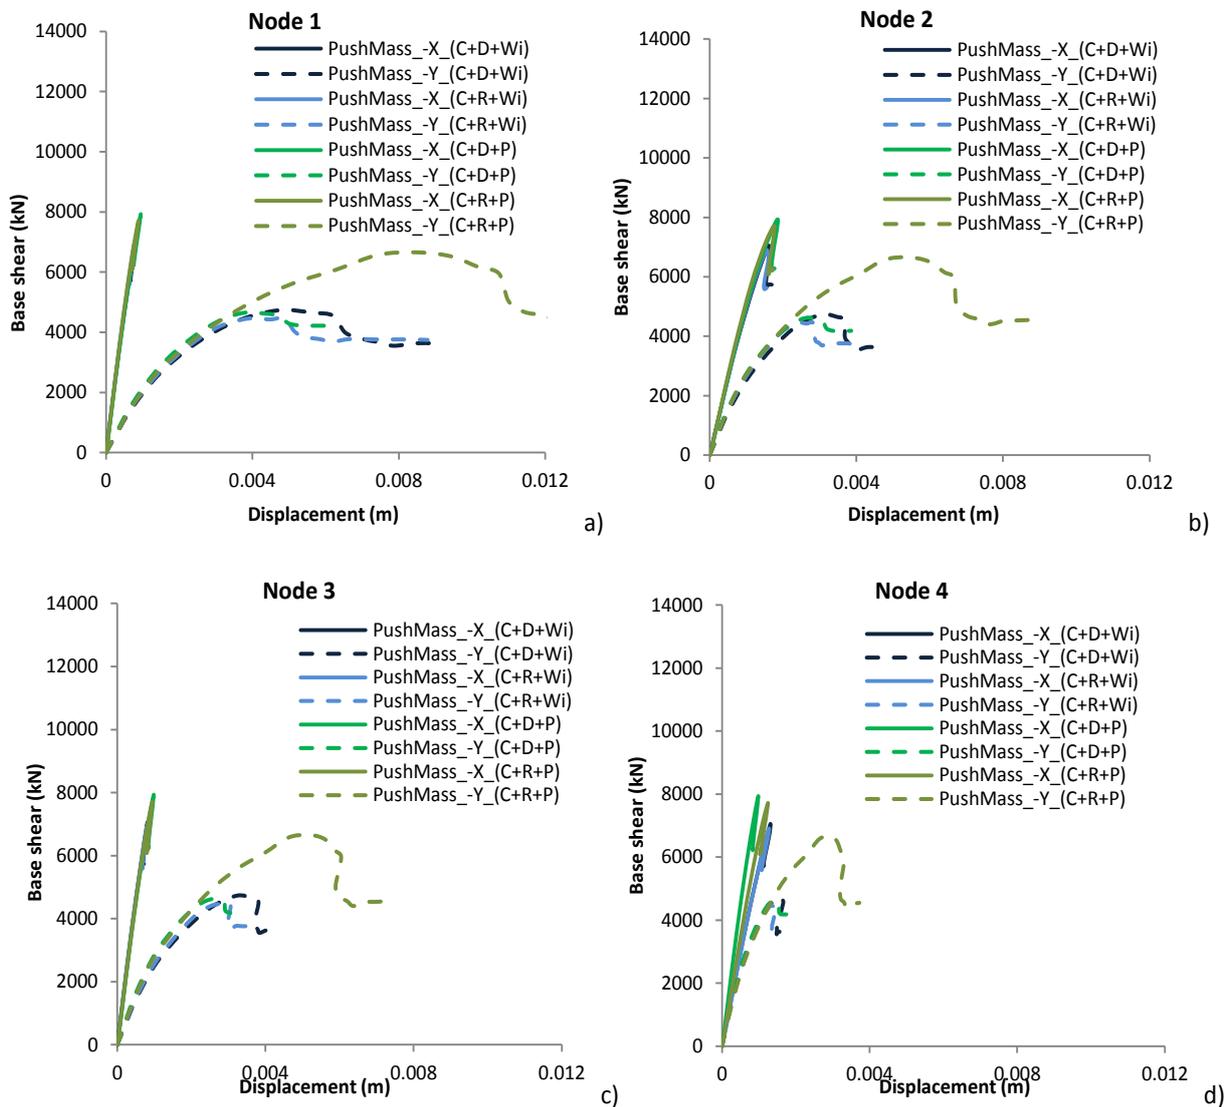
Fig. (27). Capacity curves at varying of the control points for the 3D NMs: (C+D+Wi), (C+R+Wi), (C+D+P) and (C+R+P).

The first evidence, with respect to the models with the annex, is a reduction of both resistance and stiffness. The X-Direction, as in the case with the annex, has a brittle behavior. Meanwhile, in the Y-Direction a more ductile behavior is observed.

In order to detect the vulnerability of the isolated church, the NMs were simplified deleting the annex and obtaining (C+D+Wi), (C+R+Wi), (C+D+P) and (C+R+P) (see Figs. 12c-d-g-h). The main capacity curves are reported in Fig. (27).

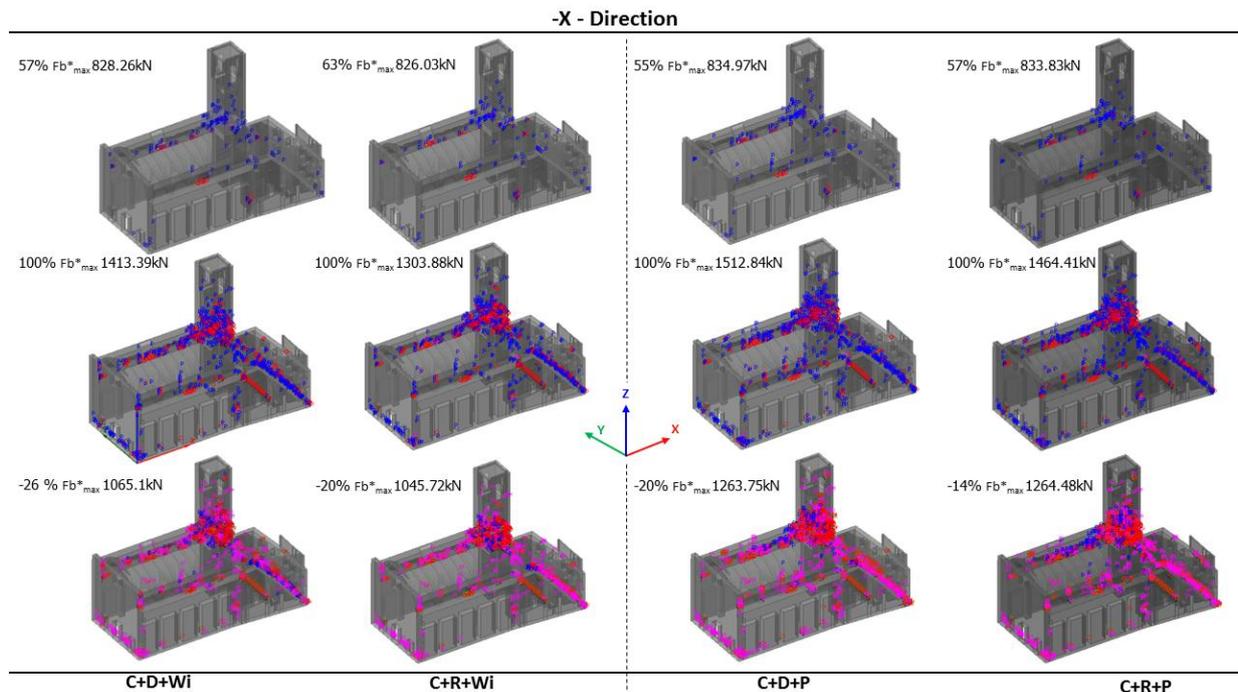
Analysing the damages for increasing values of the transversal load, as reported in Figs. (28 and 29), presence or absence of a rigid diaphragm has a minimal effect on X-direction, but it results more marked on the Y-Direction as well as in presence of the annex. In fact, the cracking evolution is concentrated around the tower near the connection between the triumphal arch and the nave walls, but when the load acts along the Y-Direction Fig. (29), NMs (C+D+Wi), (C+R+Wi), (C+D+P) and (C+R+P) more extended damages appear in the main vault and on its connection with the nave walls.

Fig. (28). Pushover: uniform load -X-Direction. Cracking patterns for (C+D+Wi), (C+R+Wi), (C+D+P) and (C+R+P) NMs.

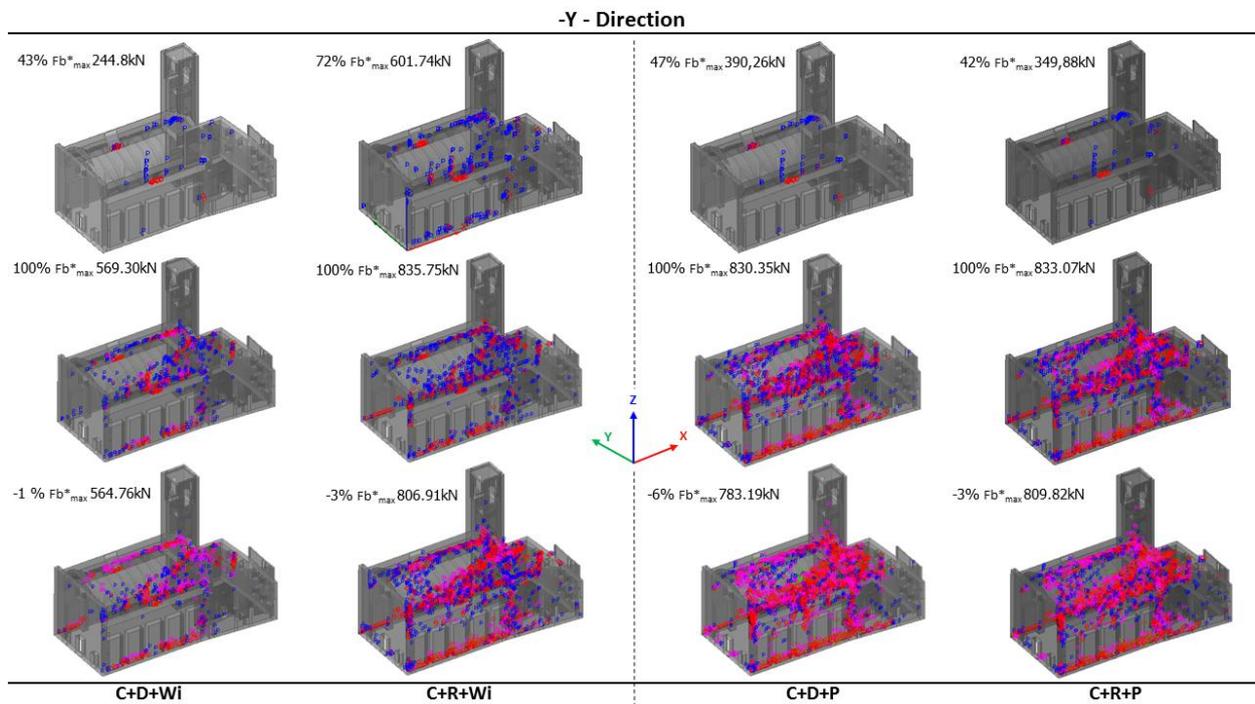
Also in this case, comparing the real damages reported in Fig. (9) with those of NMs in Fig. (29) when the load act in Y-Direction, a diffuse micro-cracking is visible in the middle height of the nave walls, where some stuccos are present. Actually, this represents a specific vulnerability of this church. Differently, in both directions, a micro-cracking is visible in the presbytery vault near the connection with the triumphal arch, as reported in Fig. (9d) where the last real damage is reported.

Fig. (29). Pushover: uniform load -Y-Direction. Cracking patterns for (C+D+Wi), (C+R+Wi), (C+D+P) and (C+R+P) NMs.

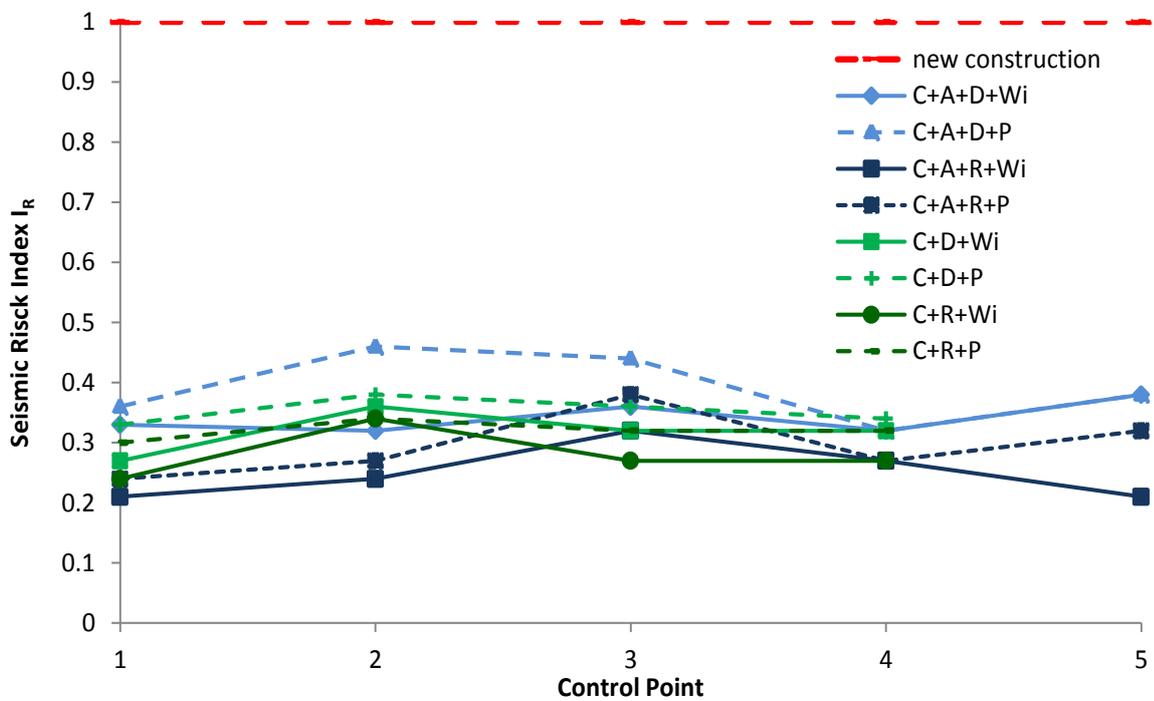
Fig. (30). Seismic Risk Index for the eight MNs at varying of the control points.

From Fig. (30) the continuous line represents the ante-intervention condition while the dashed line the post-

intervention one. The main difference consists in the fact that with the retrofitting of the roof, all the indexes are bigger than the previous condition. Furthermore, another consideration is related to the presence of rigid floors, which is not always associated with major I_R , as in this case. In fact, not spread rigid floors (see Fig. 12) do not permit the collaboration between the walls, and the damages accumulate in areas where this process is obviously minimum.

It might be worthy to remind that $I_R \geq 1$ corresponds to a safe structure, and $I_R < 1$ corresponds to an unsafe building on the standard of the new constructions [44]. The $T_{R,C}$ in Eq. (1) is the return time of the seismic action that produces, for the requested SLSD, the non-respect of the inequalities $d^*_{max} \leq d^*_u$ (d^*_{max} is the demand, and d^*_u is the capacity in the equivalent s.d.o.f. system [45] or $3 < q^* < 6$), while $T_{R,D}$ is reported in Sect. 5.2. The use of the I_R gives the possibility to work, indifferently, with PGA (International country) or T_R (Italy). In fact, the exponent 0.41 in (1) is tuned to have the same scale of seismic vulnerability with I_R calculated in terms of PGA [46]. Fig. (30) shows how I_R differs at the

As can be seen, the presence of the annex increases the I_R in the case of deformable floors, both with and without interventions. Differently, the presence of rigid floors and annex concentrates the damage in a little area, giving a worse seismic behavior.
