# The Open Civil Engineering Journal

## RESEARCH ARTICLE

# Integrated Empirical-mechanical Seismic Vulnerability Analysis Method for Masonry Buildings in Timișoara: Validation based on the 2009 Italian Earthquake

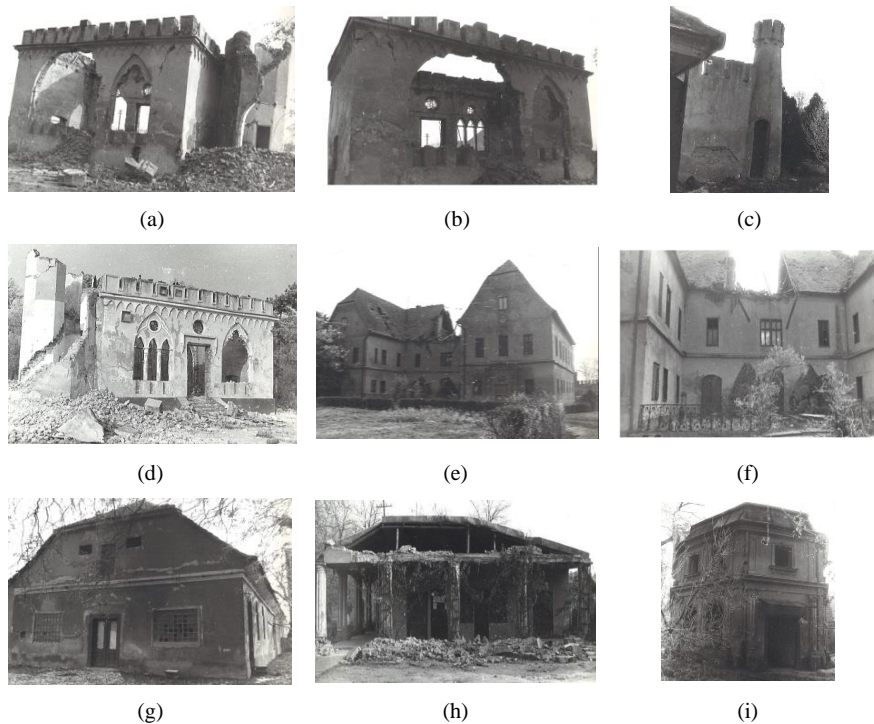
**Fig. (2).** Post-earthquake damages and failures recorded in the epicentral area near Timisoara after 1991 earthquakes [12].

shown that the Type of failure mechanisms occurred in the epicentral area (cities: Banloc, Voiteni and Ciacova, located 30-50 km far from Timisoara) have been characterised by a high level of damages to vaults, arches, towers and chimneys, as reported in Fig. (2) [12].

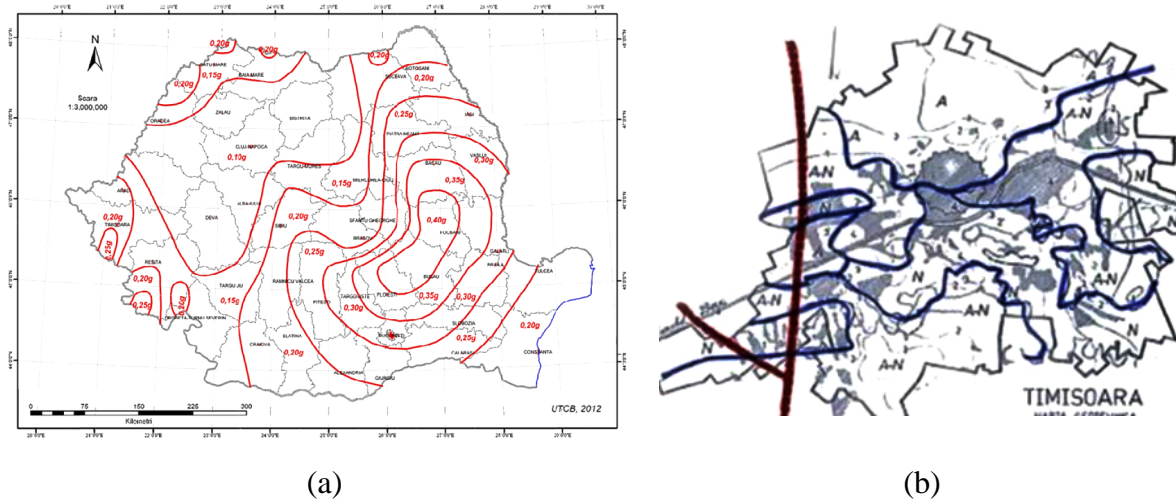
Fig. (3). Romanian zonation in terms of PGAs (a) and seismic fault lines in the city of Timisoara (b).

Moreover, the city of Timisoara is the biggest city located in the Banat seismic region, which is the second most important seismic zone of Romania (Fig. 3a), with an expected PGA equal to 0.20 g considering a return period,  $T_r$ , of 475 years [13, 14]. In Timisoara, there are two active seismic faults, as reported in Fig. (3b), both concentrated in the western part of the city.

From the previous figure, it is evident that the seismic hazard of Timisoara is very high due to the seismogenic faults present in the area. Furthermore, most of the buildings located in the historic areas of the city were designed without anti-seismic criteria. For these reasons, it is essential to provide appropriate vulnerability studies to limit expected losses and to implement a systematic seismic risk mitigation plan.

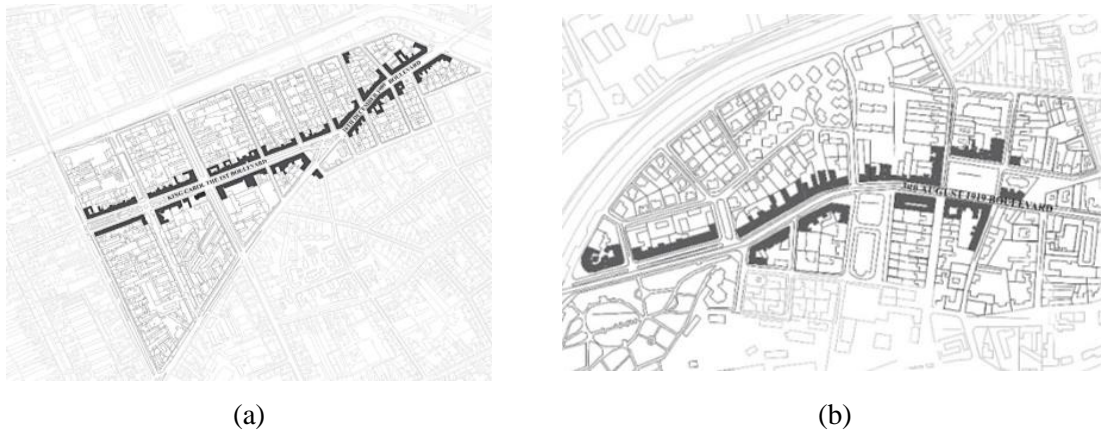
**Fig. (5).** Identification of the buildings in the districts of (a) Iosefin and (b) Fabric.

More specifically, the Iosefin area was initially designed as a village for German colonists, on both sides of the Bega river, with large houses and luxurious gardens. The district took its name from the visit of Emperor Joseph II of Habsburg, in the year 1773. From a typological point of view, only 27% of the buildings analysed have one level above the basement, 37% have two levels, 33% have three levels and finally, 3% of cases have four levels above the basement.

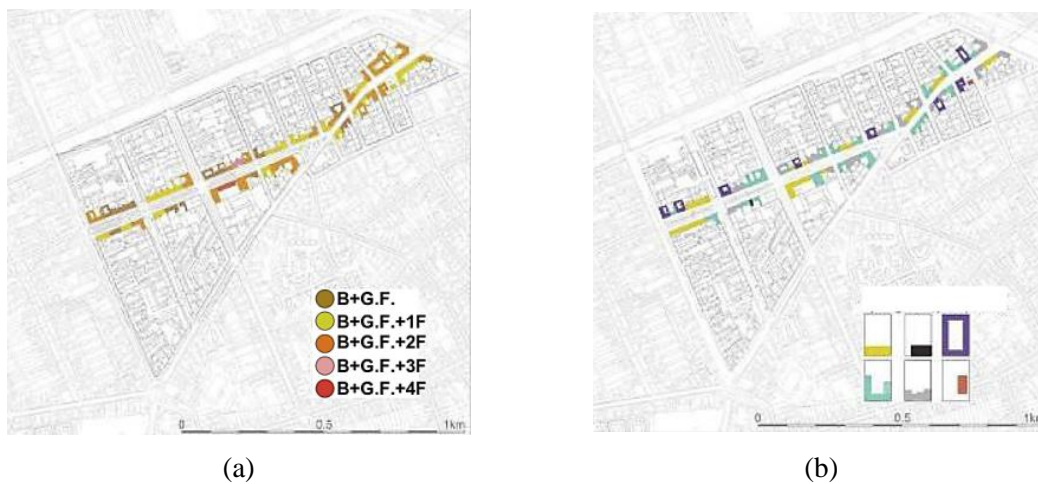
**Fig. (6).** Urban characterization of the Iosefin district (a) in-elevation development and (b) site occupancy condition [15, 16].

After on-site inspection, it was noted that most of the buildings are continuously defined on the main road, forming closed areas with common internal courtyards. At least, 35% of the building's stock is placed in a corner position in the aggregate, while only 3% of buildings are built as isolated

constructions (Fig. 6) [15, 16].

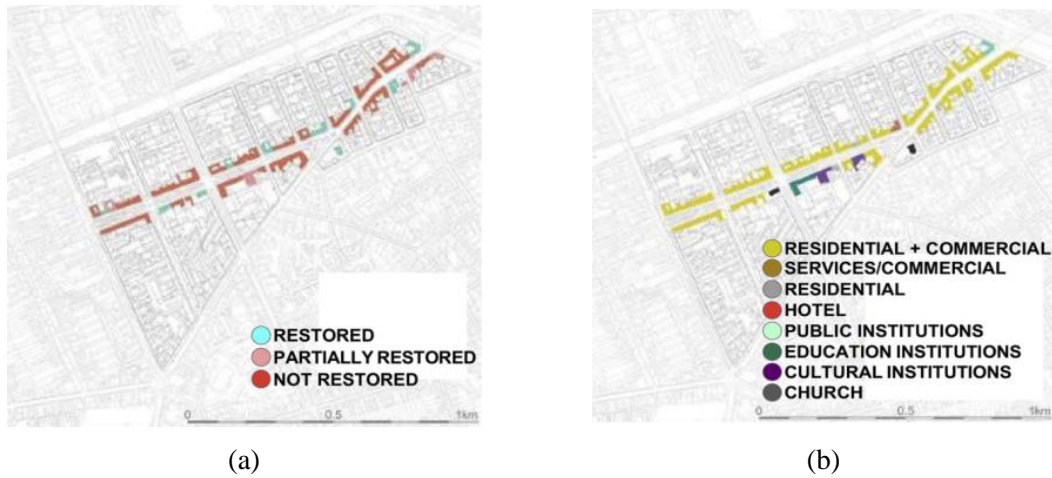
Fig. (7). Urban characterisation of the Iosefin district (a) physical conservation state and (b) designated use [15, 16].

Most of the buildings (75% of the cases) are in a medium-low state of conservation, with problems due to the lack of adequate maintenance, only 15% have been recently restored. In comparison, almost 10% were only partially restored (Fig. 7a) [15, 16]. The dynamism of the area is highlighted by the commercial promenade, that connects all the commercial spaces located on the ground floor of the buildings; only 3% of the total number of buildings is residential, while 3% represent cultural, educational and eclectic buildings, similar to the percentage of public buildings and hotels, distributed along the main avenues in the area, King Carol on 1st and 16<sup>th</sup> December 1989 (Fig. 7b) [15, 16].

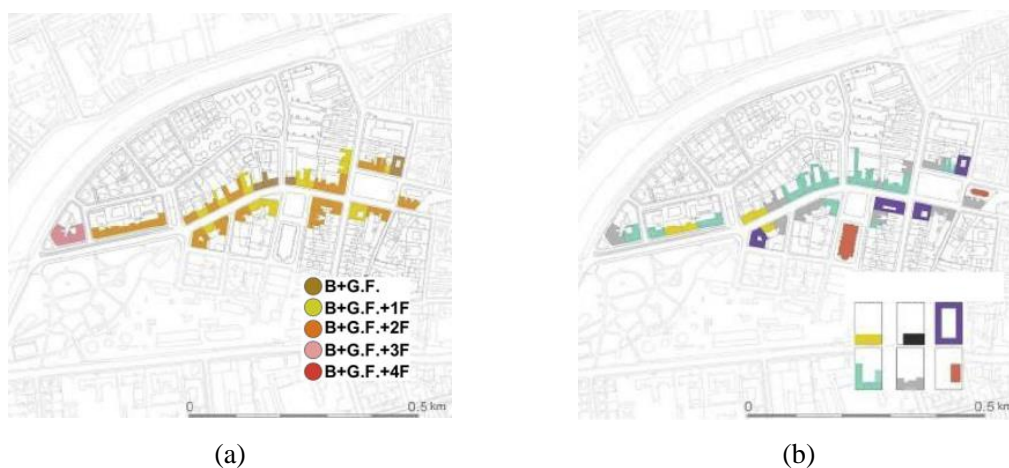
Fig. (8). Urban characterisation of the Fabric district (a) height regime and (b) site occupancy condition [15, 16].

Moreover, more than 40% of the buildings are located in a corner position in the aggregate, closing perimeters and forming common internal courtyards (Fig. 8) [15, 16].

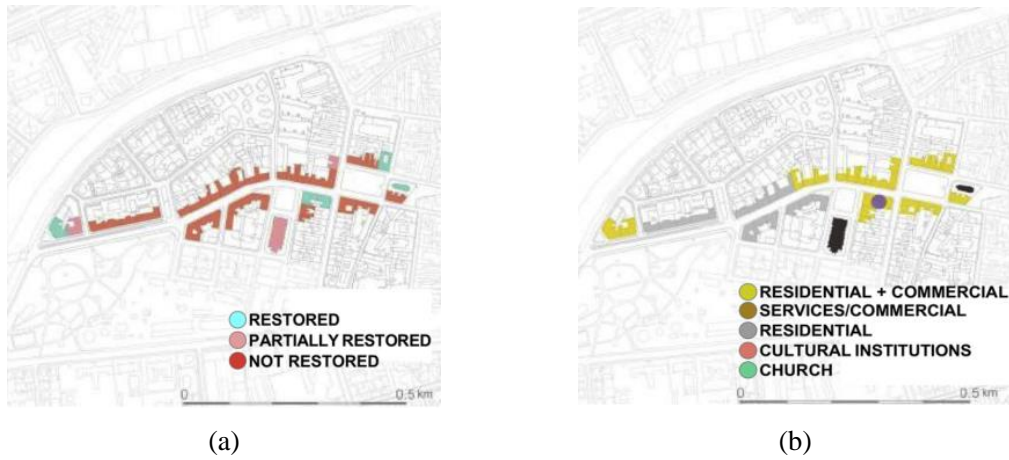
Fig. (9). Urban characterisation of the Fabric district (a) physical conservation state and (b) designated use [15].

Furthermore, only 10% of the buildings have been completely rehabilitated, 8% are partially restored, while 82% are in a medium-low state of conservation. On the other hand, the central pole of activity is located in Traian square, where more than 55% of the buildings have commercial spaces on the ground floor, as reported in Fig. (9) [15].

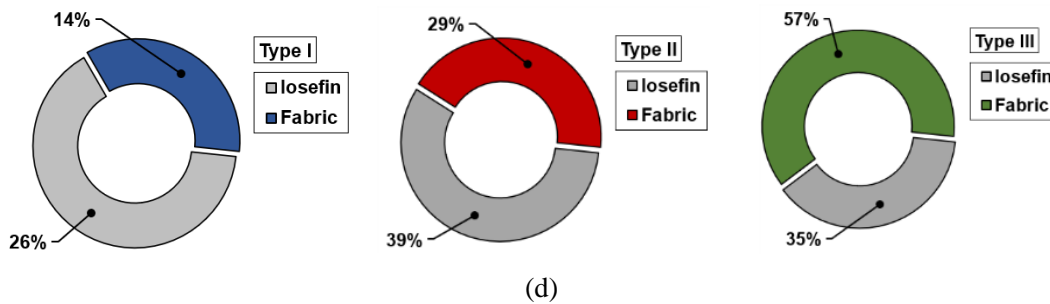
(a) – Type I

(b) – Type II

(c) – Type III

Fig. (10). Typological characterisation of the buildings (a-c), and distribution of the classes for (d) Iosefin and Fabric urban sectors [16].

Based on the geometric and structural features, it has been possible to make a classification properly conceived for the historical areas analysed. This typological classification consists of dividing the buildings into three main classes based on the number of levels above the basement, from one to more than three (*i.e.* typology class I, typology class II and typology class III), as reported in Fig. (10) [16].

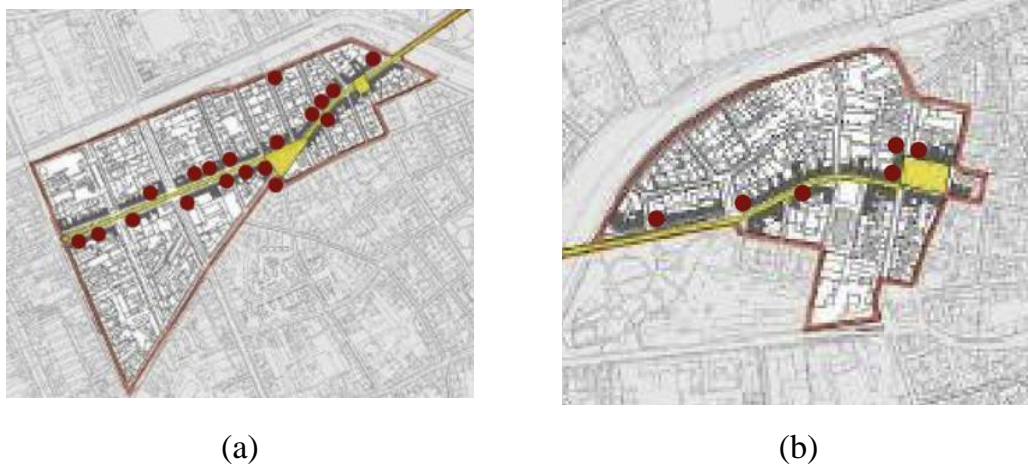
**Fig. (11).** The buildings selected for a detailed investigation in (a) Iosefin district and (b) Fabric district [16].

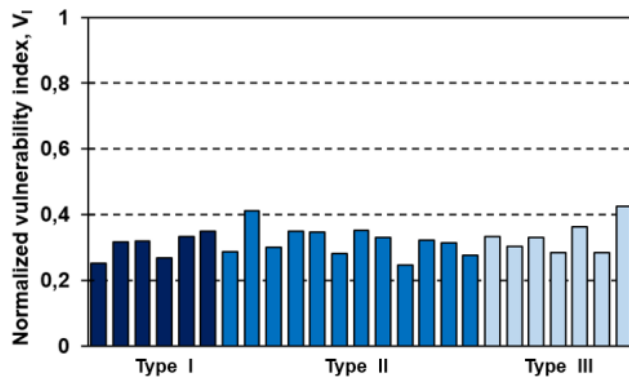
Fig. (13). Normalised vulnerability index associated to the main typological classes detected.

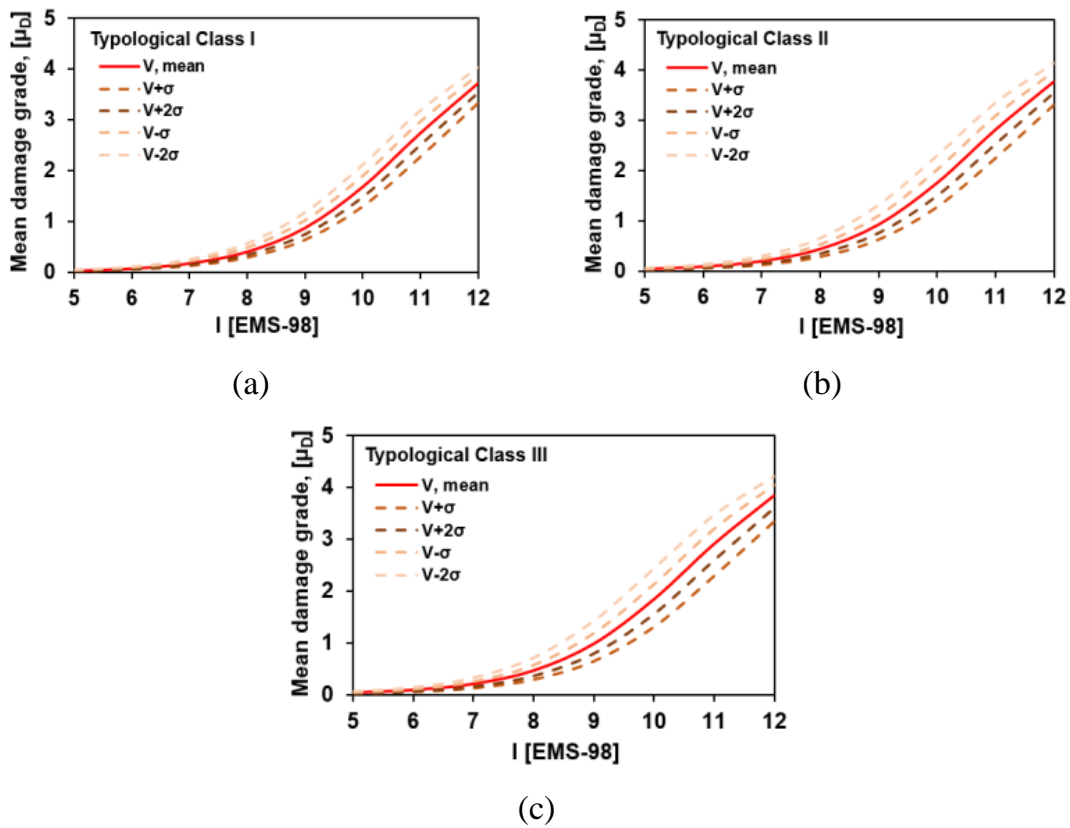
Fig. (14). Mean vulnerability curves associated to the main typological classes detected in the study areas.

Subsequently, vulnerability curves have been obtained to estimate the propensity at the damage of the analysed building typologies (Fig. 14). In particular, the vulnerability curves [25, 26] correlate the level of the expected damage that a building could reach under a given seismic intensity “ $I_{EMS-98}$ ”, which is defined according to the European Macroseismic Scale EMS-98 [27]. In particular, as proposed in a study [14], earthquakes with an epicentre magnitude,  $M_w$ , of 5.6 - 5.8 occurred 20-25 km far from the city of Timisoara [14], which the most probable macroseismic intensity equal to IX according to the European Macroseismic Scale [27] was assigned to.

As reported in the previous figure, the vulnerability curves are derived for a sample of buildings representative of the construction types found in the inspected areas. However, for a more accurate representation of the expected damage, the mean typological vulnerability curves have been represented together with other curves taking into account the statistical variability

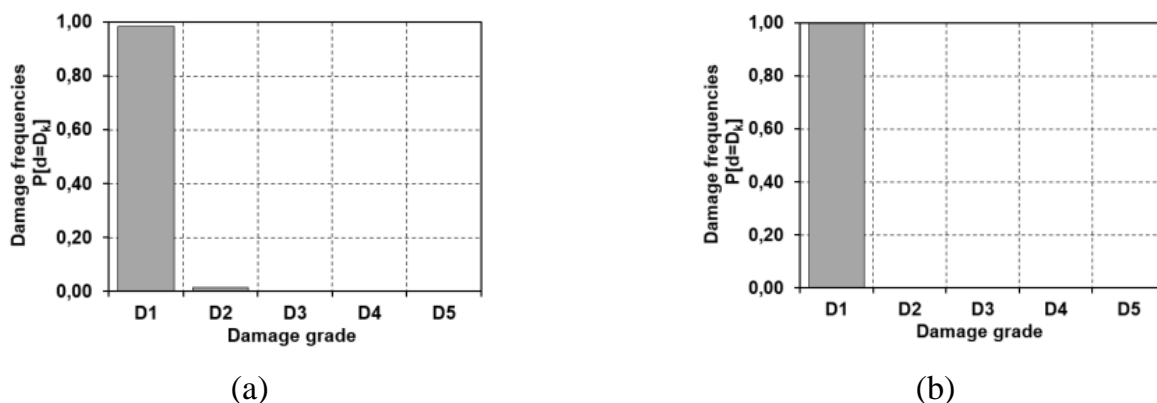
Fig. (15). The damage scenarios in the investigated urban areas of (a) Iosefin and (b) Fabric.

Extending this methodology to all historic buildings in the two districts inspected, it has been possible to define the scenario of expected damage in terms of Damage Probability Matrix (DPM), as shown in Fig. (15) [28].

Therefore, analysing the results obtained through an empirical-observational approach, it can be noted that a macroseismic intensity of IX EMS-98 would not be dangerous for the historic masonry buildings in the city of Timisoara, leading to no damage neither to structural and non-structural elements.

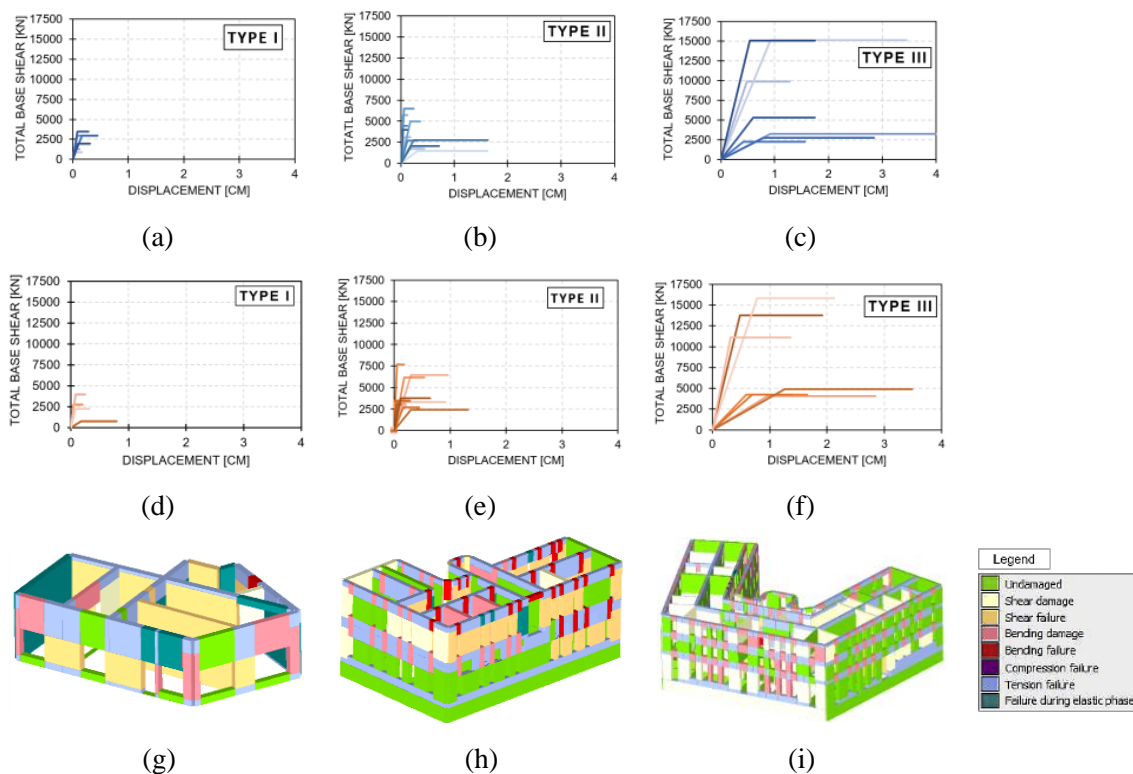
**Fig. (16).** Analysis results: (a-c) capacity curves in X directions, (d-f) capacity curves in Y direction and (g-i) in-plane failure mechanisms for the buildings representative of the typological classes examined.

The analysis has been performed on each of the 25 masonry buildings, considered as an individual structural unit. Generally, the structural model is based on the equivalent frame model, assuming that the masonry wall with openings can be modelled by a set of single-dimensional elements, such as columns, beams and nodes. In the pushover analyses, the inter-storey drift threshold has been considered as equal to 0.5% for the damage limit state [36]. To evaluate the seismic demand, the specific seismic spectrum characteristic of the Banat seismic region has been defined. Therefore, the capacity curves of SDoF systems have been obtained for each building of the Type I, Type II and Type III classes [16 and the specific in-plane failure mechanisms for the three buildings representative of the three classes examined have been shown, as reported in Fig. (16).

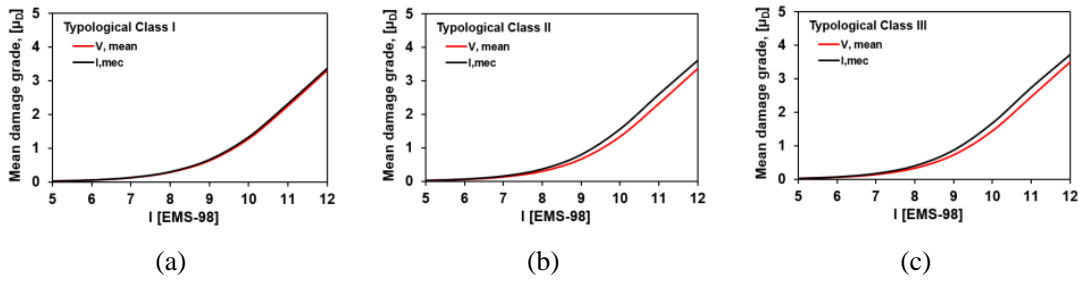
Fig. (17). Comparison between empirical and mechanical approaches for (a) Type I, (b) Type II and (c) Type III buildings.

depicted in Fig. (17). In the same figure, the comparison between the macroseismic and mechanical approaches, in terms of mean damage grade,  $\mu_D$ , has been presented [6].

The comparison between the applied methodologies shows how the two approaches are comparable, providing approximately the same level of expected damage. Nevertheless, as shown in Fig. (16), the mechanical approach offers a clear indication of the possible failure mechanisms that occurred for both structural and non-structural elements, entirely neglected by the macroseismic method [16]. Moreover, the formulation of the mean damage grade,  $\mu_D$ , proposed in a study [6] provides a damage level not on the safe side in predicting the numerical analysis one and, therefore, it needs to be adapted to historic masonry buildings located in the Banat Seismic Region.

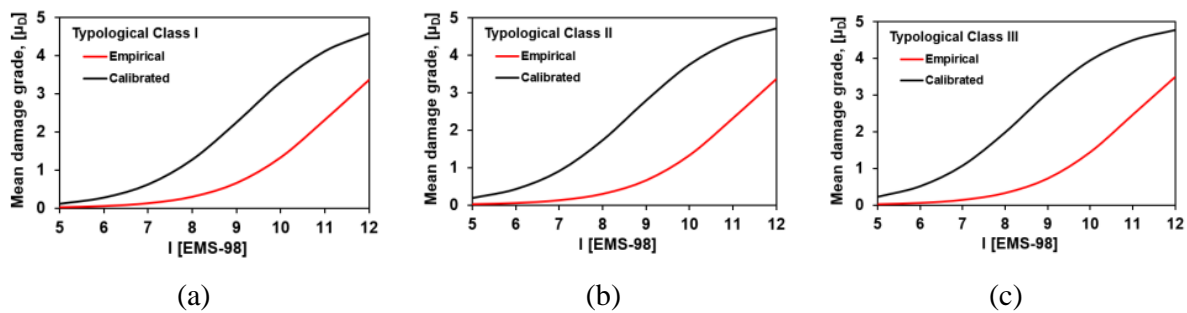
Fig. (18). Calibrated vulnerability curves for, (a) Type I, (b) Type II and (c) Type III building classes.

where, the seismic hazard is always expressed in terms of macroseismic intensity ( $I_{\text{EMS-98}}$ ), the  $\psi$ -factor has been assumed equal to 12.50, it is related to the variation of the slope of the curve and, finally, the ductility factor  $Q$ , which describes the ductility of masonry typological classes, has been assumed to be equal to 2.3 [16, 6]. Thus, a representation of the damage-intensity curve has been provided, as illustrated in Fig. (18).

From the results depicted in Fig. (18) it is possible to notice that for each class of buildings, for the same seismic intensity level, there is a difference of at least one state of damage. The empirical formulation, as it is noted, tends to underestimate the expected damage. Therefore, the most probable damage states of D1-D2 indicated by the vulnerability curves are not reliable, indicating the fact that the damage estimate formula (Equation 3) cannot be adapted to the specific Banat Seismic Region.

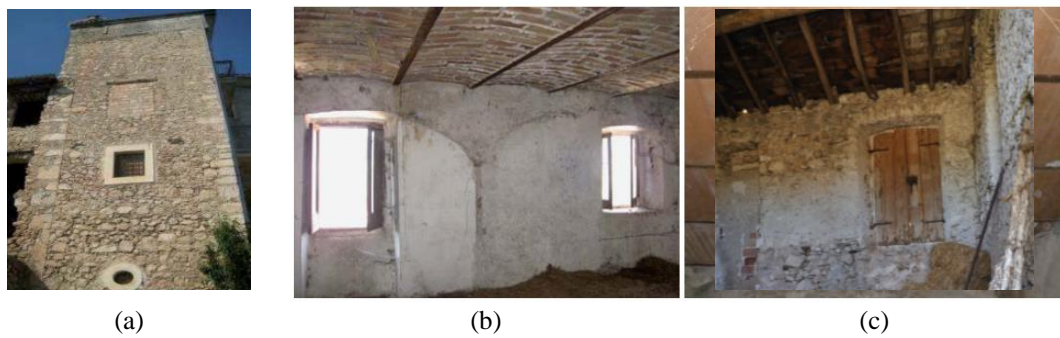
Fig. (21). Example of building features inside the historical centre of San Pio delle Camere.

In general, the historical centre consists of buildings with heights up to three floors and, in rare cases, four floors. The vertical structures are in rough stone (thicknesses of 60 cm) with the basement used for commercial or pastoral activities, while the upper floors are for private use. The horizontal structures are typically made up of masonry vaults or, in some cases, of wooden beams (Fig. 21).

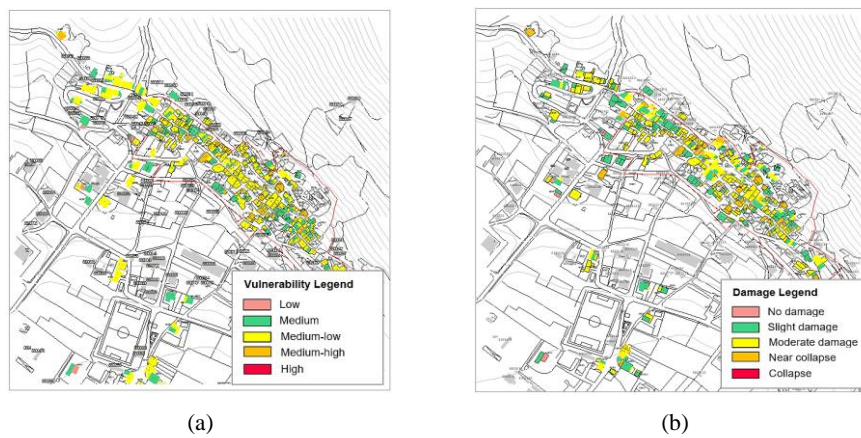
Fig. (23). Vulnerability (a) and damage (b) maps of the city of San Pio delle Camere [39]

Aiming at assessing the damages caused by the 2009 April 6<sup>th</sup> earthquake, the seismic vulnerability levels of the aggregates of San Pio delle Camere have been estimated using the empirical methodology previously examined in Section 3.1. The results presented in a study [39] allowed to both have a classification of the building heritage and to identify the damage that occurred in terms of the mean damage grade,  $\mu_D$ . The vulnerability and damage maps of the historic urban sector of San Pio delle Camere are shown in Fig. (23).

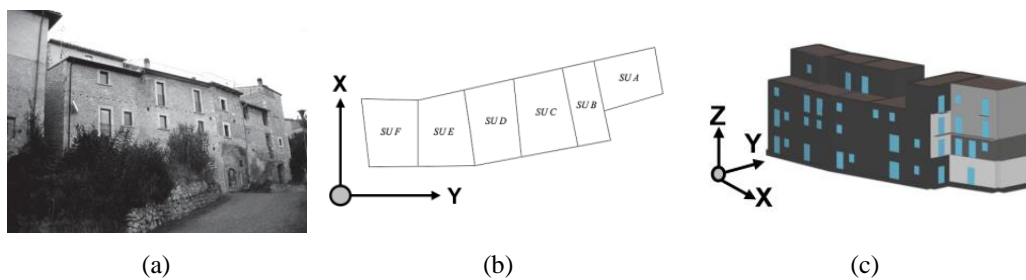
Fig. (24). The case study building: (a) street view of the North façade, (b) plan layout

The Macro-element model, developed by the 3Muri analysis program [30], has been used to model the masonry compound, as depicted in Fig. (24c) [38]. The site is characterised by a PGA of 0.26 g, which a macroseismic intensity of VII corresponds to.

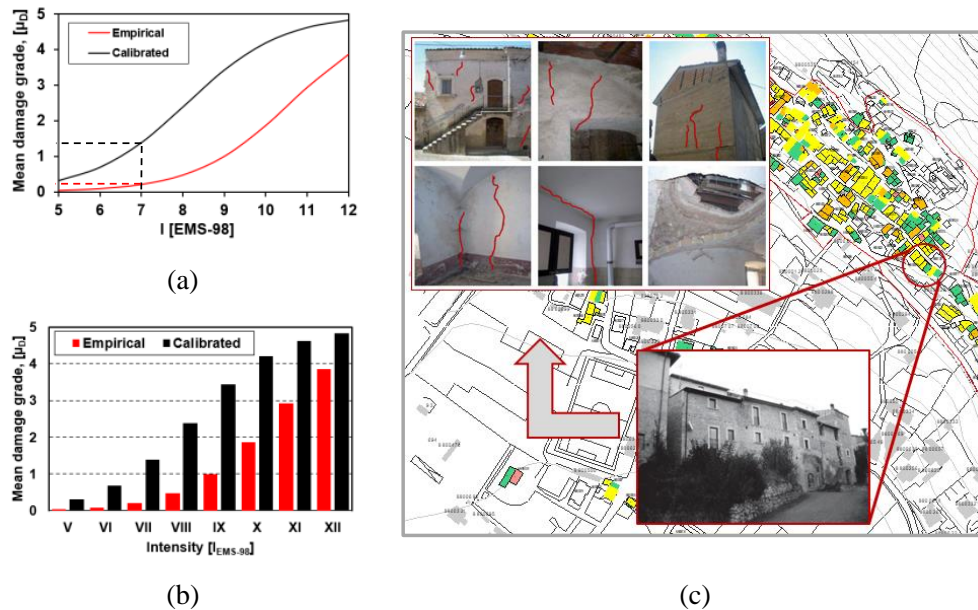
Fig. (25). Damage comparison between empirical and calibrated formulations.

From pushover analyses performed on the masonry aggregate [16], a mechanical vulnerability index,  $I_{MEC}$ , equal to 0.40 has been derived for the whole aggregate. Once the mechanical vulnerability index has been assessed, the next step is to compare the mechanical index with the expected mean damage grade,  $\mu_D$ , derived from both empirical and calibrated formulations in order to take into account the effectiveness of the simplified approach in predicting the structural damage. To this purpose, a direct comparison of the above-mentioned formulations is presented in Figs. (25a and 25b).

From the results obtained, it is evident that considering the damage scale between 0 and 1, for a macroseismic intensity of VII, the empirical formulation discussed in a study [6] provides a damage level of about 0.05, while the new calibrated curve gives a damage level of about 0.3. Therefore, considering that the mechanical index is 0.40, it appears that the original empirical formula tends to underestimate too much the expected damage. In contrast, the new method, even if it is not on the safe side, allows to predict the same damage level (equal to 2, as shown in Figs. (25a and 25b), depicted in reality in Fig. (25c), which has been attained by more complex numerical analyses.
