# Performance of Soil-bearing Spread Footings Supporting Highway Structures

**Objective:** The primary objective of this study is to assess the performance of highway structures that SBSF supports at four specific locations in Ohio. The findings from this assessment will serve as valuable recommendations for the future application of spread footings while identifying potential usage constraints.

#### 5. MAH-680-2.83 Bridge

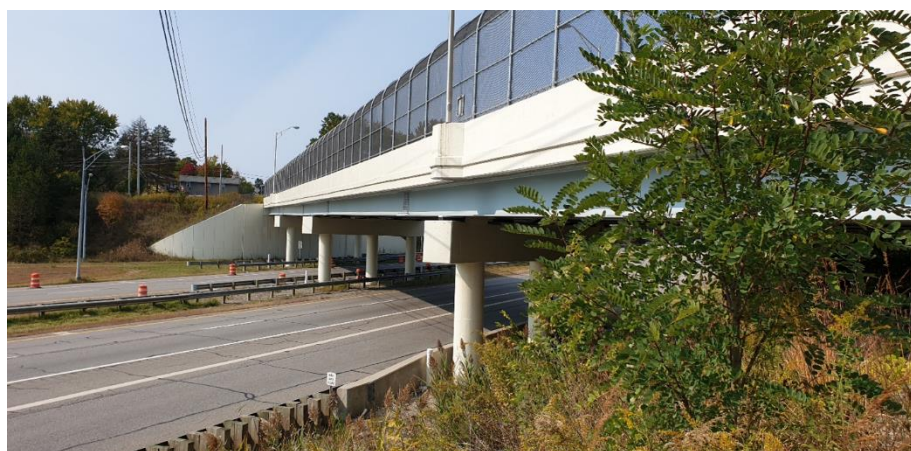
Fig. (1). The MAH-680-0283 bridge.

An on-site inspection was carried out on October 6, 2020, at the MAH-680-0283 bridge, focusing on the bridge deck and sidewalk to identify any cracking or settlements. Fortunately, no evidence of settlements or cracking was discovered. The piers were found to be in satisfactory condition with no observed settlement. During the inspection, it was noted that one of the PVC pipes above the settlement pins was broken at ground level. The current spread footing foundation of the bridge functions as intended, exhibiting no signs of settlement. Refer to Fig. (1) for an image of the MAH-680-0283 bridge.

approximately four years, there was minimal change in settlements, and they remained well within acceptable limits for the given span lengths. The ratio of measured settlement to girder length was 0.00067, which is significantly below the acceptable limit of 0.004, as established by Felix Yokel [26].

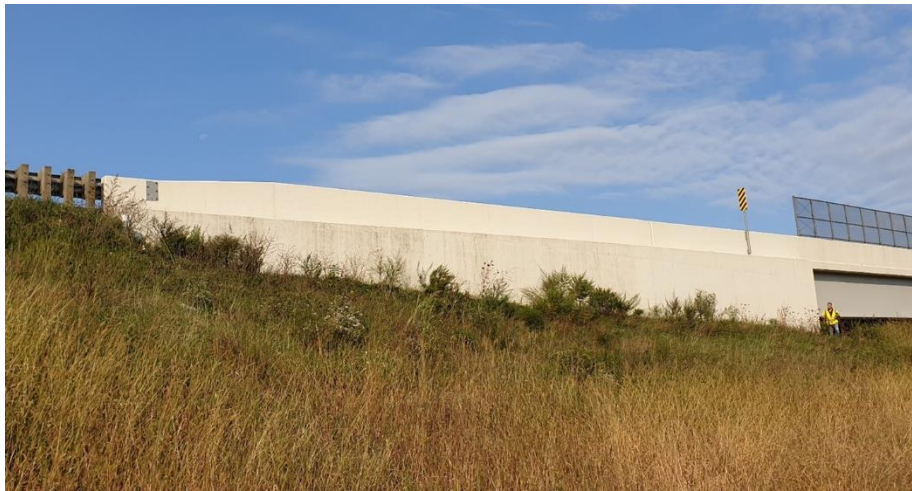
**Fig. (2).** CUY-77-14.35. The right forward abutment wing wall (wall 3).

The footing width for Walls 1 and 4 is 3.8 m and 3 m, respectively, while the footing width for Walls 2 and 3 is 4.26 m. On October 6, 2020, a site visit was conducted. Inspection of the cantilevered cast-in-place concrete wing walls revealed vertical alignment without any noticeable leaning or sliding. The foundation of the bridge retaining walls, founded on spread footing, was confirmed to function as designed. Refer to Fig. (2) for an illustration of the Right Forward Abutment Wing Wall (Wall 3).

In the recent survey, the maximum measured settlement recorded was about 37 mm for Wall 2 and 18 mm for Wall 3. It's noteworthy that settlements generally remained stable, except for Wall 2, monument 2, where a notable change was observed.

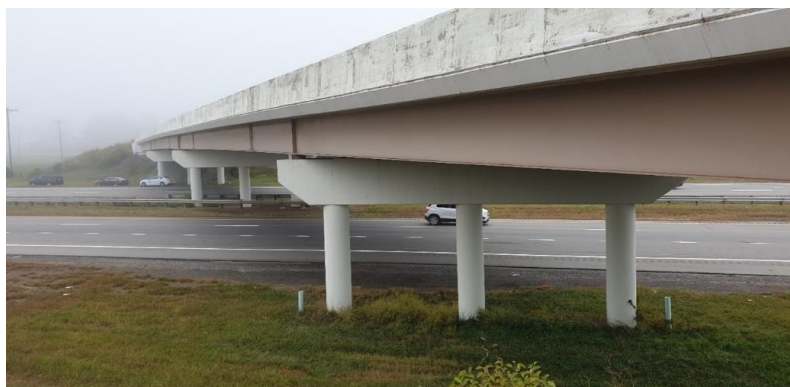
**Fig. (3).** The FAI-33-1309 bridge.

A site visit was conducted on October 5, 2020, to assess various aspects of the FAI-33-1309 bridge. The inspection covered embankment slopes, roadway settlement at abutments, the condition of the concrete deck, and relative substructure orientation. Fortunately, no signs of settlements were detected, and the softness of the soils around the piers was attributed to drainage issues. Some PVC caps were missing or damaged, likely due to vandalism. The existing spread footing design for bridge foundations was functioning as intended. Refer to Fig. (3) for a visual representation of the FAI-33-1390 bridge.

FAI-33-1309 demonstrated acceptable differential settlements ranging from 0.0 to 15.5 mm upon completion of construction. However, recent survey data monitoring settlements revealed differential settlements within the 5.5 to 54 mm range, with values at the piers lower than those observed at the end of construction. Notably, a recent recording indicated a differential settlement of 54 mm between the rear abutment and Pier 1, which can be attributed to the current settlements of 64 mm at the rear abutment. This variation may be influenced by cohesive soils, specifically stiff to hard silt and clay (A-6) and silty clay (A-6) at deeper layers beneath the rear abutment. Importantly, no indications of this differential settlement were observed at the rear abutment approach.

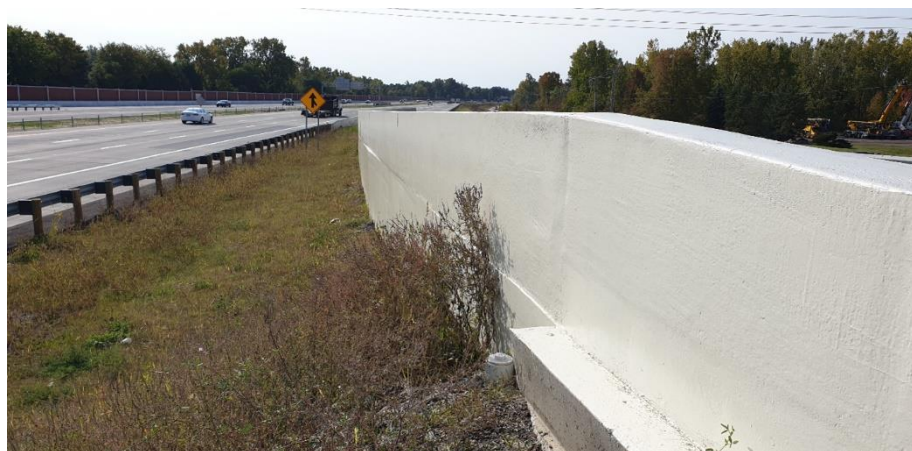
**Fig. (4).** CUY/SUM-271-00.00/14.87 RW-1 (WS1).

E.L. Robinson Engineering conducted a site visit on October 6, 2020. The inspection of the cantilevered cast-in-place concrete wall indicated vertical alignment with no observed leaning or sliding. The existing foundation of the retaining wall, designed with a spread footing, was verified to be operational as intended. Refer to Fig. (4) for a visual depiction of RW-1 (WS1).
