Timely Constructed and Enhanced Lining for Managing Extensive Deformations of Tunnel in Coal Stratum: A Case Study

Yiming Wang^{1,2,*}, Hazrina Mansor¹ and Thevaneyan Krishta David¹

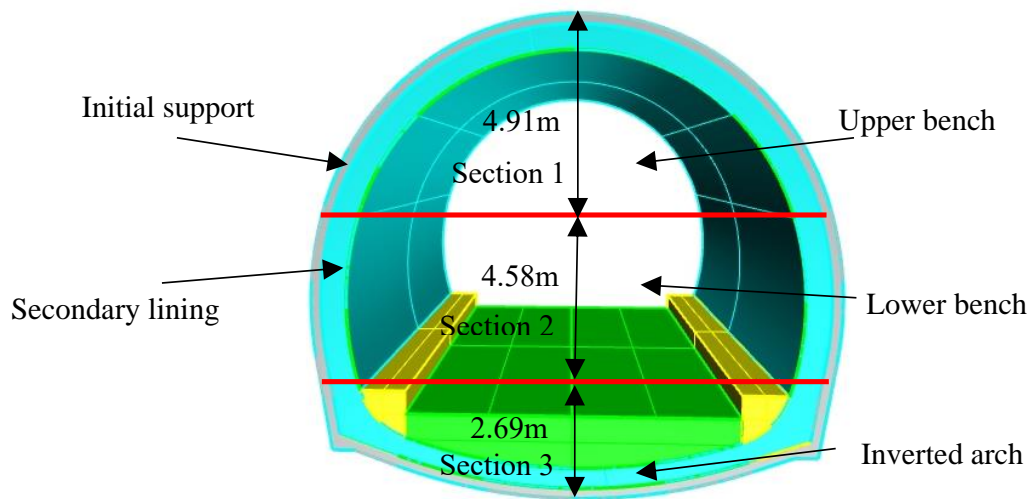
Fig. (1). Schematic diagram of the bench cut method.

Sanlian Tunnel was designed as a single tunnel with a double track to accommodate the design speed of 160km per hour. It was an extra-long railway tunnel of 12214m (DK300+387~ DK312+ 601). The tunnel was designed with an inverted arch, and the composite lining consisted of the initial support and secondary lining. The tunnel was constructed by the bench cut method, which consisted of four construction steps, as shown in Fig. (1). Step 1: Excavate the upper bench and construct the initial support around Section 1. Step 2: Excavate the lower bench and construct the initial support around Section 2. Step 3: Excavate the inverted arch and construct the filling layer in the Section 3. Step 4: Construct the secondary lining when the initial support deformation stabilized.

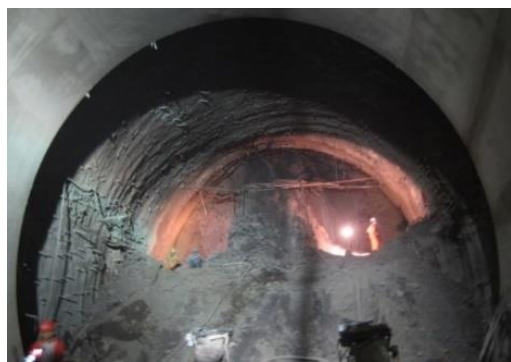
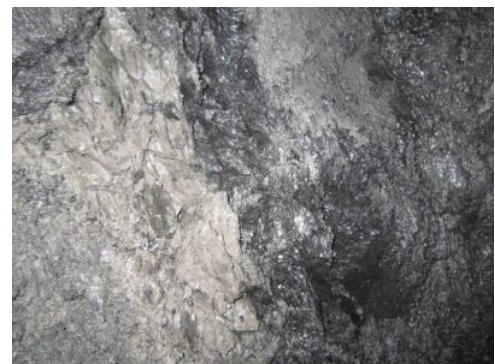
(a) Tunnel excavated in the coal stratum

(b) Coal stratum revealed by the tunnel excavation

Fig. (2a,b). Sanlian Tunnel constructed in the coal stratum.

The geology lithological characters of this tunnel consist of mudstone interbedded with sandstone, carbonaceous shale, and coal seams. The mudstone is dark purple and greyish-purple, the sandstone is purplish-red, and the carbonaceous shale is dark gray in color. With a total length of 302 meters, the tunnel between DK306 + 650 and DK306 + 952 traveled through the coal stratum, as shown in Fig. (2a,b). This coal seam belongs to the Upper Permian Xuanwei Group with a burial depth of 130~230 m. The thickness of each coal seam is more than 0.5 m, and the angle of intersection with the tunnel is 20 degrees. The coal is mainly composed of bright coal with block structures in gray-black color. The joints are developed, and the surrounding rocks are broken and soft in the coal stratum.

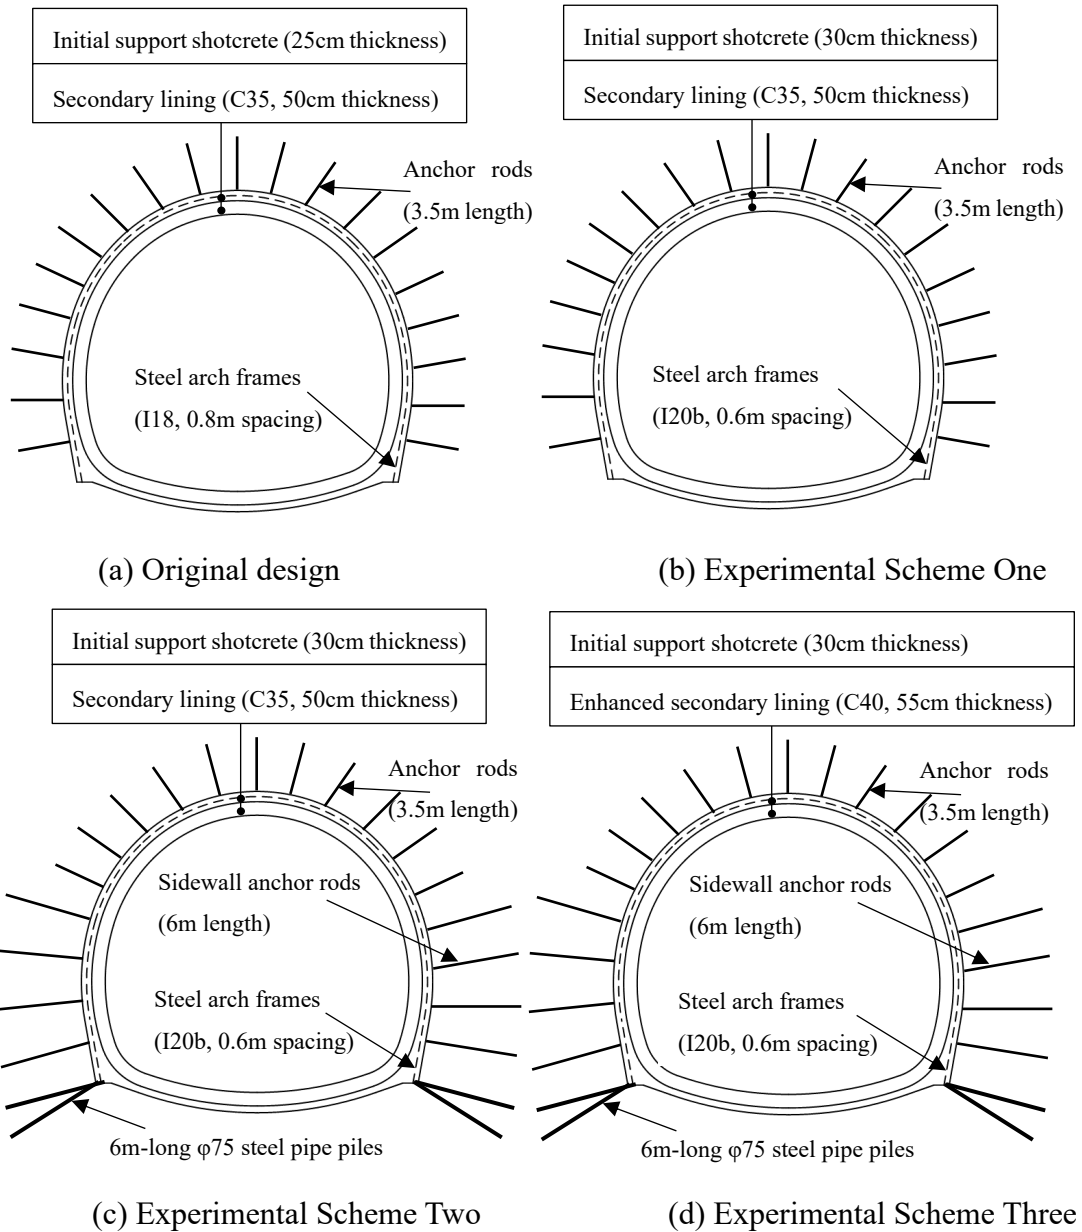
Fig. (3a-d). Schematic of experimental schemes.

Addressing the issue of extensive deformations calls for innovative control. The goals of this work are to mitigate the deformations and to ensure the tunnel stability. The field experiment was adopted to select the appropriate technical measures to control extensive deformations. Based on the original design of the tunnel, three experiment schemes were developed. Scheme one was applied to the construction of the section between DK306+680 and DK 306+695, Scheme two was applied to the section between DK306+695 and DK 306+710, and Scheme three was applied to the section of DK306+710 and DK 306+725. These three experimental sections had similar geological conditions, namely the coal stratum and high geostress. The displacements and stresses in the tunnel were monitored, and then the appropriate control techniques were selected based on the field observation results. Table 3 and Fig. (3a-d) illustrate the original design and three experimental schemes.

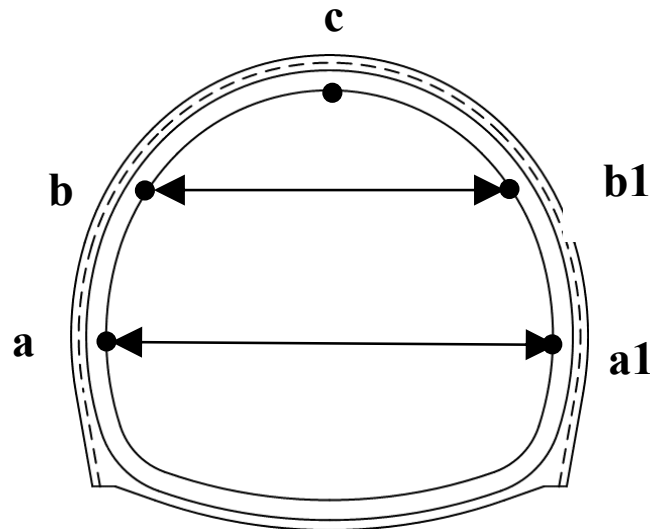
Fig. (4). Monitoring point arrangement of displacement.

Field observations of displacements and stresses in the tunnel were implemented to evaluate the effectiveness of different experimental schemes. Monitoring points were placed on the tunnel's inner wall surface to monitor the displacement, as illustrated in Fig (4). After excavating the upper bench, measurement point c was arranged at the vault to monitor the apex settlement; moreover, measurement point b and b1 were arranged at the arch hance to monitor the horizontal convergence. After excavating the lower bench, points a and a1 were arranged at the side wall to monitor the horizontal convergence.

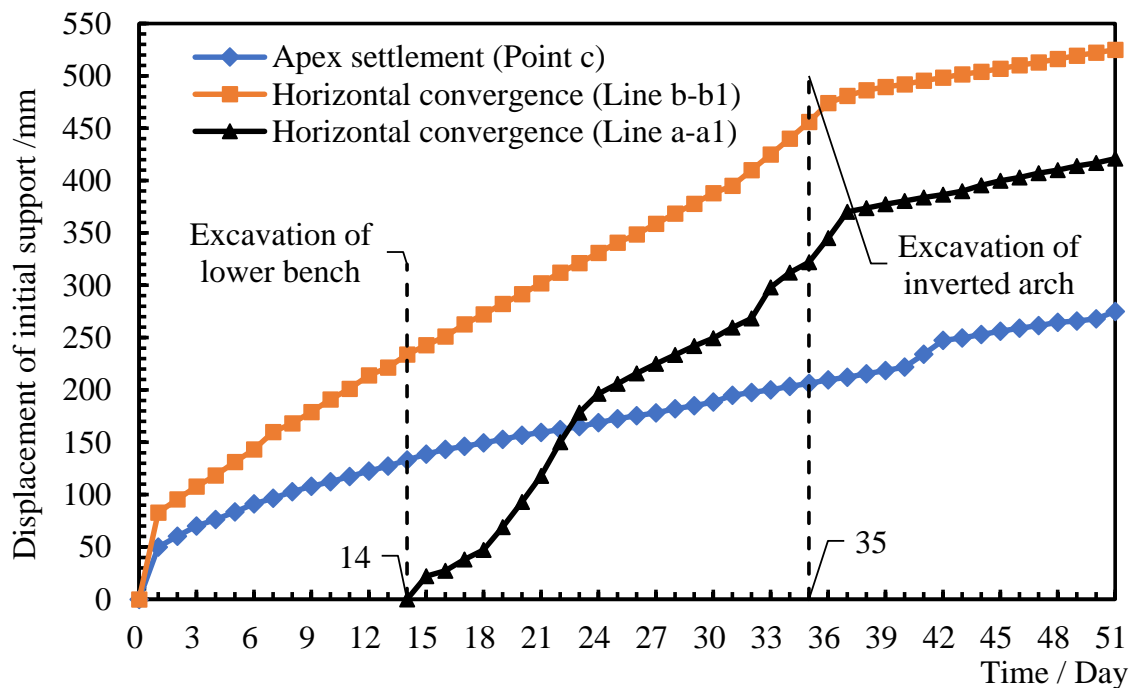
(a) Displacement of initial support of Scheme 1

Fig. (6a-c). Experimental results of initial support of Scheme 1.

The monitoring results of the initial support displacement in Scheme One are shown in Fig. (6a). At the beginning of the monitoring period, the displacement of the initial support increased quickly. It indicates rapid settlement at the vault and a speedy horizontal displacement of the hance into the tunnel's interior after the upper bench was constructed. After excavating the lower bench (*i.e.*, on the fourteenth day), the same rapidly increasing trend was shown at the horizontal convergence of Line a-a1 on the side wall. The initial support was

disturbed by the excavation of the inverted arch (i.e., on the thirty-fifth day), and the displacement showed fluctuations and continued to increase. On the fifty-first day, the apex settlement at Point C reached 275mm, and the maximum horizontal convergence at Line b-b1 reached 524.9mm. As seen in Fig. (6b), the distortion of the grid

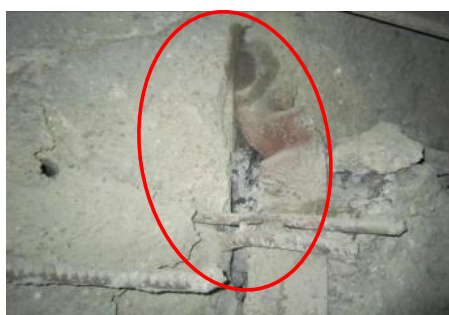
(b) Distortion of the grid steel frame

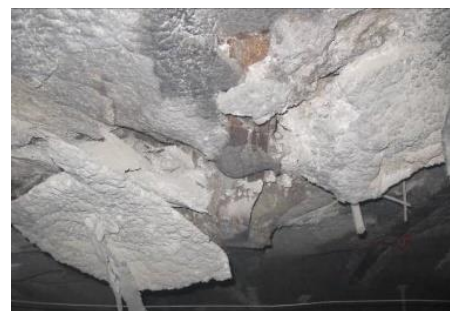
(c) Cracking and spalling of initial support concrete

steel frame appeared in Experimental Scheme One. Furthermore, cracking and spalling were examined at the vault of initial support concrete, as shown in Fig. (6c). Moreover, the initial support intruded into the tunnel clearance limit. These indicate that the structural design in Scheme One cannot effectively control the large deformation of the surrounding rock.

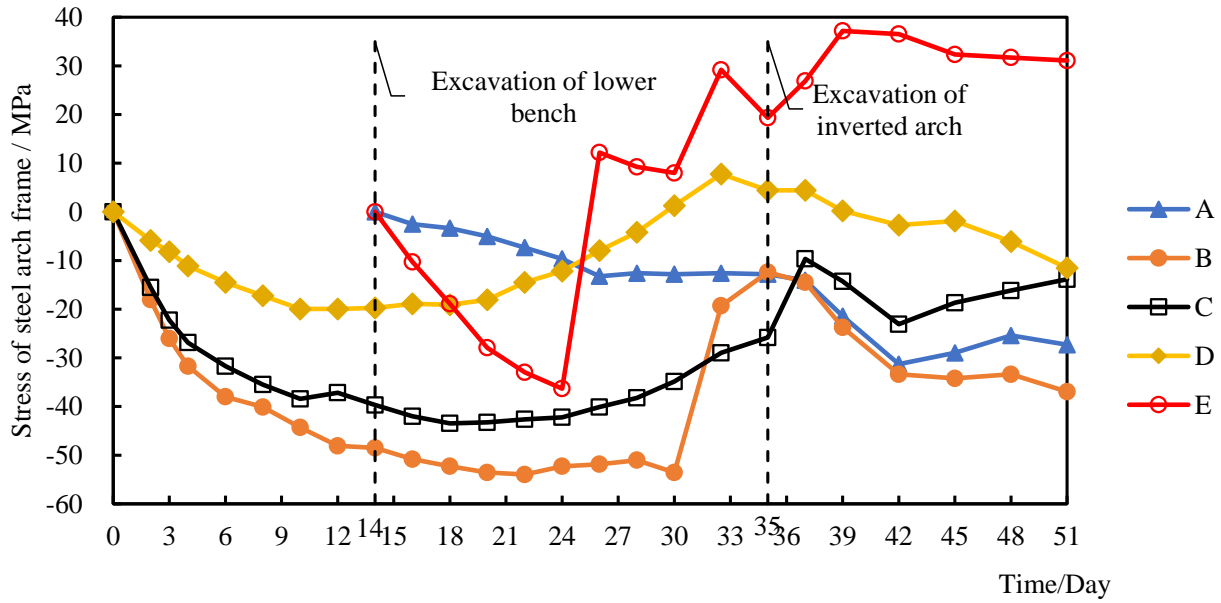
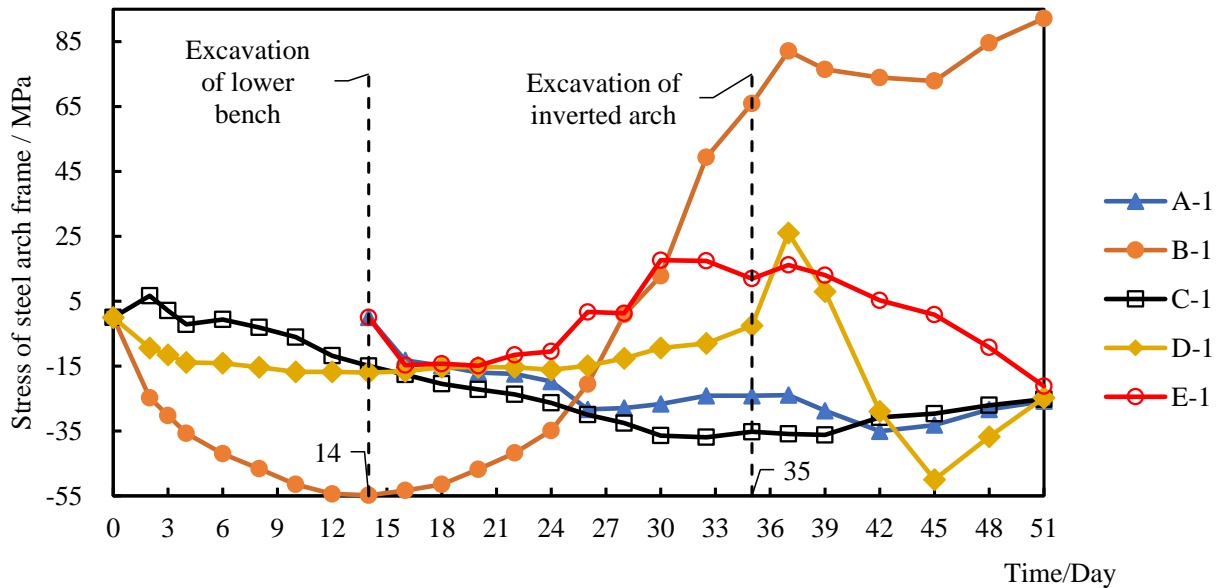
(a) Stress at the inner edge

(b) Stress at the outer edge

Fig. (7a,b). Stress of steel arch frame of Scheme 1.

The monitoring results of stress at the inner and outer edge of the steel arch frame in Scheme One are presented in Fig. (7a,b). The positive stress indicates tensile stress, while the negative stress indicates compressive stress. As soon as the upper bench was excavated, the steel arch frame started to support loads, and the stress quickly increased. After excavating the lower bench, the stresses at the side wall (i.e., at Points A, E, A-1, and E-1) increased rapidly as the steel arch frames at the sidewall were immediately subjected to loads after installation. Then, the

stresses in the steel arch frame experienced significant changes due to the excavation of the inverted arch on the thirty-fifth day. When the initial support deformation intruded into the tunnel clearance limit, i.e., on the fifty-first day, the maximum tensile stress in the steel arch was 92.17 MPa, which occurred at point B-1, and the maximum compressive stress was -36.96 MPa, which occurred at point B. Throughout the monitoring period, the stresses of the steel arch were generally in substantial fluctuation and did not reach a steady state. This implies that Scheme One cannot effectively solve the problem of extensive deformations.

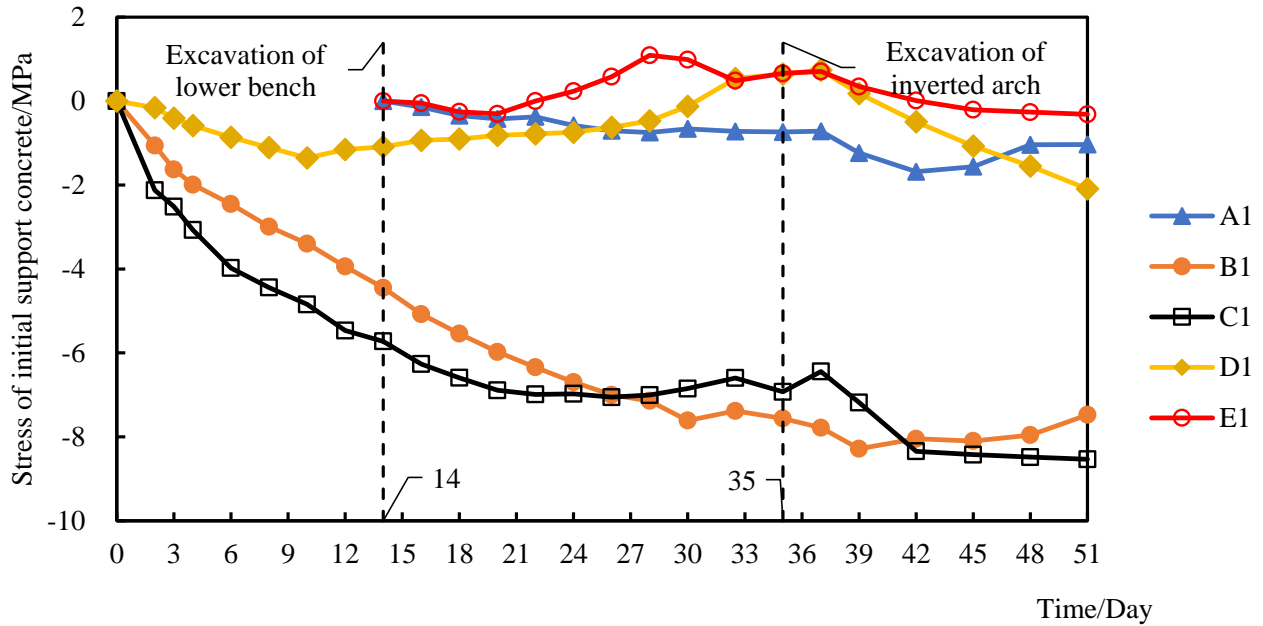
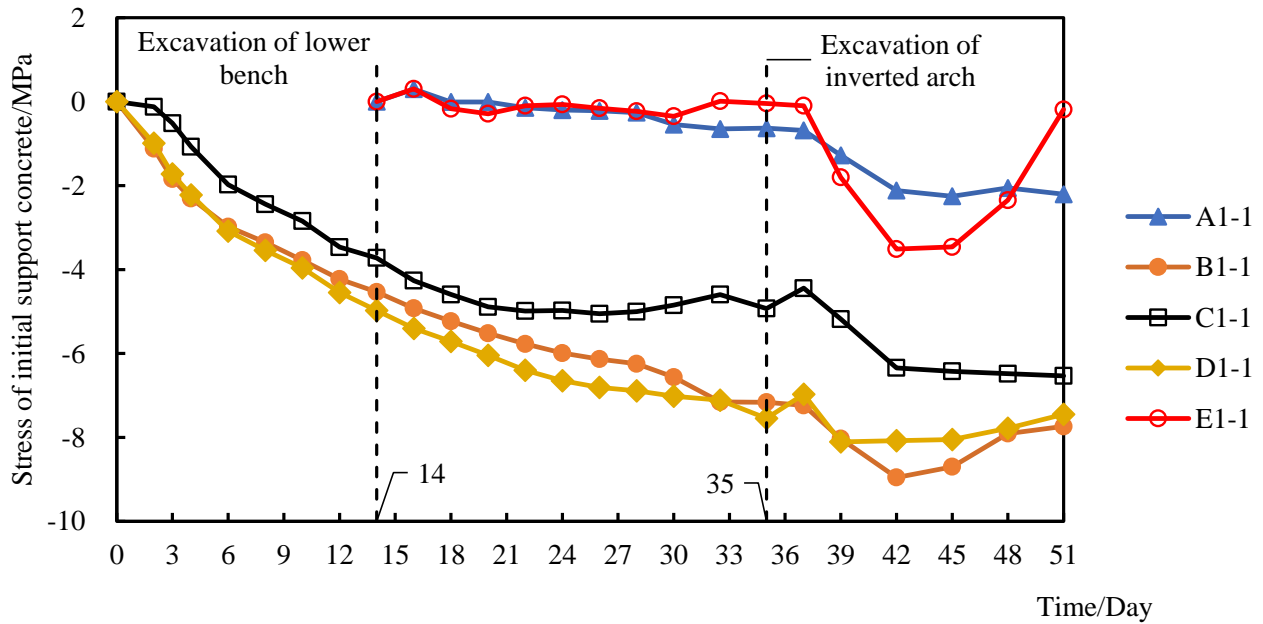
(a) Stress at the inner edge

(b) Stress at the outer edge

Fig. (8a,b). Stress of initial support concrete of Scheme 1.

The monitoring results of stress at the inner and outer edge of the initial support concrete in experimental scheme One are illustrated in Fig. (8a,b). The positive stress indicates tensile stress, while the negative stress indicates compressive stress. The initial support concrete stress had a rapid increase trend at the start of the monitoring period. After the fourteenth day, *i.e.*, when the

lower step was excavated, the shotcrete at the sidewalls started to take the load, and the stress gradually increased. Later, the initial supporting concrete stresses showed fluctuations, and continued to increase after the excavation of the inverted arch on the thirty-fifth day. At the end of the monitoring period, when the initial support intruded into the tunnel clearance limit, all measuring

points showed compressive stress, with a maximum compressive stress of -8.53MPa (i.e., Point C1) at the inner edge of the vault. Throughout the monitoring period, the stress of initial support concrete continued to increase

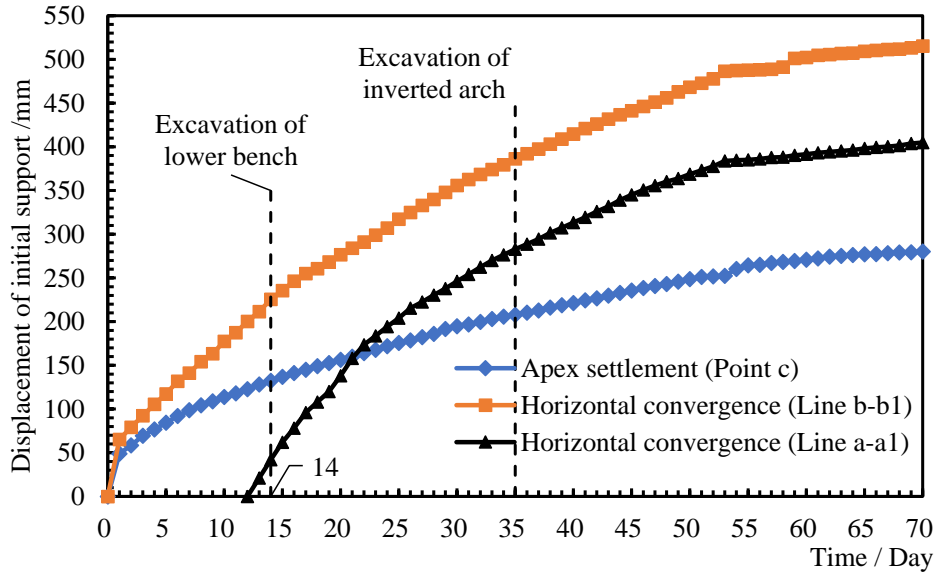
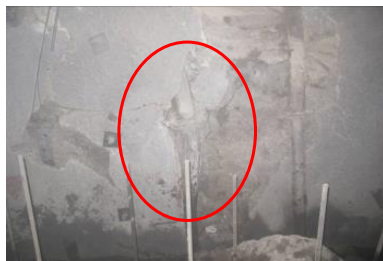
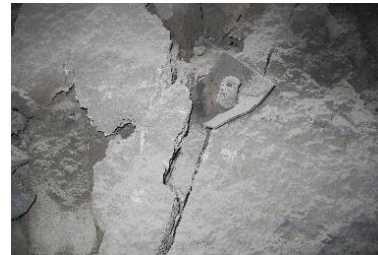
(a) Displacement of initial support of Scheme 2

(b) Bending deformation of the steel arch frame

(c) Fissuring of initial support concrete

Fig. (9a-c). Experimental results of initial support of scheme 2.

The displacements of the initial support in Scheme Two showed the same trend as Scheme One, *i.e.*, a continuous increase, as shown in Fig. (9a-c). On the seventieth day, the apex settlement at Point C reached 280.1mm, and the maximum horizontal convergence at Line b-b1 reached 515.4mm. The initial support structure of Scheme Two still intruded into the tunnel clearance limit. The difference is that the intrusion of the initial support into the tunnel clearance limit in Scheme Two was on the seventieth day, which was nineteen days later than that in Scheme One. Fig. (6b and c) show the on-site image of the initial support structure in Scheme Two. The

bending deformation of steel arch frames and fissuring of initial support concrete were examined in this experimental scheme. The failure phenomenon implies that the initial support of Scheme Two still cannot effectively solve the problem of extensive deformations.

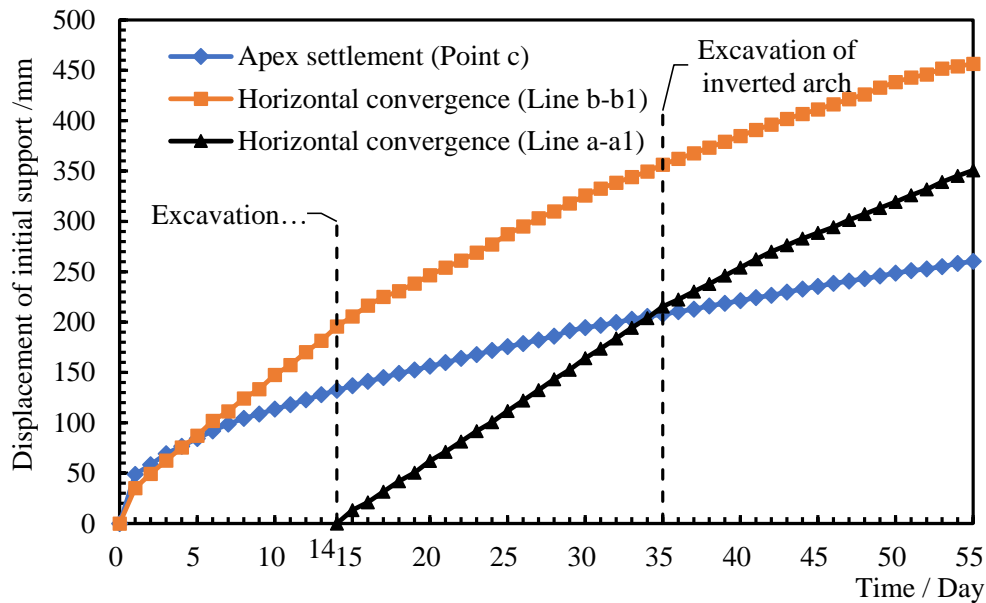
Fig. (10). Displacement of initial support of scheme 3.

The monitoring results of the initial support displacement of Scheme Three are shown in Fig. (10). During the first fourteen days of the monitoring period, the displacement of the initial support (*i.e.*, Line b-b1, Point c) increased quickly. It indicates there was a rapid displacement of the surrounding rock towards the interior of the tunnel after the upper bench was excavated. After the excavation of the lower bench (*i.e.*, on the fourteenth day), the horizontal convergence at Line a-a1 on the side wall showed rapid growth. Then, the initial support was disturbed by excavating the inverted arch (*i.e.*, on the thirty-fifth day), and the displacement continued to increase. On the fifty-fifth day after the tunnel excavation, the vault settlement of the initial support at point c was 260.3mm. Additionally, the cumulative horizontal convergence at Line a-a1 on the side wall and Line b-b1 on the hance was 350.7mm and 456.5mm, respectively. In Scheme Three, when the horizontal convergence of the initial tunnel support exceeded 450 mm, the secondary lining was constructed. Hence, the monitoring of the initial support displacement ended, and the secondary lining was constructed on the fifty-fifth day.

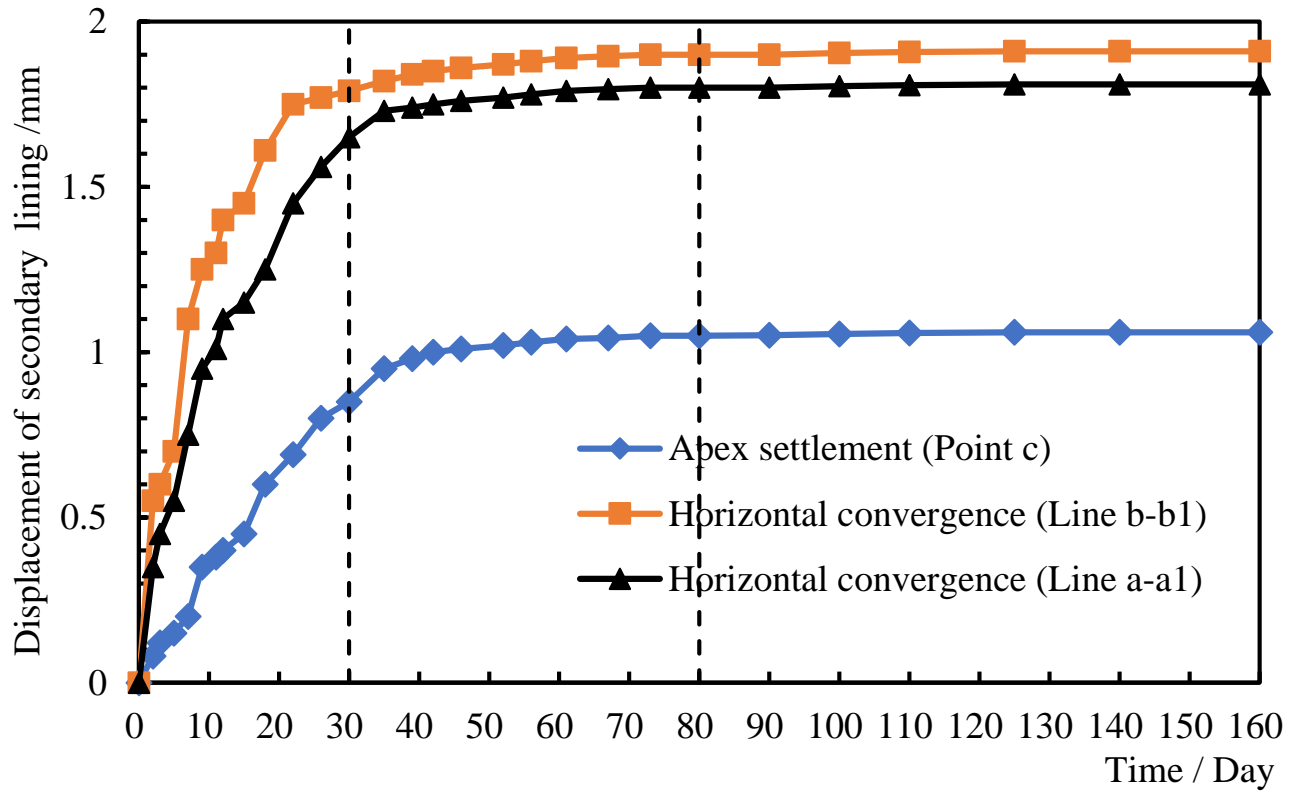
Fig. (11). Displacement of the secondary lining of scheme 3.

Fig. (11) depicts the monitoring results of the secondary lining displacement. During the first thirty days of the monitoring period, the displacement of the

secondary lining increased quickly. It implies that the secondary lining that had just been constructed worked together with the initial support to resist the surrounding rock's large deformation toward the tunnel's interior. A continuous but slow growth appeared in the displacement from the thirtieth to the eightieth day. This may be because the combined effect of the secondary lining and initial support gradually stabilized the surrounding rock displacement. Then, the displacement of the secondary lining remained almost steady after the eightieth day. At the end of the monitoring period, the vault settlement at point c was 1.06mm. Additionally, the cumulative horizontal convergence at Line a-a1 on the side wall and at Line b-b1 on the hance was 1.81mm and 1.91mm, respectively. Overall, eighty days after completion of the secondary lining, the secondary lining displacement reached a steady state; moreover, the cumulative displacement of the secondary lining was not significant. It can be inferred that the timely constructed and enhanced lining structure could effectively manage the condition of the extensive deformation.

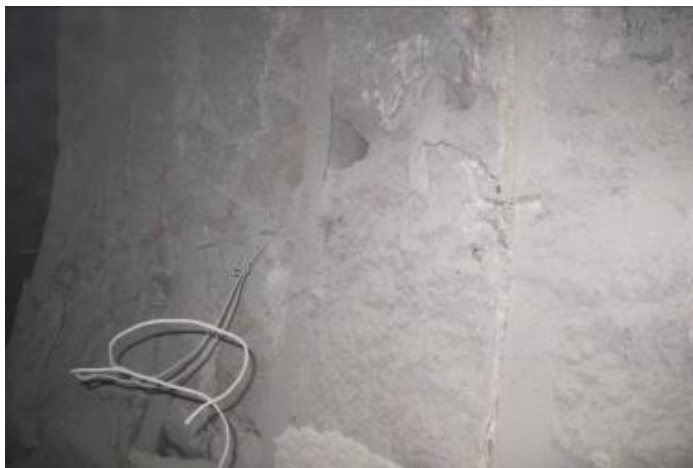
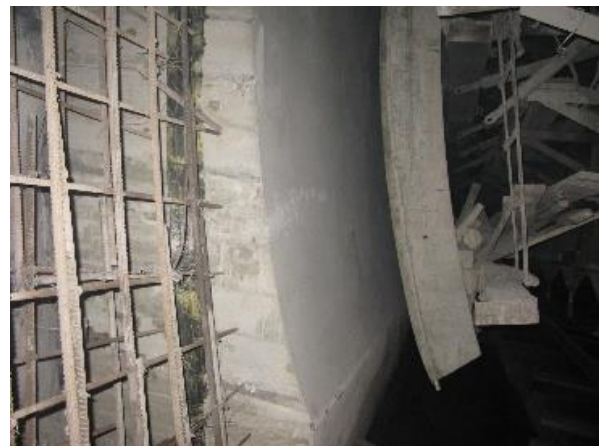
(a) Initial support

(b) Secondary lining

Fig. (12a,b). Image of the tunnel construction of scheme 3.

Fig. (12a,b) shows the images of the initial support and secondary lining in Scheme Three. No significant deformations were monitored in the initial support prior to the construction of the secondary lining. Moreover, there were no cracks on the surface of the secondary lining during the monitoring period. From the on-site situation of tunnel construction, it is inferred that Scheme Three is effective in controlling the extensive deformation.

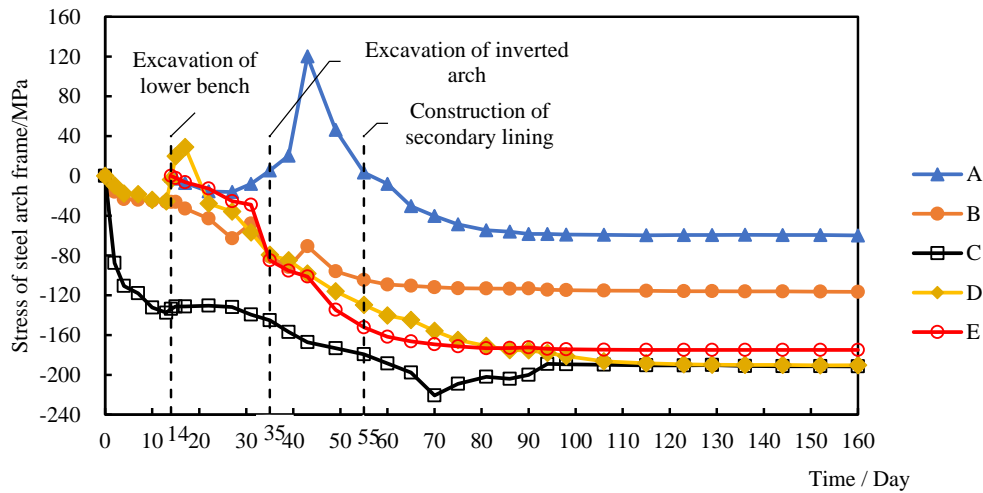
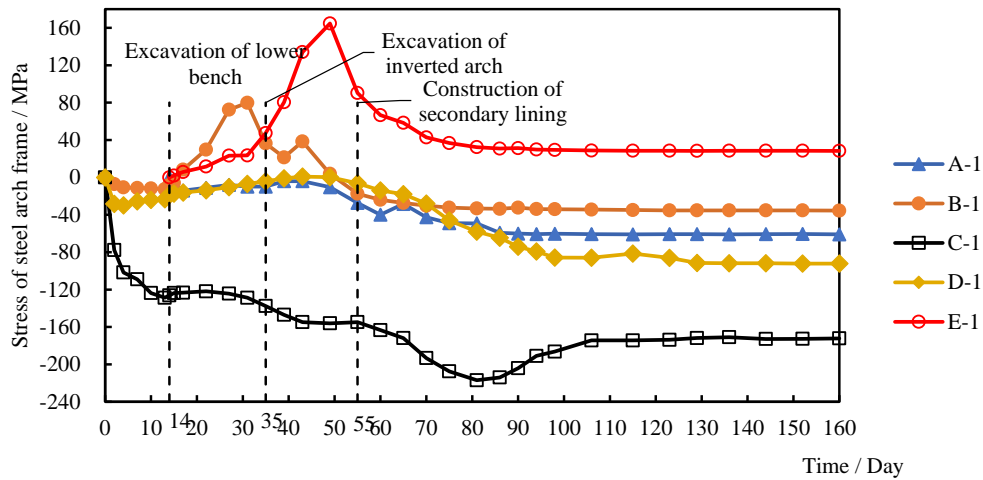
(a) Stress at the inner edge

(b) Stress at the outer edge

Fig. (13a,b). Stress of steel arch frame of scheme 3.

The monitoring results of stress in the steel arch frame are presented in Fig. (13a,b). The positive stress indicates tensile stress, while the negative stress indicates compressive stress. The steel arch frame began to bear loads immediately after completing the upper bench, and the compressive stress in the steel arch frame increased rapidly. On the fourteenth day, *i.e.*, when the lower step was excavated, the compressive stresses at the inner and outer edge of the vault reached -133.77MPa (*i.e.*, at Point C) and -126.21MPa (*i.e.*, at Point C-1), respectively. After excavating the lower bench, the stresses at the side wall (*i.e.*, at Points A, E, A-1, and E-1) increased rapidly as the steel arch frames at the sidewall had just been erected and were immediately subjected to loads. Influenced by the excavation of the inverted arch on the thirty-fifth day, there were large fluctuations in the stresses at the

monitoring points of the steel arch frame. The maximum tensile stresses of 120.12MPa (*i.e.*, Point A at the left side wall) and 164.64MPa (*i.e.*, Point E-1 at the right side wall) appeared at the inner and outer edge of the steel arch frame, respectively. Later, after the construction of the secondary lining on the fifty-fifth day, the tensile stresses in the steel arch frame gradually decreased, while the compressive stress gradually increased. Afterward, the stress of the steel arch frame was gradually adjusted and tended to be steady in the initial support, as the reinforced secondary lining and the initial support acted jointly to bear loads. After the one hundred and thirty-fifth day, the stresses changed very little and eventually reached a steady state. At the end of the monitoring period, the maximum compressive stresses occurred at the vault, *i.e.*, -191.5 MPa (Point C) at the inner edge and -172.2 MPa (Point C-1) at the outer edge of the steel arch frame.

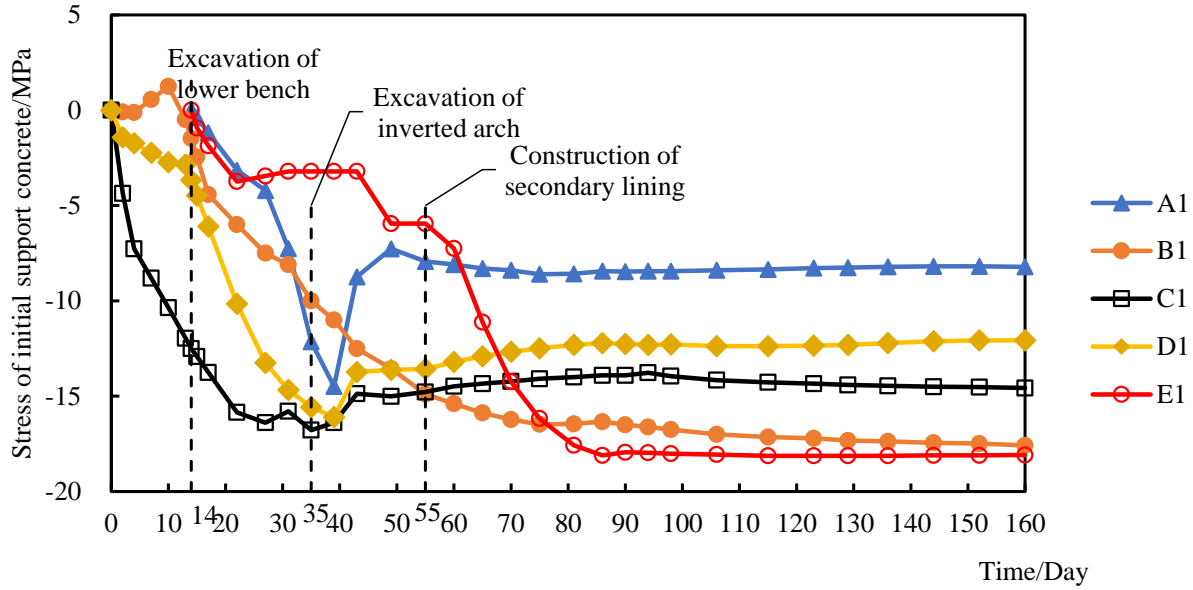
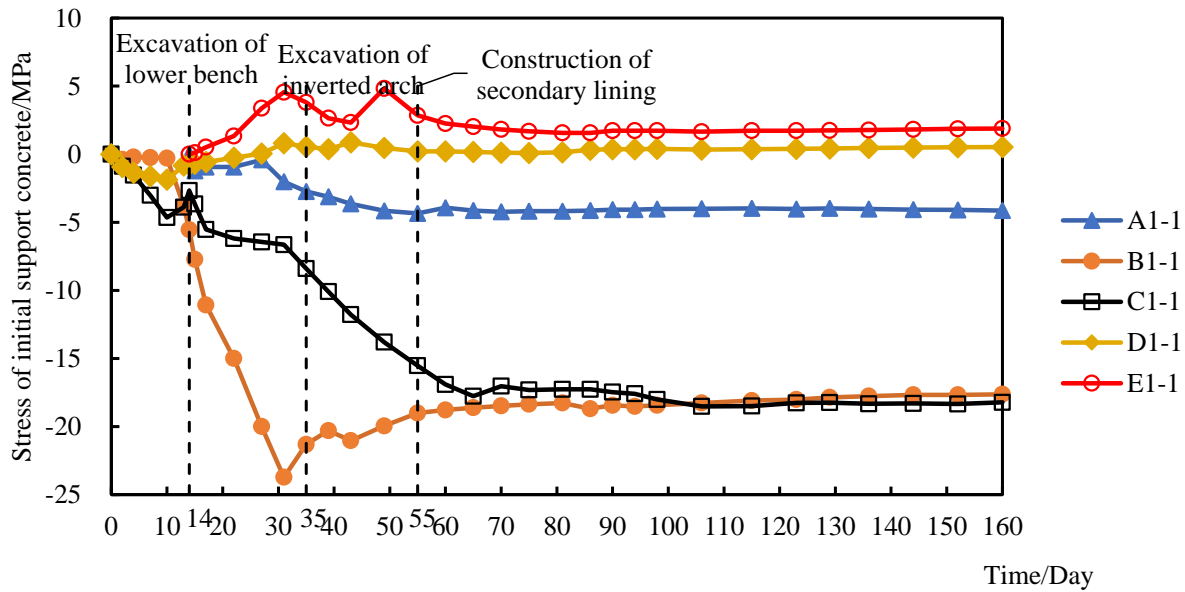
(a) Stress at the inner edge

(b) Stress at the outer edge

Fig. (14a,b). Stress of initial support concrete of scheme 3.

The monitoring results of the initial support concrete stress are illustrated in Fig. (14a,b), separately. In the beginning, the stress showed a rapid growth trend. It suggests that the initial support concrete resisted the deformation of the surrounding rocks and bore considerable compressive stress. On the fourteenth day, i.e., when the lower step was excavated, the stress in the

initial support concrete increased rapidly, with a maximum tensile stress of -23.73MPa at Point B1-1. This implies that the surrounding rocks underwent a large extrusion deformation towards the tunnel's interior, resulting in large loads on the initial support. Influenced by the excavation of the inverted arch on the thirty-fifth day, there were large fluctuations in the stresses. Later,

after the construction of the secondary lining on the fifty-fifth day, the stress was gradually adjusted and tended to be steady, as the reinforced secondary lining and the initial support acted jointly to bear loads. After the one hundred and twentieth day, the stresses changed very little and remained almost steady. At the end of the monitoring period, two monitoring points (*i.e.*, D-1 and

E-1) presented tensile stress, while the other monitoring points showed compressive stresses. The maximum tensile stress of 1.89MPa (*i.e.*, Point E1-1 at the right-side wall) appeared at the outer edge. Meanwhile, the maximum compressive stress of -18.22MPa (*i.e.*, Point C1-1 at the vault) occurred at the outer edge of the initial support concrete.

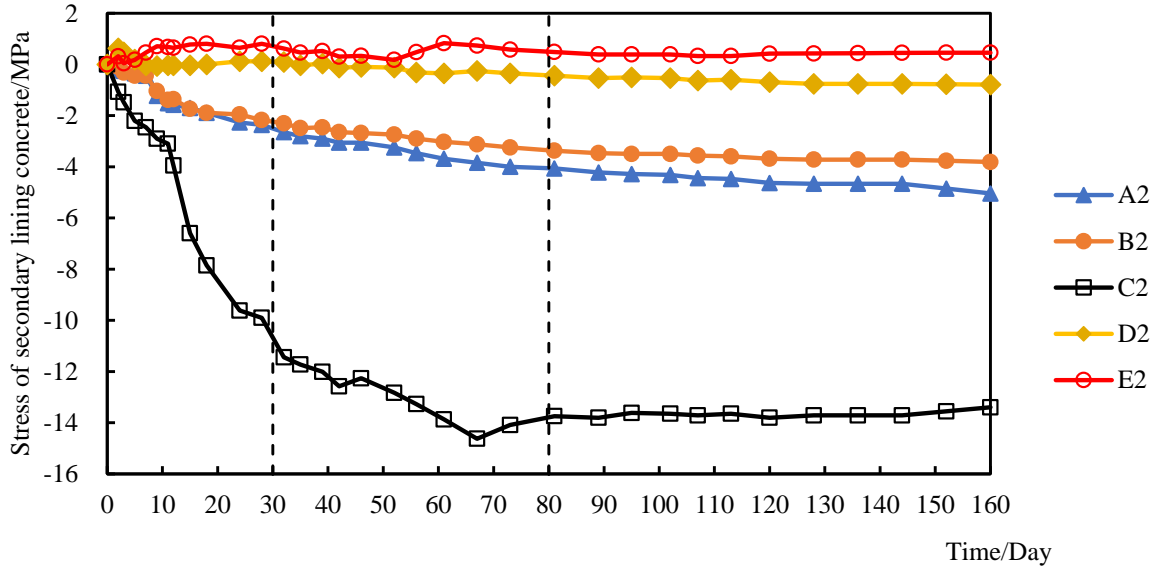
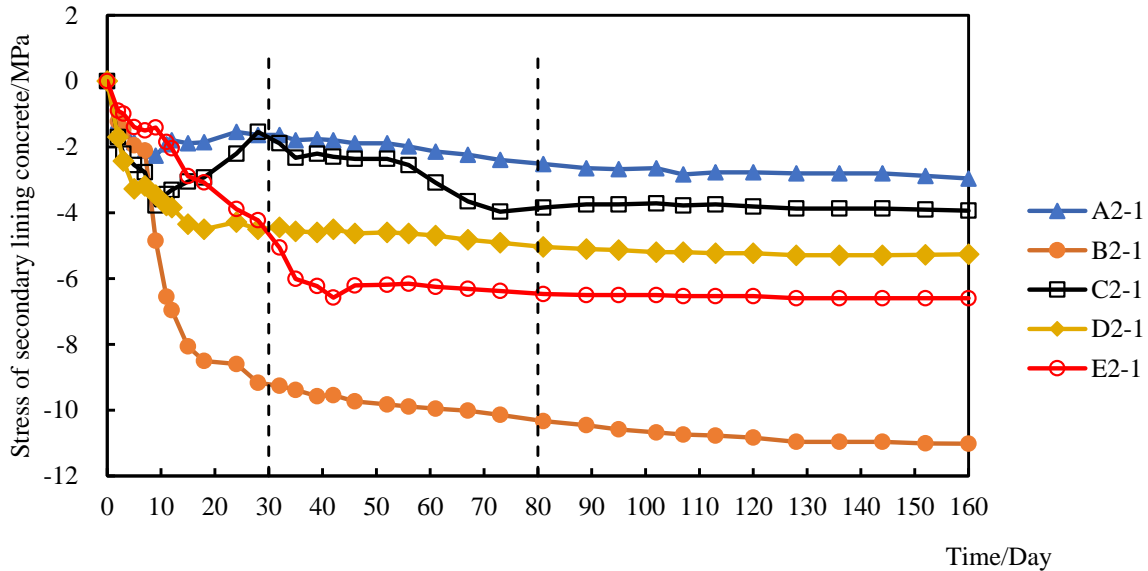
(a) Stress at the inner edge

(b) Stress at the outer edge

Fig. (15a,b). Stress of secondary lining concrete of scheme 3.

Fig. (15a,b) depicts the monitoring results of the secondary lining concrete stress. In the first thirty days of the monitoring period, the stress in the secondary lining concrete increased quickly, implying that the concrete lining began to bear loads after the lining was completed. A continuous but slow growth appeared in the lining stress from the thirtieth to the eightieth day. This is probably because the enhanced secondary lining was gradually controlling the extensive deformation of the surrounding rock. During this period, a maximum compressive stress of -14.63MPa (i.e., point C2) showed at the inner edge of the vault. The secondary lining bears loads together with the initial support, so the stress of the secondary lining was gradually adjusted and tended to be steady after the eightieth day. The stress at point C2 slightly reduced, while the stress at point B2-1 increased somewhat. At the end of the monitoring period, the ultimate compressive stress was -13.4 MPa (i.e., Point C2), and the ultimate tensile stress was 0.46 MPa (i.e., Point E2).
