# Experimental Study on Precast Concrete Shear Walls with Different Hollow Slabs

**Abstract:** To study mechanical behaviors of shear walls built with precast two-way hollow slabs, two shear walls with different details of hollow slabs were quasi-statically tested under low cyclic loading. The failure mode was analyzed, which vertical macro-cracks appeared on walls due to the details of hollow slabs. Brittle shear failure can be avoided in terms of the failure behaviors evolved from integral wall to the combination of wall and columns. Test results also show that that dimension of transverse holes can affect compressive capacity of the walls when it is larger than that of longitudinal holes in the hollow slab.

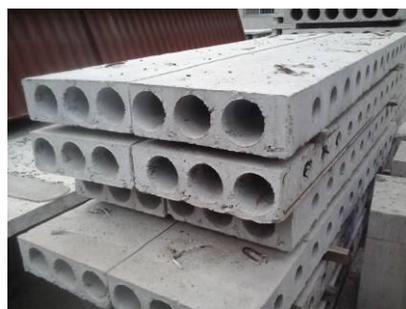
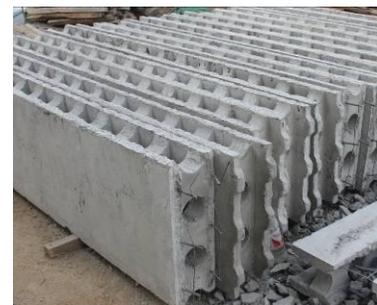
**Fig. (1).** Precast two-way hollow slabs.

As shown in Fig. (1), two kinds of hollow slabs A and B are designed to study the effect of different details of the slabs on mechanical behaviors of PTHSWs. The bidirectional holes of slab A are all circular, while the diameter of transverse holes (89 mm) is less than that of longitudinal holes (140 mm). For arranging the horizontal reinforcement more conveniently, the transverse holes of slab B are designed square (the longitudinal holes remain circular), moreover, the side-length of the transverse holes (120 mm) is larger than the diameter of the longitudinal holes (104 mm).

a. Slab A

b. Slab B

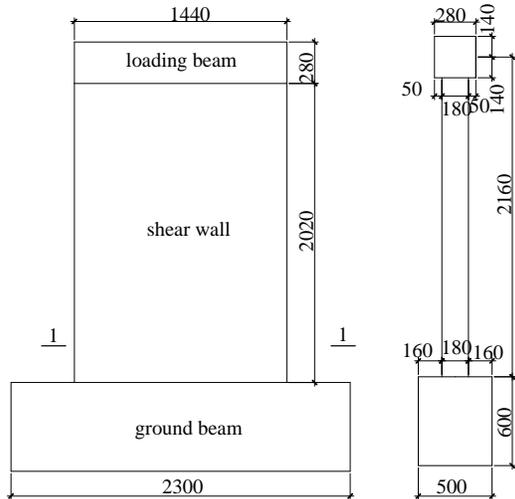
**Fig. (2).** Dimensions of SW1.

ratio is 1.5 and the same axial fore ratio 0.15 for all specimens. A loading beam and a ground beam were fixed on the wall at two ends to ensure the uniform stress of specimens. Dimensions of the types of walls are shown in Fig. (2) and Fig. (3) respectively.

Based on the design above, two PTHSWs constructed with hollow slab A and B respectively were tested under low cyclic loading. The cross-section of SW1 is 1440 mm × 180 mm, and 1600 mm × 200 mm for 2-SW1. The aspect

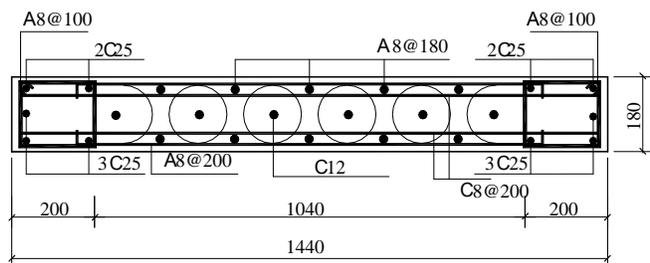
**Fig. (4).** 1-1 profile for reinforcement details of SW1.

Under the guideline of the concept ‘strong bending capacity and weak shear capacity’, the boundary elements of SW1 are reinforced with 5 $\pm$ 25 HRB400 (Hot-rolled Ribbed-steel Bar) longitudinal bars and  $\Phi$ 8 HPB235 (Hot-rolled Plain Bar) stirrup hoops at 100mm spacing. Meanwhile, the boundary elements of 2-SW1 are reinforced with 6 $\pm$ 25 HRB400 longitudinal bars and  $\pm$  8 HRB400 stirrup hoops at 100 mm spacing. The volume-stirrup ratios of specimens are 1.5% and 0.56%, respectively. Reinforcement details of specimens are shown in Fig. (4) and Fig. (5), and some experimental parameters are listed in Table 1.

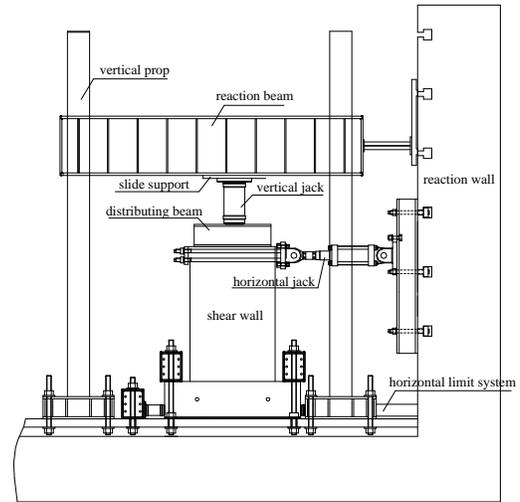
**Fig. (6).** Test setup.

The test setup is plotted in Fig. (6). A vertical (axial) load was applied on the top of the specimens by a hydraulic jack (capacity of 3000 kN) and kept constant during the test; meanwhile a steel distributing beam was placed under the

hydraulic jack in order to maintain compression uniformity along the cross-section of the specimens. A low cyclic lateral load was applied by a hydraulic jack (capacity of 1500 kN) fixed on a reaction wall and controlled by loading-displacement control system. At the early stage of the test, loading control was applied before yield when the first diagonal crack occurred. After that, displacement control was applied with every subsequent cycle repeated twice up to

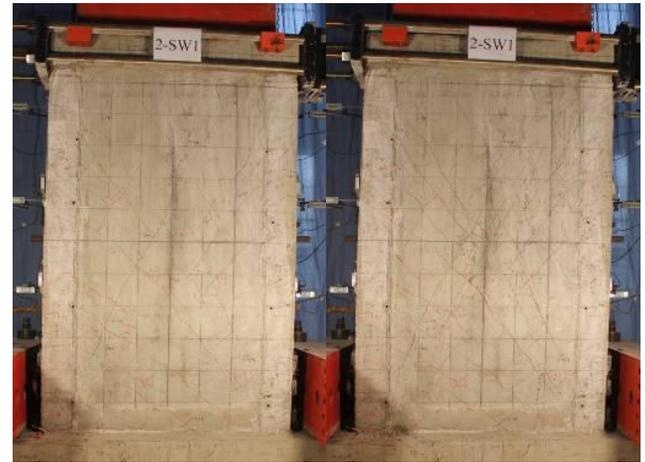
Fig. (7a) illustrates the peak state of 2-SW1. Diagonal cracks increased gradually along diagonal lines with the increase of displacement. The lateral load reached the maximum at load -1319kN and +1342kN.

a. Crack pattern at peak load b. The drift ratio 1/70  
**Fig. (7).** Failure process and pattern of 2-SW1.

After that, with increase of the control displacements, concrete around two joints and the cross diagonal lines peeled off with hissing sound in the wall. When the control displacement reached -30 mm, some short minor diagonal cracks occurred along the longitudinal distributed reinforcement and concrete around the cracks quickly peeled off then formed vertical macro-cracks. Meanwhile, concrete in a rhombic area formed by cross diagonal cracks in the middle of the wall was crushed partly. Fig. (7b) shows the photo of failure point under the drift ratio 1/70 when the lateral load dropped to 85% of the maximum load. The middle area concrete was crushed severely and out-of-plane protruded, with strong cracking sound. Reinforcement in the hollow slab exposed and yielded gradually with the increase of displacements. At the end of the test, rhombic concrete failure areas were formed in the middle of the wall with longitudinal distributed reinforcement yielded severely.

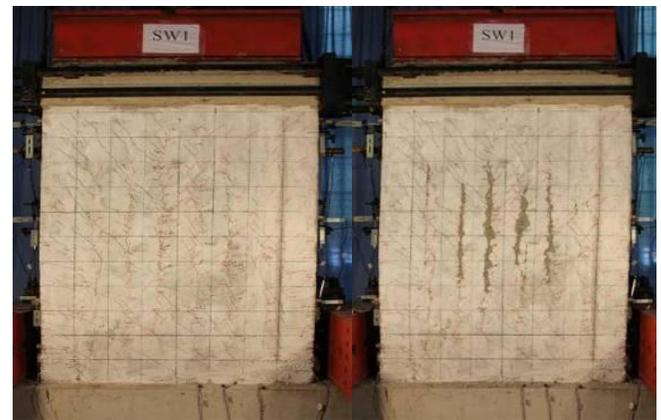
After that, concrete along vertical macro-cracks peeled off gradually with the increase of displacement. Relative deformation of two sides of the wall increased continually meanwhile the failure behavior changed from integral wall to the combination of wall-columns. Fig. (8b) shows the failure point of SW1 when the drift ratio was 1/100. Concrete along vertical macro-cracks was crushed severely with the increase of displacement. Cast-in-situ columns inside longitudinal holes exposed and became visible. When the test finished, concrete at two toes of the wall and between the vertical macro-cracks was almost intact.

a. Crack pattern at peak load b. The drift ratio 1/100  
**Fig. (8).** Failure process and pattern of SW1.

The initial failure process of SW1 was similar to 2-SW1. When the lateral load increased -492kN and +600kN, multi-strip two-way short minor diagonal cracks occurred along the longitudinal holes of the hollow slab crossed the weakest joints of concrete between longitudinal holes and then formed gradually vertical macro-cracks. At the same time, no visual diagonal cracks occurred on the wall. Vertical macro-cracks increased and extended upward and downward before yielding, which divided the wall into some wall-columns. The occurrence of wall-columns changed the development of diagonal cracks of the wall and avoided the brittle shear failure. Fig. (8a) illustrates the peak state of SW1. When the control drift ratio reached 1/144, the lateral load came to the peak value of -886kN and +853kN respectively.

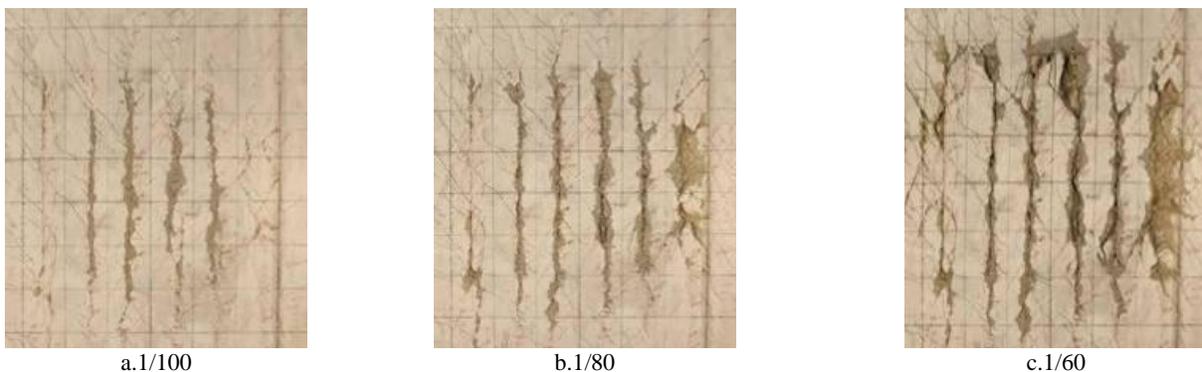
Fig. (9 and 10) show the crack patterns of two specimens when the drift ratio reached 1/100, 1/80 and 1/60 respectively. Fig. (11) shows the inner failure patterns of walls. Concrete in the precast slab of 2-SW1 had been crushed when the drift ratio reached 1/60, at the same time, that of SW1 was relatively intact. Concrete between longitudinal holes (namely the longitudinal force transferring

a.1/100 b.1/80 c.1/60  
**Fig. (9).** Failure behaviors of SW1 at three drift ratios.

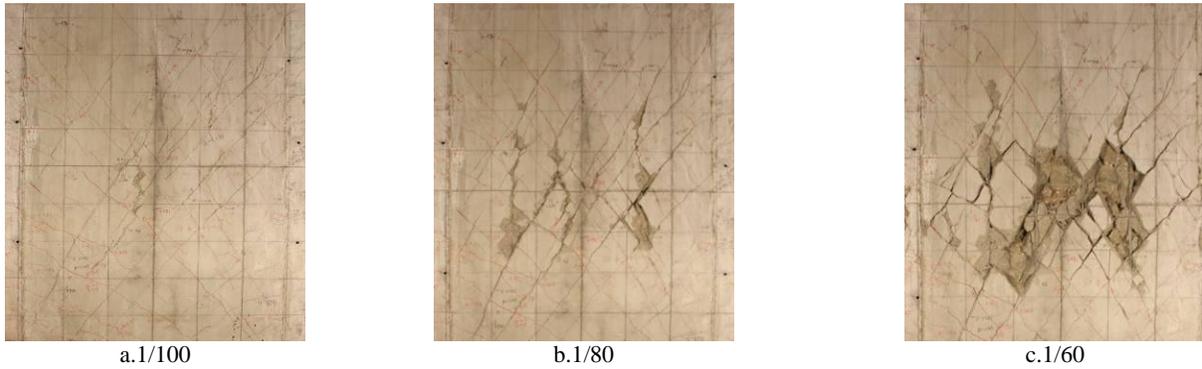
Fig. (10). Failure behaviors of 2-SW1 at three drift ratios.

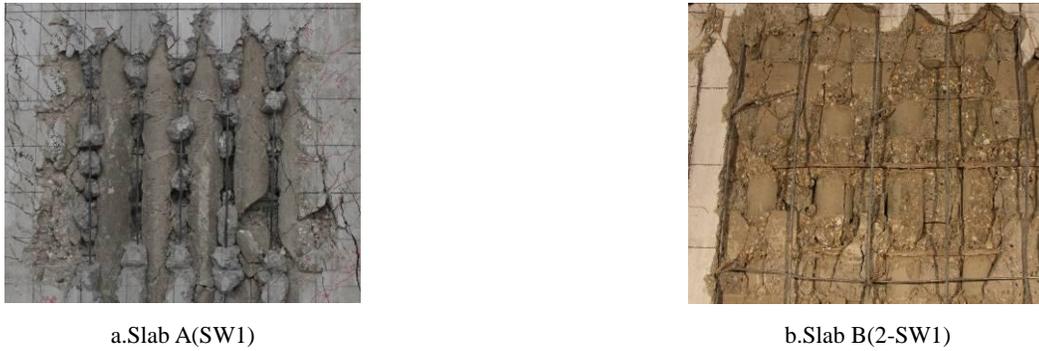
Fig. (11). Inner failure pattern of specimens.

paths) of hollow slab B (2-SW1) were broke completely by transverse holes, however, that of hollow slab A (SW1) were relatively continuous, namely, the longitudinal force

transferring paths were not broken. It indicates that when the dimension of transverse holes is larger than that of longitudinal holes, continuity of concrete between longitudinal holes in precast slabs can affect the compressive capacity of walls.

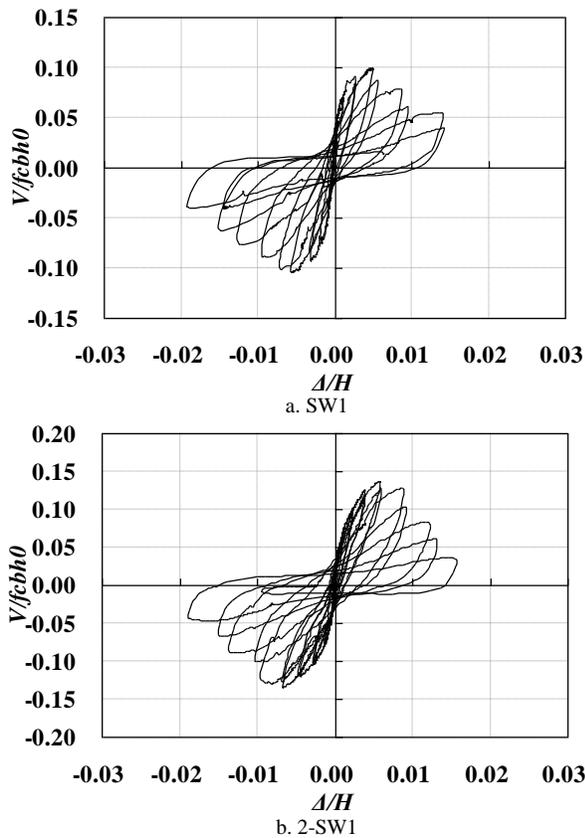
Fig. (12). Hysteretic loops of specimens.

The top lateral force-displacement hysteretic loops and skeleton curves of specimens are shown in Fig. (12) and Fig. (13), where the horizontal axis is the drift ratio measured at the loading point, and the vertical axis is the shear compression ratio  $V/f_c b h_0$ . From the curves, it could be found that:

1. Hysteretic loops of the two specimens had a similar shape which was average plump before peak value, yet gradually pinched after that. Both of them exhibited good ductility in terms of their residual deformations increased rapidly at the descending stage of the lateral load.

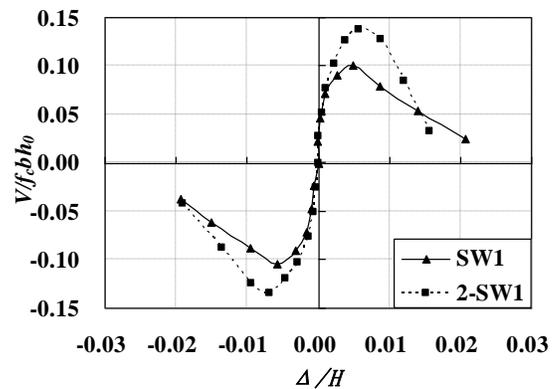
Fig. (13). Comparison of skeleton curves of specimens.

- The lateral load-bearing capacity of 2-SW1 decreased rapidly, while the axial compressive capacity was no longer stable after peak point. It again indicates that the compressive capacity of walls can be affected due to the dimension of transverse holes is larger than that of longitudinal holes.
