# Test on Durability of Shield Tunnel Concrete Segment under Coupling Multi-Factors

**Abstract:** To study the durability of shield tunnel concrete segment under coupling multi-factors, the durability and degradation law of reinforced concrete segments under the joint action of carbonation, sulfate, chloride salt and stray current was studied by accelerated environmental and direct current (DC) power simulation test. The results show that the presence of the stray current not only accelerates the migration of chloride ions to the concrete, but also makes chlorine ion gradually converge to the steel surface. The steel corrosion near the corrosion solution on the up surface of segment is more serious than the steel corrosion near the carbon dioxide on the lower surface. The interaction of chlorine ions and stray current primarily controls the durability of the segment.

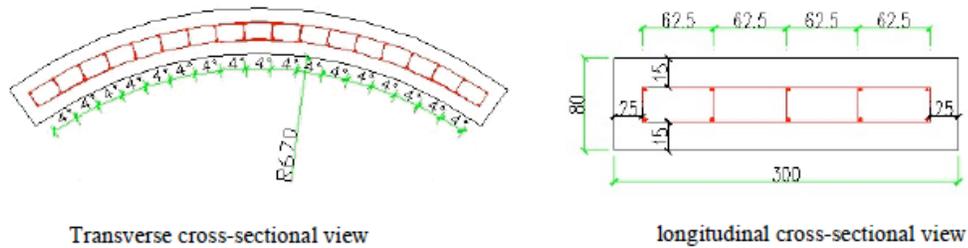
The dimension of segments and arrangement of reinforcement are shown in Fig. (1). Hot-rolled Plain Steel Bar with diameter of 6.5mm was used in specimens. The measured yield and tensile strength of reinforcement are 472.52MPa and 586.58MPa respectively; the designed thickness of concrete cover is 1.5cm, actual concrete cover is close to the 2cm. Radius of segment is 670 mm, radian is 72°.

Fig. (1). Segment model layout and reinforcement arrangement.

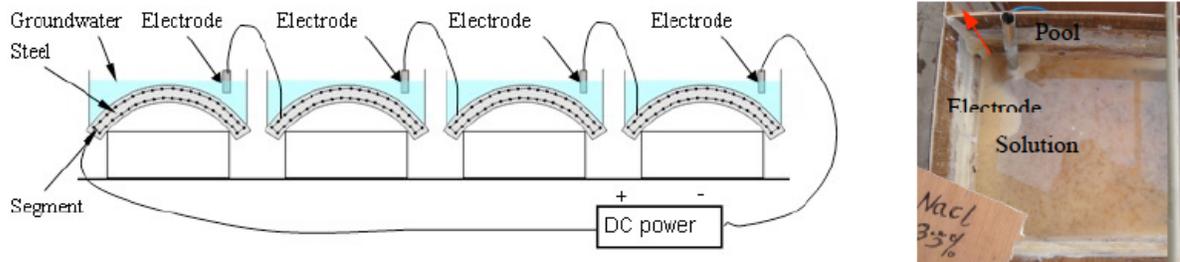
Fig. (2) shows the test device of shield segment under the combined effect of the corrosion solution and stray current. Series connection was adopted to ensure equal current flowing through the segment. Environmental relative humidity is 70% ± 5%, temperature 20°C±5°C, current 1A. Stirrups and reinforcement is not insulated which is identical with the actual engineering

A pool was made on the external surface of segment to fill the corrosion solution simulating the soil or water environment containing the NaCl and Na<sub>2</sub>SO<sub>4</sub>. Reinforcement in segment as anode and stainless steel tube placed in corrosion pool as anode were connected to DC power supply to simulate the stray current. In this way, the coupling effect of sulfate corrosion, chloride ion diffusion and stray current was simulated.

Fig. (2). Test device of shield segment under the combined effect of the corrosion solution and stray current.

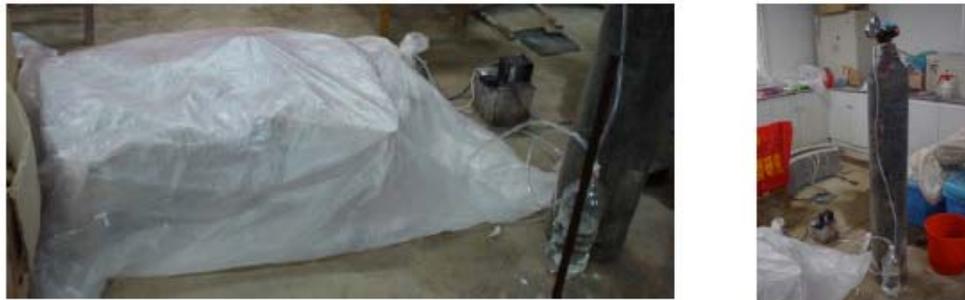
Fig. (3). Photo of carbonation test device.

Fig. (3) is a photograph of carbonization test device. The carbonization corrosion of shield segment is to put its lower surface into the CO<sub>2</sub> environment with its concentration of 20%, temperature 20°C, and humidity 70%±5%. Usually carbonization box was used in carbonation test. However, due to the larger size of the segment and requirement of only inner surface of segment being carbonated, following measures were taken to meet the above requirements:

(1) To isolate the invasion of gas to the outer side of the segment, 0.3mm thick plastic film with the same size of segment was covered on it. The film was sealed on the segment around four edges with sealant to ensure only the inner part of the segment be carbonated.

(2) The segment was sealed into a big plastic bag. To ensure the gas concentration, canned liquid CO<sub>2</sub> was used in this test in which CO<sub>2</sub> content is 20% and remaining 80% was N<sub>2</sub>. Two ventilation pipes were linked to plastic bag. To continuously make CO<sub>2</sub> go through the bag, one end of the inlet pipe was connected to CO<sub>2</sub> can, and one end of the outlet pipe was free.

(3) To control the temperature at 20°C, a temperature and humidity controller and a dry burning bar was used. The dry burning rod was arranged in the plastic bag.

(4) To control the humidity in the 70%, a humidifier and digital temperature and humidity controllers were placed in a poly bag.

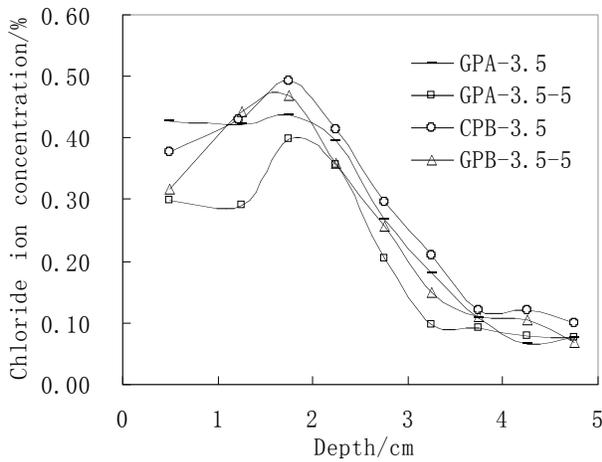
The concrete powder was collected using a drill at 5mm steps to a maximum depth of 50mm. selective electrode method was used for determination of free chloride ion in concrete. Fig. (4) shows distributions of the chloride ion concentration. It can be seen from the Fig. (4) that the depth of chloride ion penetration is higher than the thickness of concrete cover. The concentration of chloride ion distribution curve with depth showed parabola distribution, increased at first and then decreased. The highest value is concentrated in the 20mm from the surface where the reinforcement is located. Stray current would not only accelerate the migration of chloride, but also change the migration direction and distribution of chloride ion in concrete. In fact, penetration of chloride ions in concrete under the action of stray current not only shows parabola distribution in the depth direction, penetration perpendicular to the reinforcing steel bar is also shows parabola distribution. The presence of stray current causes the chloride ions to gradually gather to

the surface of steel bar, resulting in the concentration of chloride ion in concrete at the same penetration depth is different in different regions. Chloride ions perpendicular to reinforcement surface is relatively higher.

It also can be seen from the Fig. (4) that for the same mixture, chloride ion concentration is relatively larger for Cl<sup>-</sup> ion corroded segment compared with the SO<sub>4</sub><sup>2-</sup>+Cl<sup>-</sup> corroded segment. This is because the pore of concrete may be filled by ettringite produced by reaction of SO<sub>4</sub><sup>2-</sup> ion in the solution and hydration products. The transmission channel of Cl<sup>-</sup> ions in the structure is restricted, which hinders the Cl<sup>-</sup> ion migration. Moreover, the chemical activity of SO<sub>4</sub><sup>2-</sup> ions is stronger than that of Cl<sup>-</sup> ion. SO<sub>4</sub><sup>2-</sup> ions will first react with C<sub>3</sub>A producing ettringite. Therefore the opportunity for integration of Cl<sup>-</sup> ion and C<sub>3</sub>A is decreased, and more likely to be absorbed by C-S-H, which alters the combination form of Cl<sup>-</sup> ions.

Fig. (4). Chloride ion concentration distributions.

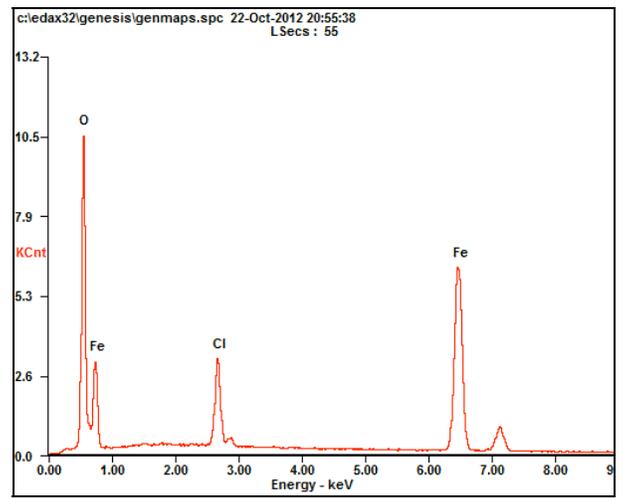
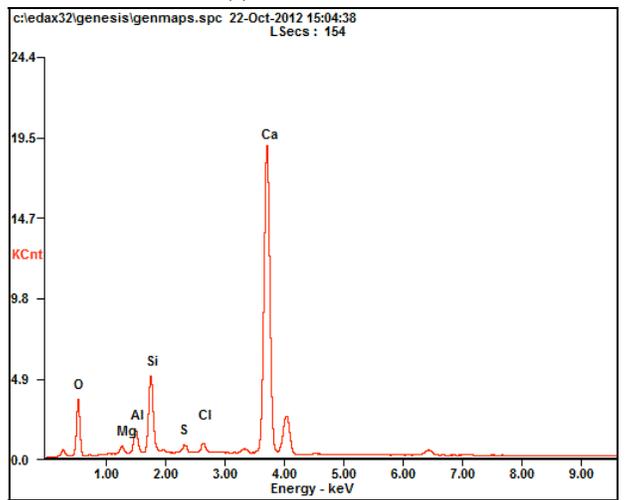
Fig. (5) shows the EXD spectroscopy analysis of concrete in different regions for GPB-3.5-5. It can be seen from the Fig. (5) that the chloride ions were unevenly distributed in the cement paste due to the effects of electric current. The concentration of chloride ion is increased gradually from outside to inside. The nearer the reinforcement, the higher the chlorine ion concentration is. The distribution of chloride ions of rest of 3 segments also showed the same characteristics. This further proves that the existence of stray current in addition to accelerate the migration of chloride ion in concrete, it cause the chloride ions to gradually gather to

the steel surface, increasing the concentration of chloride ion on the surface of the steel bar, and finally accelerate the corrosion of reinforcement.

(a) Reinforced surface

(b) 15mm from the steel surface

Fig. (5). EXD spectroscopy analysis of concrete in different regions.

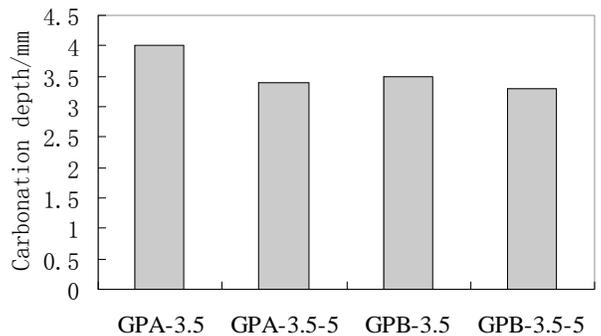
Fig. (6) shows the carbonation depth. It can be seen from the Fig. (6) that the carbonation depth of concrete segment is only 1~4 mm. It did not exceed the thickness of concrete cover. According to the similarity theory of carbonation [19], carbonization is not a controlling factor for concrete segment compared with the chloride and sulfate ions and stray current corrosion.

Fig. (6). Determination of carbonation depth value.

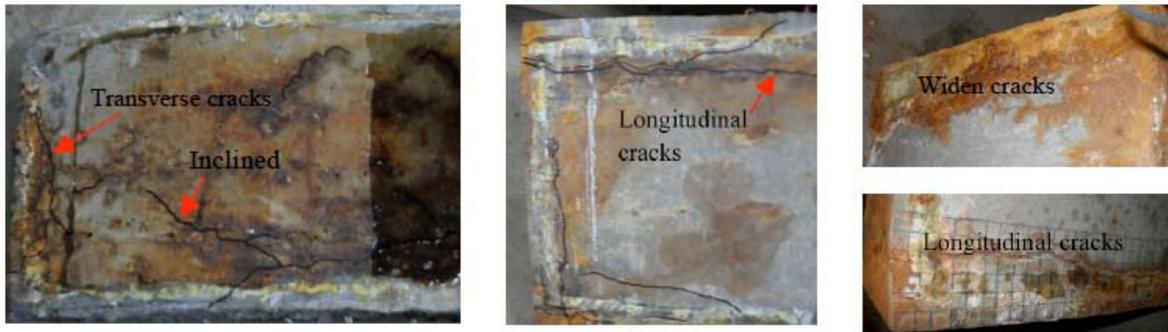
Fig. (7) shows the surface corrosion damage of the segment. Different degrees of cracks were appeared on the surface of segment under the coupling effect of carbonation, chloride, sulfate ion and stray current, mainly longitudinal, transverse cracks and some of corner cracks, with more or

Fig. (7). Damage morphology photo of corroded segment surface.

less inclined cracks. Crack width is ranging in 0.1~3 mm. This is partly due to the expanded corrosion product volume causing the concrete cover to crack. This part of the cracks occurred mainly in the reinforcement position. On the other hand, the reaction of the sulfate ion and  $\text{Ca}(\text{OH})_2$  in the cement producing  $\text{CaSO}_4$ .  $\text{CaSO}_4$  again reacts with the hydrated calcium aluminate producing Ettringite ( $3\text{CaO}\cdot\text{Al}_2\text{O}_3\cdot 3\text{CaSO}_4\cdot 31\text{H}_2\text{O}$ ), whose volume was expanded 2-3 times. The coupling effect of chloride, sulfate ions and stray current caused a few widen cracks at the corner of the segment.

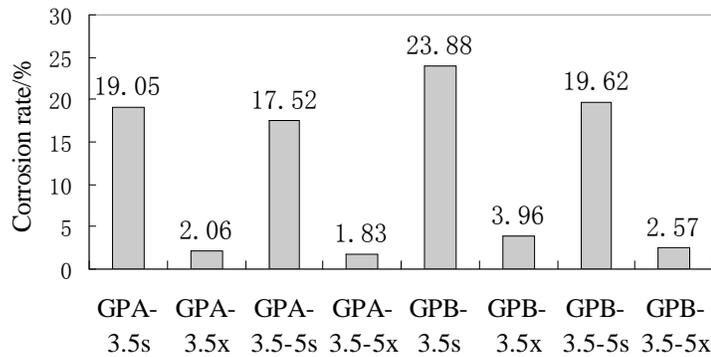
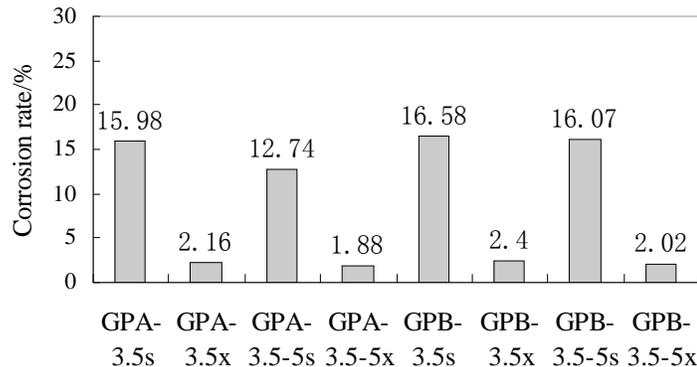
(a) The stirrups corrosion rate

(b) Reinforcement corrosion rate

Fig. (8). Corrosion rate of reinforcement.

Fig. (8) shows the reinforcement corrosion rate. The results shows that the corrosion of reinforcement near the corrosion solution is more serious compared with the rein-

forcement close to the inner part of the lining. Effect of stray current on inner reinforcements is much smaller than the outer ones. For same segment the corrosion of reinforcement is more serious than stirrup. This may due to the fact that the stirrup is closer to the corrosive solution. The chloride ion concentration at stirrups is greater than that at longitudinal reinforcement. Therefore the resistivity of concrete at stirrup is smaller than that at longitudinal reinforcement. Current through the surface of the stirrup is larger. Therefore the corrosion rate is larger.

It can be seen from the Fig. (8a) that the corrosion of stirrups near the outside of the segment with the mixing proportion A is larger than that with the mixing proportion B. (In Fig. (8), S represents the upper reinforcement, X represents the lower reinforcement). This is due to the fact that for mixing proportion B, the mineral admixture reached 55%. How-

ever, for mixing proportion A the mineral admixture is only about 13% of the cementitious materials. The corrosion rate of reinforcement of segment in 3.5% NaCl solution is larger than that in 3.5% NaCl +5%Na<sub>2</sub>SO<sub>4</sub> solution. This is because the concrete pore is filled by SO<sub>4</sub><sup>2-</sup> ion and hydration products of which hindered the migration of Cl<sup>-</sup>ions. The resistivity of concrete increased and electrochemical equivalent of reinforcement reduced. It can be seen from the Fig. (8b) that the corrosion rate of reinforcement shows the same rules.

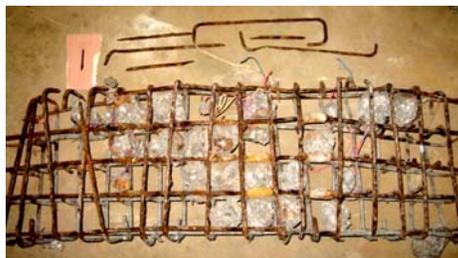
Fig. (9) shows the pictures of reinforcement and stirrup corrosion in segment. It can be seen from Fig. (9) that the corrosion characteristics were identical with the measured corrosion rates. Stirrup is corroded more serious at the intersection of stirrup and reinforcement. And there is obvious pitting corrosion. The reinforcement corrosion is lower than that in the none-cross area. This is mainly because of thermocouple protection [20]. The corrosion of longitudinal reinforcement at the outside is more serious, it is also because the outer longitudinal reinforcements near the corrosion solution. The corrosion of stirrups and longitudinal reinforcement in inner part of segment is significantly lighter. This shows that the local environment has great effect on corrosion of reinforcement. Using Faraday's law to predict the corrosion rate of the accelerated corrosion of steel bar may have randomness and error. It further illustrates that the performance of local materials and components can't correctly reflect the overall performance of the components, and the durability results of small specimens is difficult to reflect the evolution of durability for actual concrete structures in the process of service.

Fig. (9). Steel corrosion photos.
