# Test Studies on the Corrosion Features for the Bridge Foundations Durability in a Household Refuse Landfill Environment

Fangyuan Li\*, Junchao Huang and Yin Shen

Department of Bridge Engineering, School of Civil Engineering, Tongji University. 1239 Siping Road, Shanghai 200092, P.R. China

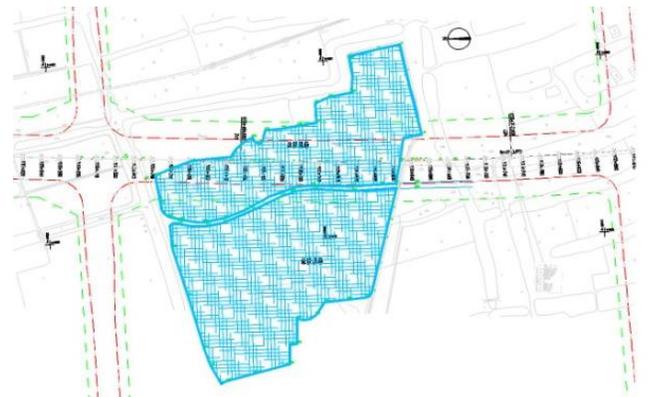
As shown in Fig. (1), the planed Linhai Road, with a width of 50 m, is denoted as the red lines. The green lines are 20 m away from two sides of the red line. Starting from the point A20, the road ends at the point A30, running across Minhang District, Nanhui District and Fengxian District. The stake marks of the road from the starting point to the terminal point are from K1+230 to K27+300. The road, with an overall length of 26.070 km, is designed in accordance with the first-class highway standards, on which the rated velocity is 80 km/h. When entering into the construction site, the construction unit found a refuse landfill in the subgrade, located at Huinan Village, Pujiang Town, Minhang District (the stake marks in the mileage ranges from K15+340 to K15+640). The dump was formed approximately 4 years ago, with the size of 120,000 m<sup>2</sup>. It can be observed from Fig. (1) that the subgrades in this range pass through the dump. By consulting the village committee, we are informed that the dump used to be vegetable fields, parts of which were ponds. Accordingly, this area, abounding in water and sludge, was then excavated to be a landfill.

Fig. (1). Planar graph of the refuse landfill.

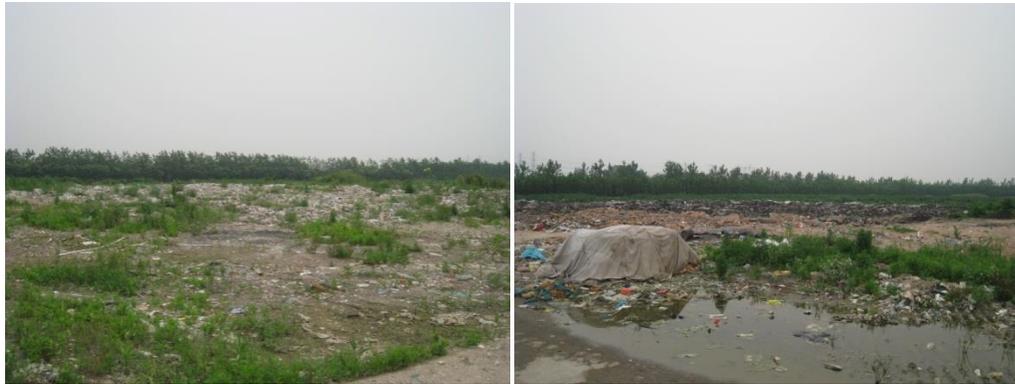
As a simple landfill, the dump is approximately 2.5 ~ 7.0 m deep, with comparatively loose structure and poor compactness. The surfaces of some areas are covered with a layer of laminated soils, preventing the exposure of refuse. The leachates are discharged disorderly, without any rain and sewage diversion facilities. The sewage deposits at the low-lying areas and no guided disposal measures are taken. Additionally, there are no workers and no supervision of the landfill, as evident in Fig. (2).

As displayed in Fig. (2), the landfill is surrounded by harsh environments, lacking some necessary protection measures. Besides, the dump is illegal, without any seepage proofing and pollution control measures. Since the refuses are thrown away randomly, the foundation soils are distributed unevenly. More seriously, the intensity of foundation is reduced drastically, also characterized by uneven distributions.

Fig. (2). Pictures of the refuse landfill.

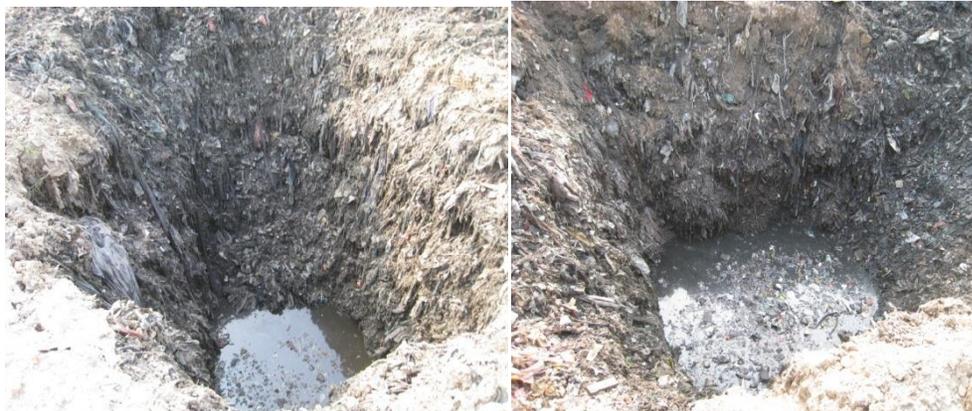
holes at either side of the bridge, with the diameters of top and bottom openings of 4 and 1.5 m, respectively. From Fig. (4), we can easily observe that the sludge at the bottom of holes are black clays soaked in sewage, and therefore the texture is quite soft. The actual depth of sludge is approximately 1.0 m.

Fig. (4). Pictures of sample holes.

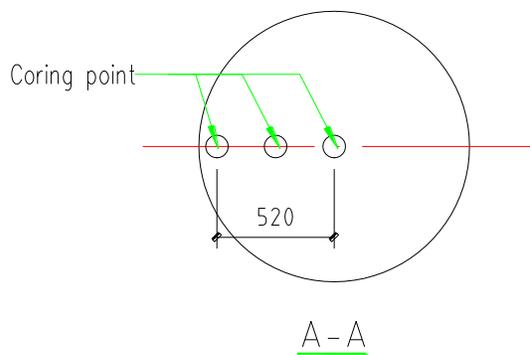
- (iv) As shown in Fig. (5b), along the radial direction, three samples were taken below the lowest sewage level, with a same length as the section radius of barrel. Similarly, under poor conditions, only three samples at the same depths were taken.

(a) Coring positions along the radial direction

Fig. (5). Schematic diagram for the coring location.

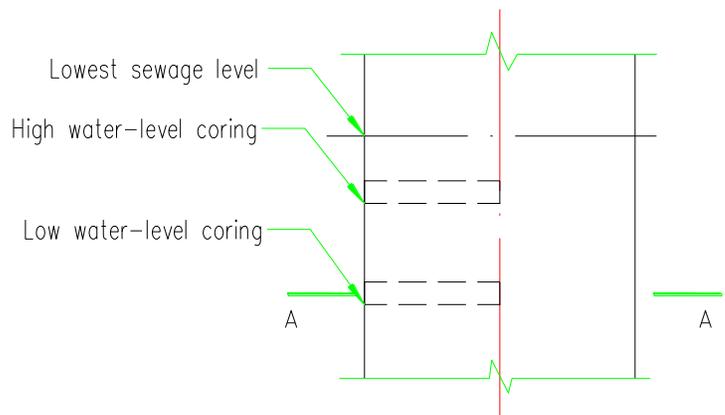
- (iii) As shown in Fig. (5a), along the axial direction, three samples should be taken from the barrel center to the periphery, with a same interval of 260 mm. The depth of coring should be at least 400 mm below the lowest sewage level. At least six cylinders with a length of 50 mm were obtained, in which three cylinders were used for the present tests and the rest were used for the tests for electric flux. Under poor conditions, only two samples were taken, located at the innermost and outermost positions along the axial direction.

(b) Coring positions along the height direction

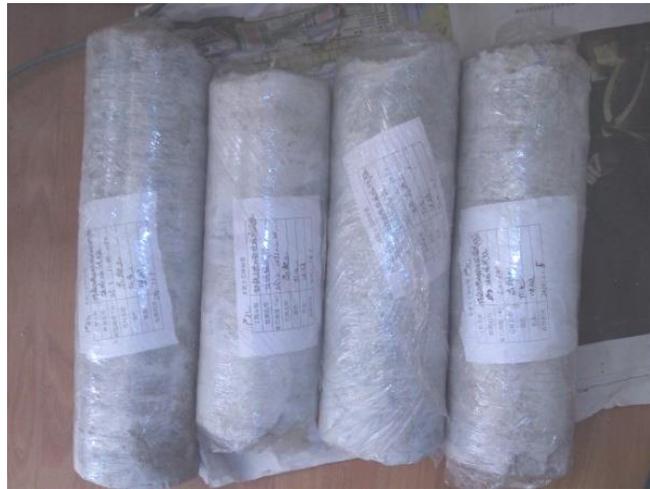
Fig. (6). Coring samples used in tests.

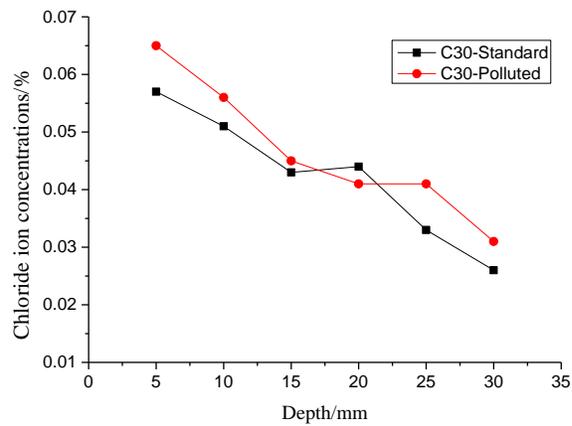
During the tests, for convenient data sorting, we have labeled the samples at different coring depths with different serial numbers; namely, No. 1 denotes the central parts of piles, No. 2 denotes the central parts of the coring barrel radius, and No. 3 denotes the outermost parts along the axial direction. The coring samples, parts of which are displayed in Fig. (6), present different chloride ion permeability on account of their different depths. The chloride ion concentrations of different samples were measured, as shown in Table 3. For each sample, the concentrations were measured at different depths. The measured chloride ion concentrations under different maintenance conditions are compared and listed in Table 4, with the corresponding variation rules presented in Fig. (7).

Fig. (7). Variation rules of chloride ion concentrations with the varying depths.

From the data in Table 3 and Table 4 and the variation rules in Fig. (7), some main conclusions can be obtained, as listed below.

- (i) With regard to the positions along the radial direction of pile sections, the chloride ion concentrations of the No. 1 sample (the samples located at the center of coring barrel) varies slightly and negligibly with the

- (ii) The chloride ion concentrations of the No.2 and No.3 samples increases by approximately 0.002% ~ 0.008% with the varying coring depths, indicating that the chloride ion permeability in pile foundations is enhanced gradually with the increasing buried depths.
- (iii) In a pile section, the chloride ion concentration reduces steadily from the periphery to the center. Though
