# The Open Civil Engineering Journal

# Performance of Cantilever Beam in Fire

This paper presents results from an experimental study on the temperature effect of reinforced concrete cantilever beam.

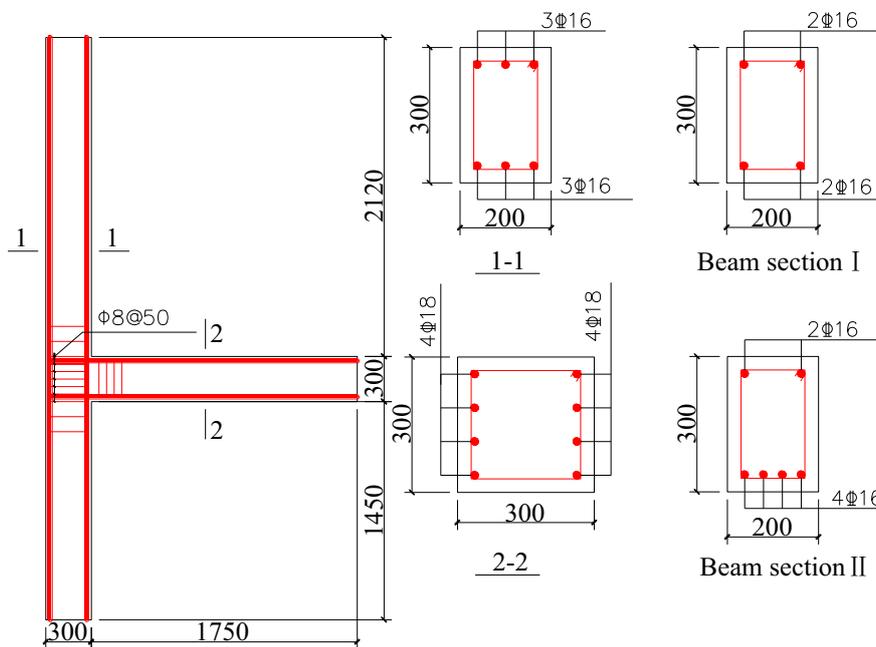
**Fig. (1).** Design of specimen.

In the test, the method of horizontal pouring was applied according to actual situation. The reinforcement bars of the specimens are shown in Fig. (1).

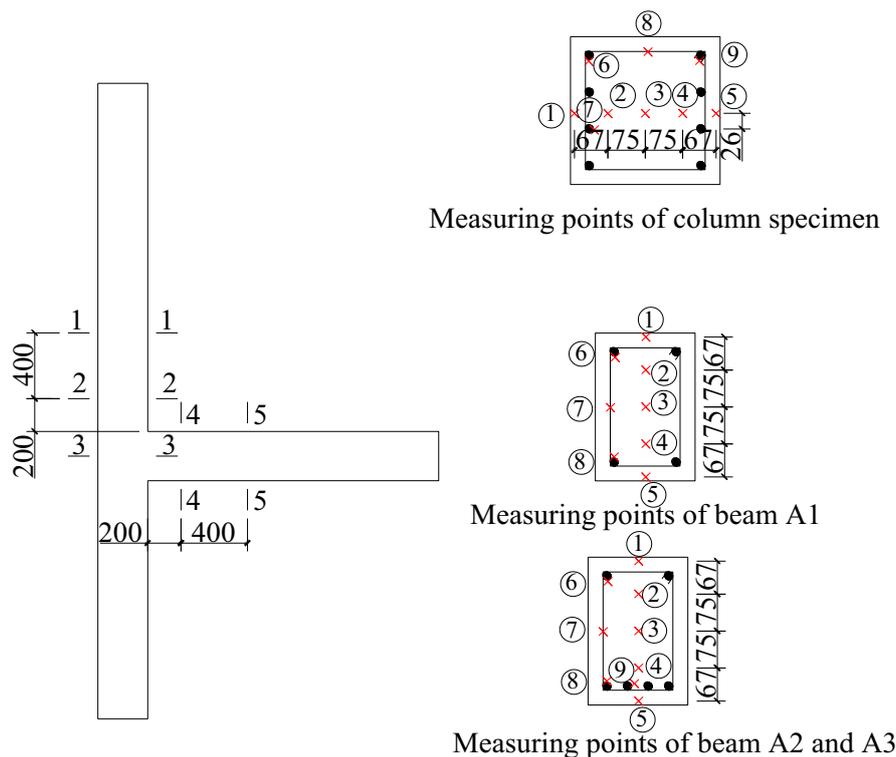
In order to investigate the temperature field distribution of the specimen, the thermocouple was connected with the specimens in advance as shown in Fig. (2). Among all the thermocouples, points 1, 2, 3, 4 and 5 are used to measure concrete temperature; points 6, 7, 8 and 9 are used to measure steel temperature. The electric thermocouples are K-type thermocouples.

Fig. (2). Thermocouple design of specimen.

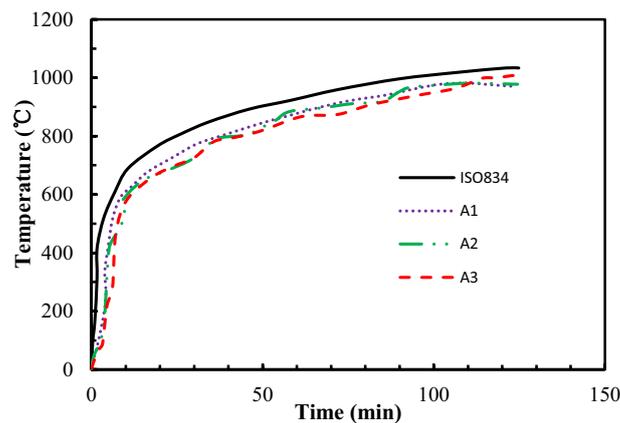
**Fig. (3).** Heating curve.

The specimens were heated in furnace following the ISO-834 heating curve. The measured curve conforms to the ISO-834 heating curve in Fig. (3).

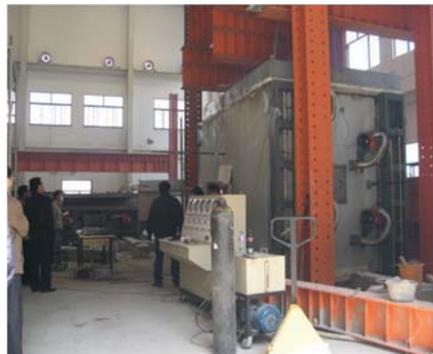
**Fig. (4).** Test furnace.

The fire test furnace consists of a steel framework supported by four steel columns and the furnace chamber inside. The test furnace is designed to produce all the needed conditions. The columns were confined with a rigid reinforced groove at the bottom and a rigid angle steel frame at the top. A constant vertical load was applied on the top of the column. The load of A1 and A2 is 400 KN, which is equal to 30% of the ultimate capacity. The load of A3 is 667 KN, which is equal to 50% of the ultimate capacity. The beam end was free and the vertical load (120 KN) is applied in the

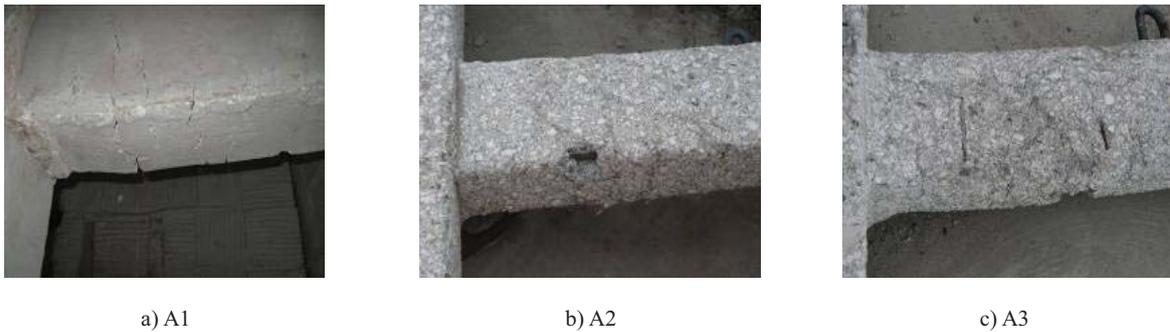
Fig. (5). Cantilever beam after fire.

The test observation does not obtain from heating process for the furnace is closed. When the furnace is switched off, the specimens are then allowed to cool down naturally in the furnace. The test observation is shown in Fig. (5).

As shown in Fig. (5) that the bending cracks appear at the bottom of the beam. The cracks are slight different, most of them are bending cracks and a little are shearing cracks.

The longitudinal reinforcement is pulled out and the deformation is obvious.

Fig. (5) shows that the plastic hinge is not produced at the maximum bending moment. It occurs in a certain distance form the edge of the column. The distance of A1, A2 and A3 is 220 mm, 240 mm, 310 mm respectively.

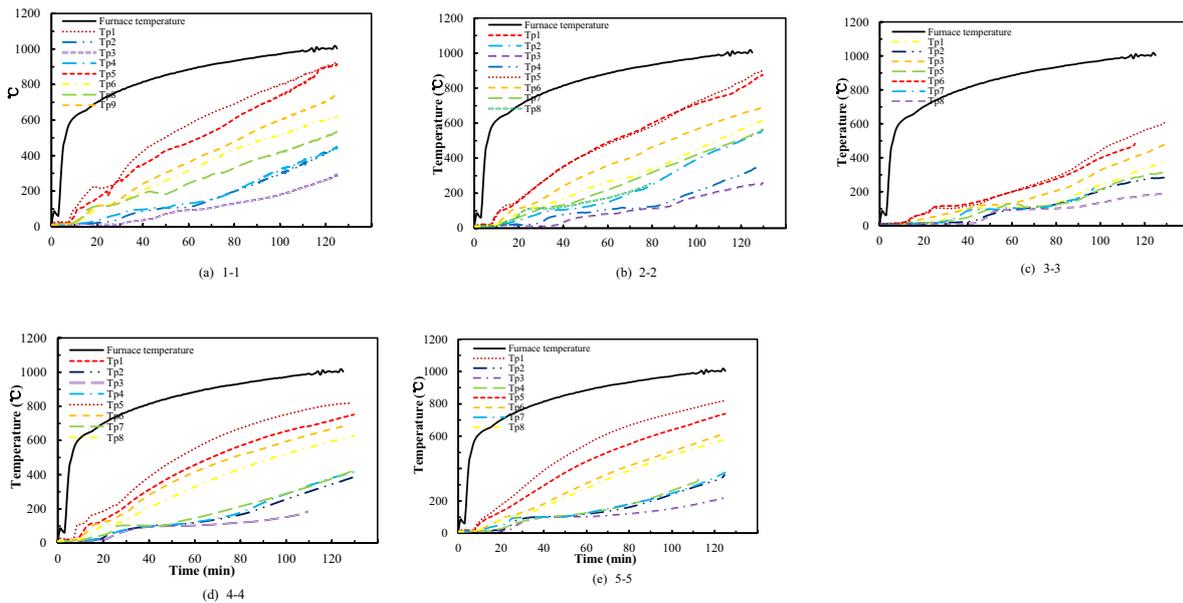
Fig. (6). The section temperature variation of the specimen A1.

The temperature variation curves of the different point are shown in Fig. (6). The temperature of the measuring points decreases obviously from the lateral section of the cross section to inward direction, which indicates that the thermal conductivity of concrete is poor. The temperature difference between point 1 and point 5 is obvious at the beginning of the heating, and then becomes smaller in the later period, which shows the temperature and heating of the concrete section has hysteresis. The temperature of the 3-3 section is much lower than the other sections. The difference may be caused by the enclosure of the beam and column near the core. Fig. (6) also shows that the temperature of measuring points reaches a plateau near 100 degrees centigrade, because of heat absorption when vapor appears for the moisture in concrete is heated constantly. The temperature of concrete will further increase after the process of water evaporation. The closer to the measuring point of the inside section, the longer the duration of the plateau. Plateau of some measuring points lasts for 30 min, because moisture evaporation of the internal section is relatively slower. The temperature field distribution law of specimen A1 is very similar to the others, so only the specimen A1 is listed in Fig. (7).

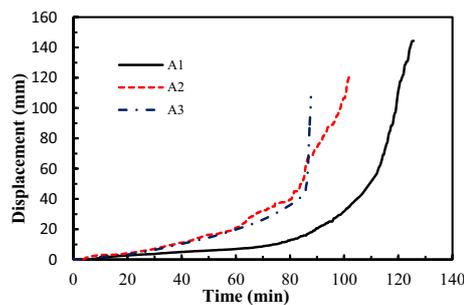
Fig. (7). The displacement of beam end.

The displacement-time curve of the specimen is illustrated in Fig. (7). The displacement of the beam increases slowly on the early period of the heating process, and the displacement increases obviously when the test lasts for more than 80 min. The displacement loses load bearing capacity in a relatively short period of time. The destruction of specimen occurs with a sudden.

Fig. (7) shows that the beam end displacement of specimen A2 is almost equal to A3 under the same test condition, and is much larger than that of A1. The displacement of A2 and A3 keeps steady when the test lasts for no more than 60 min, 60 min later it decreases rapidly. And 80 min later, the displacement of A1 decreases rapidly. It can be seen the fire resistant limit of specimen A1, A2 and A3 is 125 min, 102 min and 113 min respectively. For the difference of beam reinforced ratio ( $A1 > A2 = A3$ ), the displacement of A1 is larger than that of A2 and A3. Data above indicates that beam displacement of specimen is obviously influenced by beam reinforced ratio.
