RESEARCH ARTICLE

Integrated Empirical-mechanical Seismic Vulnerability Analysis Method for Masonry Buildings in Timișoara: Validation based on the 2009 Italian Earthquake

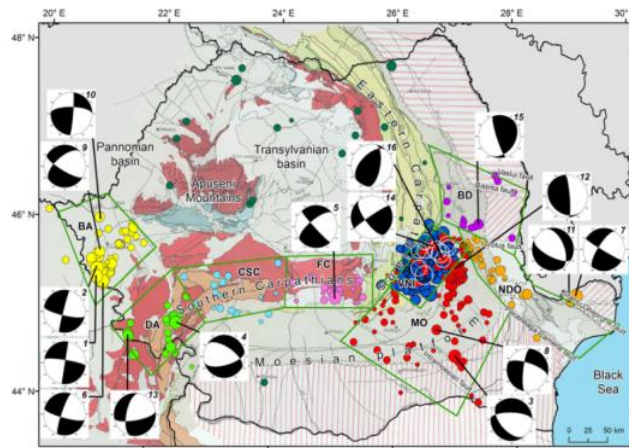
Fig. (1). Focal mechanisms detected in Romania [10].

Generally, the earthquakes in the Banat region occurred at the contact between the Carpathian and Pannonian plates (from Timisoara to S-W Jebel and Banloc and north of the Bega canal) and at the contact among irregular structures straddling Sânnicolau Mare, Nădlag-Jimbolia, Arad-Vinga- Calacea and Timis Valley in Faget. Moreover, the distributions of focal mechanisms associated with the earthquakes that occurred in the South-West of Romania showed a reverse and strike faults or the combination of the two. The focal depths of earthquakes in the western areas of Oltenia and Banat-Danube were between 5 and 33 km deep (Fig. 1) [10].

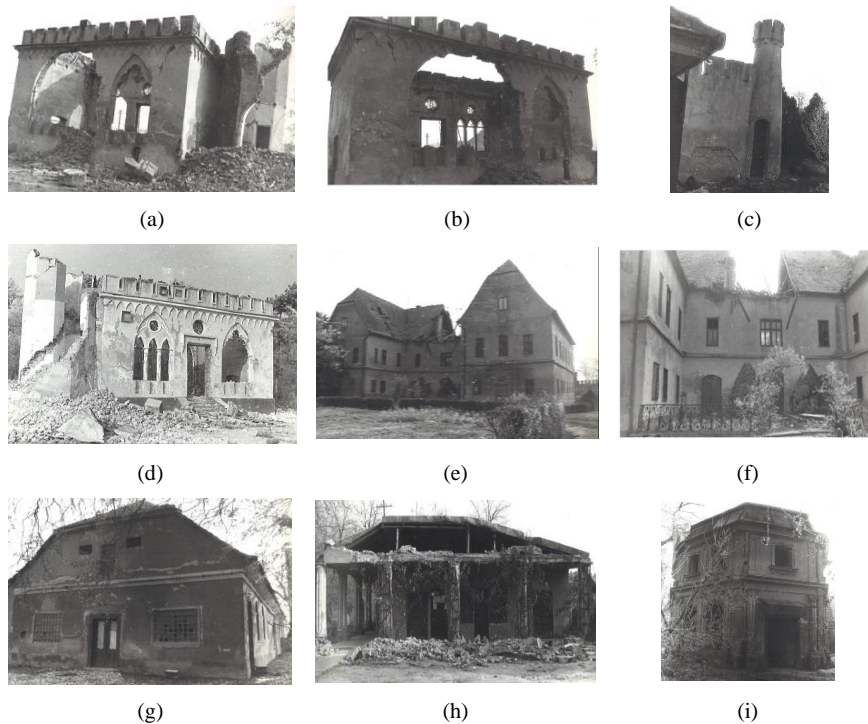
Fig. (2). Post-earthquake damages and failures recorded in the epicentral area near Timisoara after 1991 earthquakes [12].

shown that the Type of failure mechanisms occurred in the epicentral area (cities: Banloc, Voiteni and Ciacova, located 30-50 km far from Timisoara) have been characterised by a high level of damages to vaults, arches, towers and chimneys, as reported in Fig. (2) [12].

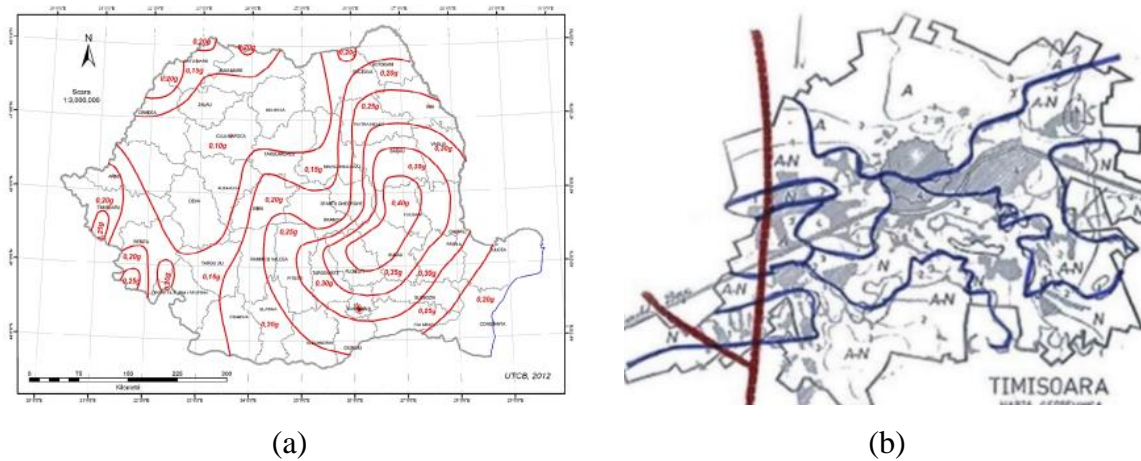
Fig. (3). Romanian zonation in terms of PGAs (a) and seismic fault lines in the city of Timisoara (b).

Moreover, the city of Timisoara is the biggest city located in the Banat seismic region, which is the second most important seismic zone of Romania (Fig. 3a), with an expected PGA equal to 0.20 g considering a return period, T_r , of 475 years [13, 14]. In Timisoara, there are two active seismic faults, as reported in Fig. (3b), both concentrated in the western part of the city.

From the previous figure, it is evident that the seismic hazard of Timisoara is very high due to the seismogenic faults present in the area. Furthermore, most of the buildings located in the historic areas of the city were designed without anti-seismic criteria. For these reasons, it is essential to provide appropriate vulnerability studies to limit expected losses and to implement a systematic seismic risk mitigation plan.

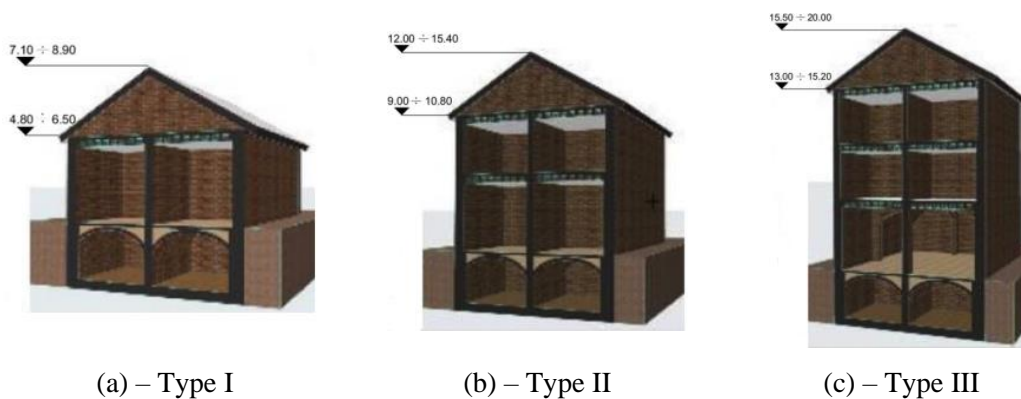
(a) – Type I

(b) – Type II

(c) – Type III

Fig. (10). Typological characterisation of the buildings (a-c), and distribution of the classes for (d) Iosefin and Fabric urban sectors [16].

Based on the geometric and structural features, it has been possible to make a classification properly conceived for the historical areas analysed. This typological classification consists of dividing the buildings into three main classes based on the number of levels above the basement, from one to more than three (*i.e.* typology class I, typology class II and typology class III), as reported in Fig. (10) [16].

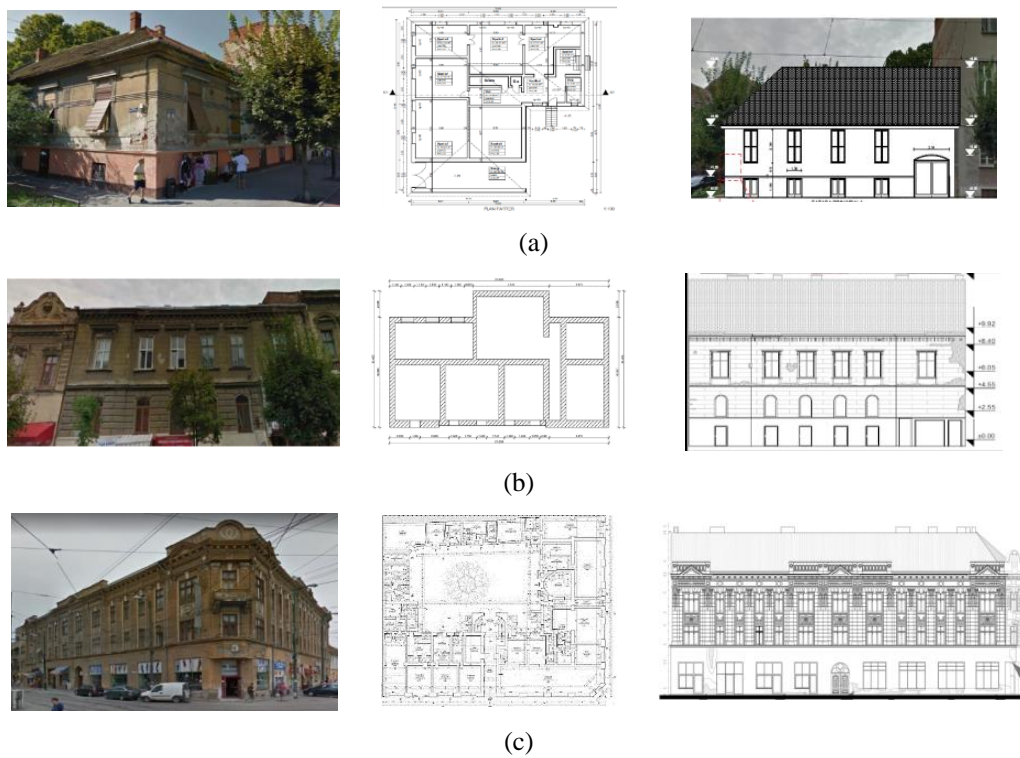
Fig. (12). Examples of typological classes of buildings: (a) Type I (Iosefin district), (b) Type II (Iosefin district) and (c) Type III (Fabric district).

These buildings are characterised by large masses and massive walls, basement, ground floor and two other levels, brick vaults above the basement and wooden floors above the other levels. The wooden roof structure is complex and robust. The main problems are similar to those of Type II buildings, such as lack of adequate maintenance, structural alterations of commercial spaces and deterioration of facade materials. The plan configuration is complex (usually U-shaped or L-shaped) and the elevation is regular, with small alterations due to the reduced thickness of the walls along the height of buildings. Some examples of the investigated typological classes are shown in Fig. (12) [16].

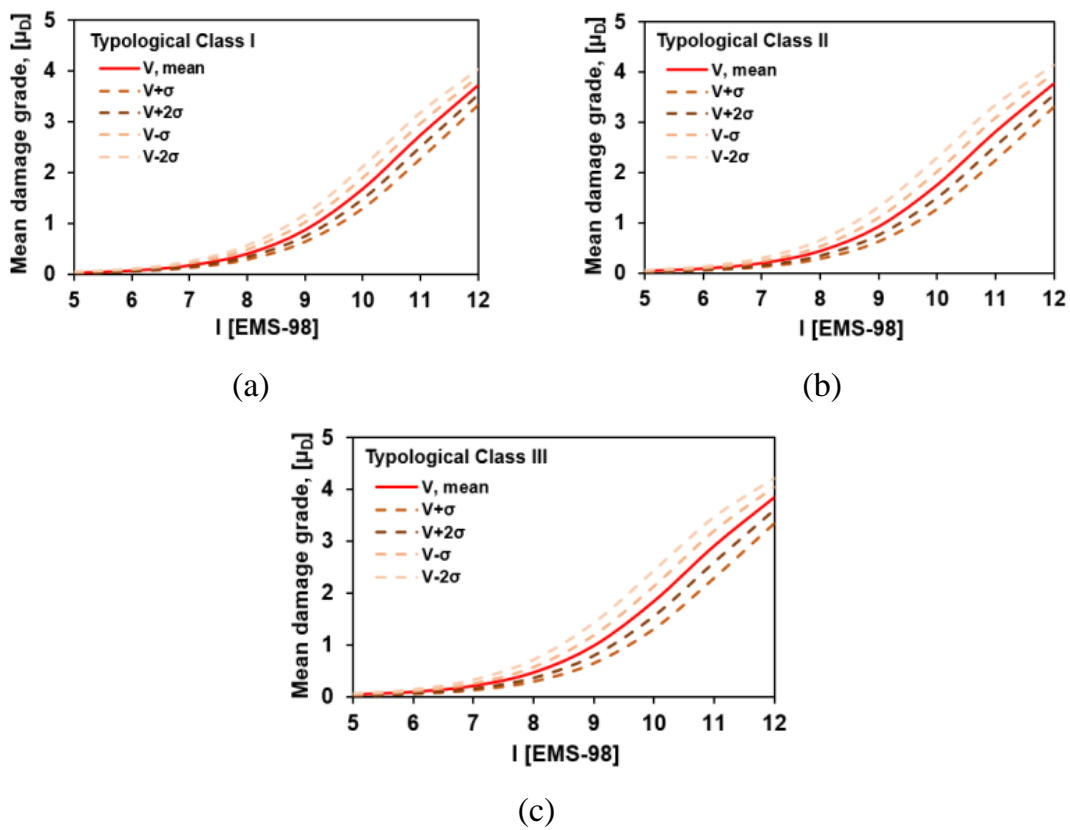
Fig. (14). Mean vulnerability curves associated to the main typological classes detected in the study areas.

Subsequently, vulnerability curves have been obtained to estimate the propensity at the damage of the analysed building typologies (Fig. 14). In particular, the vulnerability curves [25, 26] correlate the level of the expected damage that a building could reach under a given seismic intensity “ I_{EMS-98} ”, which is defined according to the European Macroseismic Scale EMS-98 [27]. In particular, as proposed in a study [14], earthquakes with an epicentre magnitude, M_w , of 5.6 - 5.8 occurred 20-25 km far from the city of Timisoara [14], which the most probable macroseismic intensity equal to IX according to the European Macroseismic Scale [27] was assigned to.

As reported in the previous figure, the vulnerability curves are derived for a sample of buildings representative of the construction types found in the inspected areas. However, for a more accurate representation of the expected damage, the mean typological vulnerability curves have been represented together with other curves taking into account the statistical variability

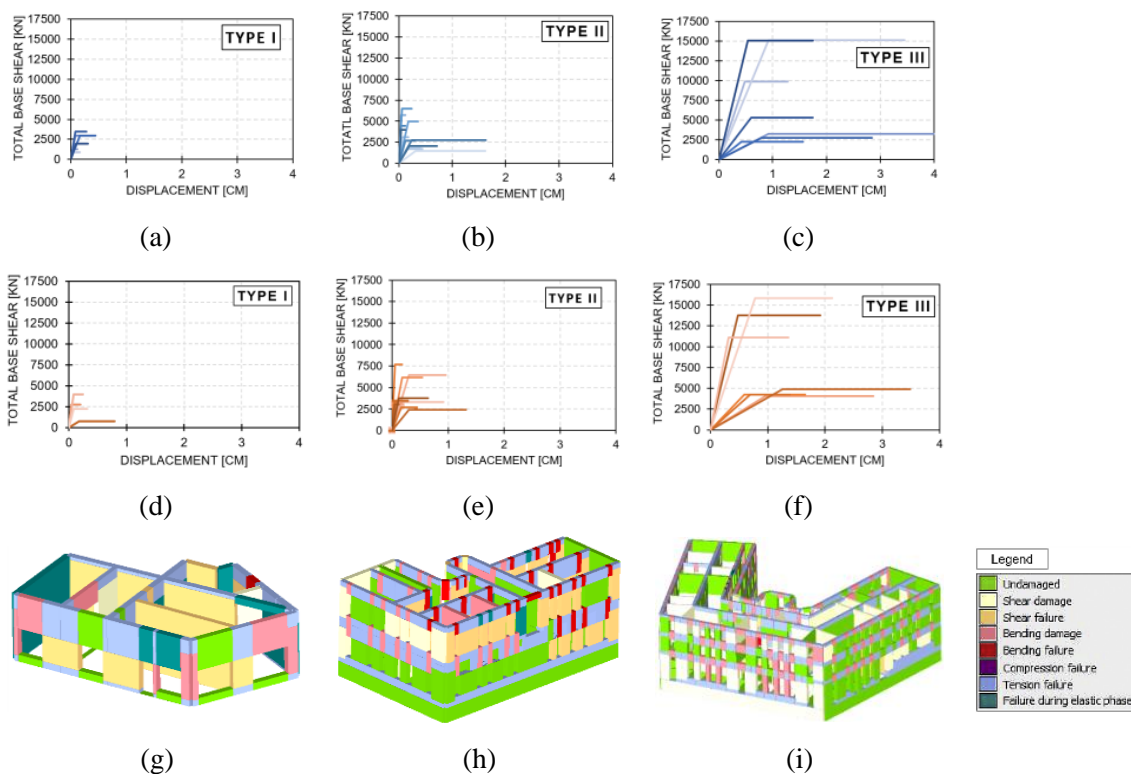
Fig. (16). Analysis results: (a-c) capacity curves in X directions, (d-f) capacity curves in Y direction and (g-i) in-plane failure mechanisms for the buildings representative of the typological classes examined.

The analysis has been performed on each of the 25 masonry buildings, considered as an individual structural unit. Generally, the structural model is based on the equivalent frame model, assuming that the masonry wall with openings can be modelled by a set of single-dimensional elements, such as columns, beams and nodes. In the pushover analyses, the inter-storey drift threshold has been considered as equal to 0.5% for the damage limit state [36]. To evaluate the seismic demand, the specific seismic spectrum characteristic of the Banat seismic region has been defined. Therefore, the capacity curves of SDoF systems have been obtained for each building of the Type I, Type II and Type III classes [16 and the specific in-plane failure mechanisms for the three buildings representative of the three classes examined have been shown, as reported in Fig. (16).

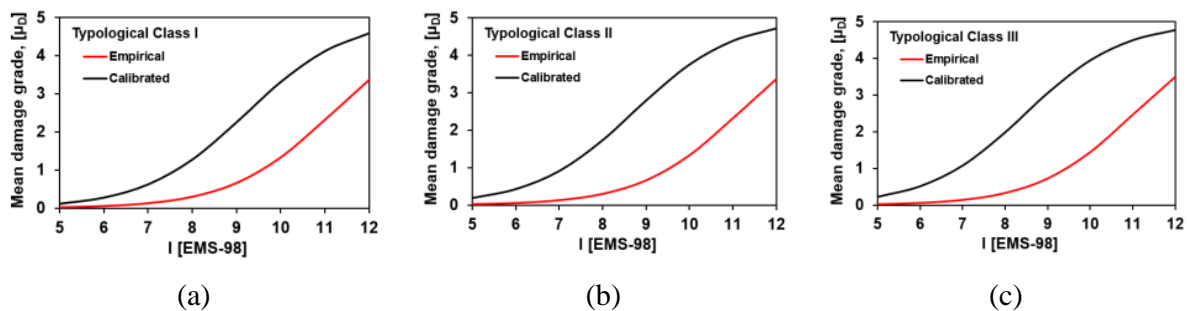
Fig. (18). Calibrated vulnerability curves for, (a) Type I, (b) Type II and (c) Type III building classes.

where, the seismic hazard is always expressed in terms of macroseismic intensity (I_{EMS-98}), the ψ -factor has been assumed equal to 12.50, it is related to the variation of the slope of the curve and, finally, the ductility factor Q , which describes the ductility of masonry typological classes, has been assumed to be equal to 2.3 [16, 6]. Thus, a representation of the damage-intensity curve has been provided, as illustrated in Fig. (18).

From the results depicted in Fig. (18) it is possible to notice that for each class of buildings, for the same seismic intensity level, there is a difference of at least one state of damage. The empirical formulation, as it is noted, tends to underestimate the expected damage. Therefore, the most probable damage states of D1-D2 indicated by the vulnerability curves are not reliable, indicating the fact that the damage estimate formula (Equation 3) cannot be adapted to the specific Banat Seismic Region.

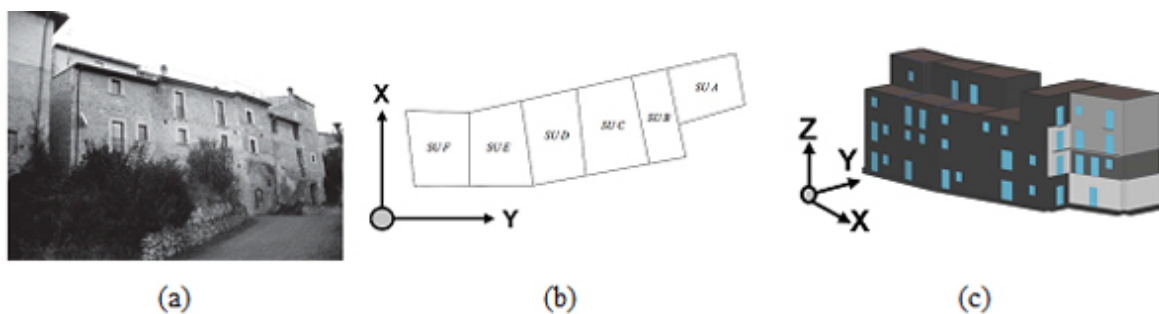
Fig. (24). The case study building: (a) street view of the North façade, (b) plan layout

The north façade has two underground storeys, representing approximately 15.5% of the total volume of the aggregate, so having a higher stiffness than that of the opposite façade. The building, following the 2009 earthquake, suffered a damage level D3 according to the EMS-98 macro-seismic scale. Nonetheless, the building was declared unusable according to the Post-Earthquake Damage and Safety Assessment (AeDES) form.

The Macro-element model, developed by the 3Muri analysis program [30], has been used to model the masonry compound, as depicted in Fig. (24c) [38]. The site is characterised by a PGA of 0.26 g, which a macroseismic intensity of VII corresponds to.

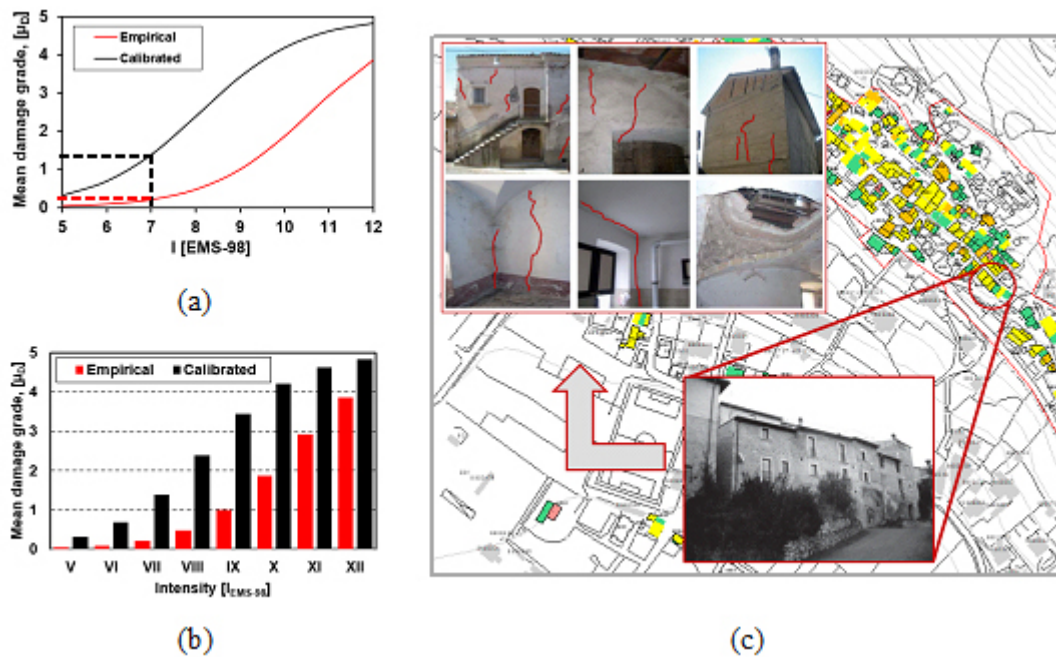
Fig. (25). Damage comparison between empirical and calibrated formulations.

From pushover analyses performed on the masonry aggregate [16], a mechanical vulnerability index, I_{MEC} , equal to 0.40 has been derived for the whole aggregate. Once the mechanical vulnerability index has been assessed, the next step is to compare the mechanical index with the expected mean damage grade, μ_D , derived from both empirical and calibrated formulations in order to take into account the effectiveness of the simplified approach in predicting the structural damage. To this purpose, a direct comparison of the above-mentioned formulations is presented in Figs. (25a and 25b).

From the results obtained, it is evident that considering the damage scale between 0 and 1, for a macroseismic intensity of VII, the empirical formulation discussed in a study [6] provides a damage level of about 0.05, while the new calibrated curve gives a damage level of about 0.3. Therefore, considering that the mechanical index is 0.40, it appears that the original empirical formula tends to underestimate too much the expected damage. In contrast, the new method, even if it is not on the safe side, allows to predict the same damage level (equal to 2, as shown in Figs. (25a and 25b), depicted in reality in Fig. (25c), which has been attained by more complex numerical analyses.
