# Performance of Soil-bearing Spread Footings Supporting Highway Structures

#### 5. MAH-680-2.83 Bridge

### 8. FAI-33-13.09 Bridge

### 9. CUY/SUM-271-00.00/14.87

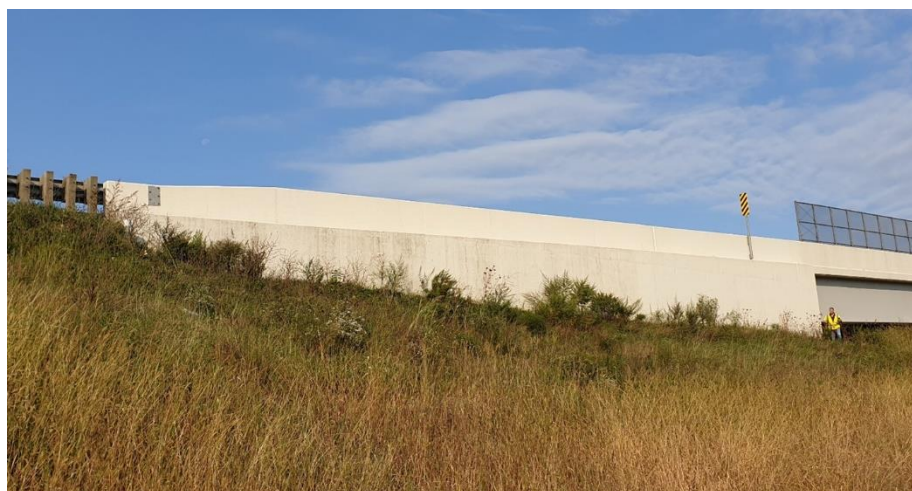
**Fig. (2).** CUY-77-14.35. The right forward abutment wing wall (wall 3).

The footing width for Walls 1 and 4 is 3.8 m and 3 m, respectively, while the footing width for Walls 2 and 3 is 4.26 m. On October 6, 2020, a site visit was conducted. Inspection of the cantilevered cast-in-place concrete wing walls revealed vertical alignment without any noticeable leaning or sliding. The foundation of the bridge retaining walls, founded on spread footing, was confirmed to function as designed. Refer to Fig. (2) for an illustration of the Right Forward Abutment Wing Wall (Wall 3).

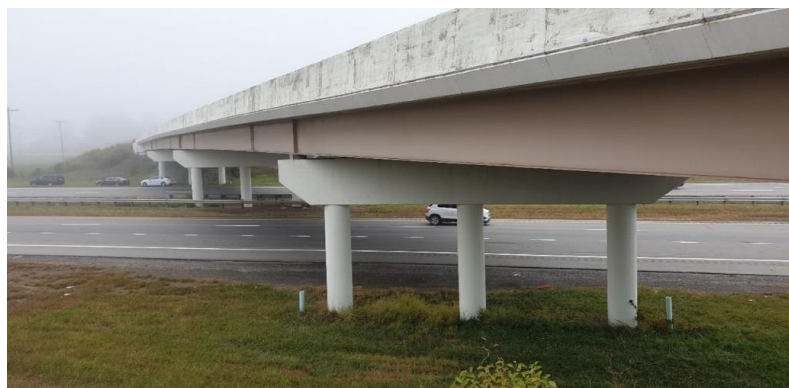
**Fig. (3).** The FAI-33-1309 bridge.

A site visit was conducted on October 5, 2020, to assess various aspects of the FAI-33-1309 bridge. The inspection covered embankment slopes, roadway settlement at abutments, the condition of the concrete deck, and relative substructure orientation. Fortunately, no signs of settlements were detected, and the softness of the soils around the piers was attributed to drainage issues. Some PVC caps were missing or damaged, likely due to vandalism. The existing spread footing design for bridge foundations was functioning as intended. Refer to Fig. (3) for a visual representation of the FAI-33-1390 bridge.
