# The Collapse Accident Analysis for Steel Structure of Waste-heat Boiler in a Cement Plant

**Abstract:** By means of on-site investigation, inspection, interior experiments, theoretical analysis and calculation, a detailed analysis is carried out on the cause of the partial collapse accident about a waste-heat boiler steel structure in a cement plant of Hunan province of China. The results of inspection and analysis show that: as a key part of load transfer, the connection weld of long thin steel plate is poor in quality, meanwhile, the detail of beam-column connection can not meet the requirement of rigid joint stipulated by the design, which are the main causes for the collapse accident of boiler steel structure. Based on the analysis of accident cause, some problems worthy of consideration are put forward to the design and construction of this kind of structure, such as the weld procedure and quality control of long thin steel plate connection weld, etc.

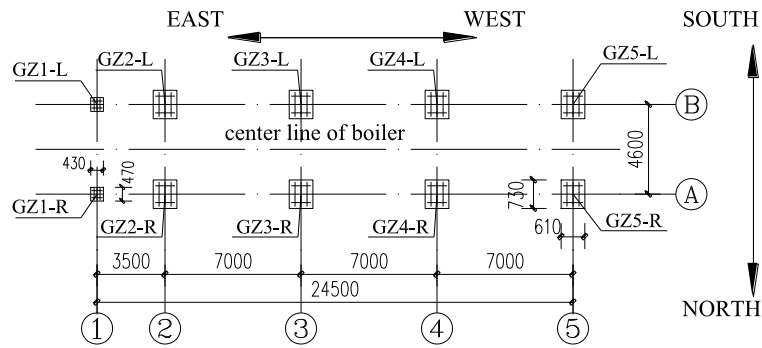
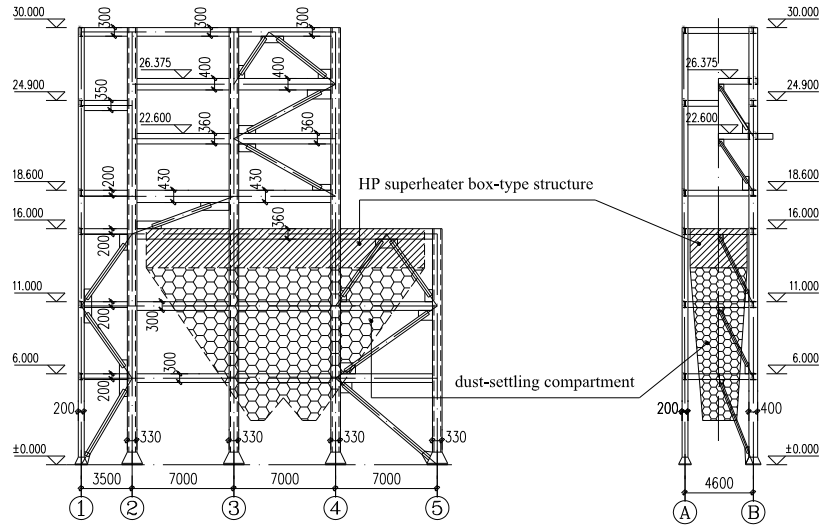
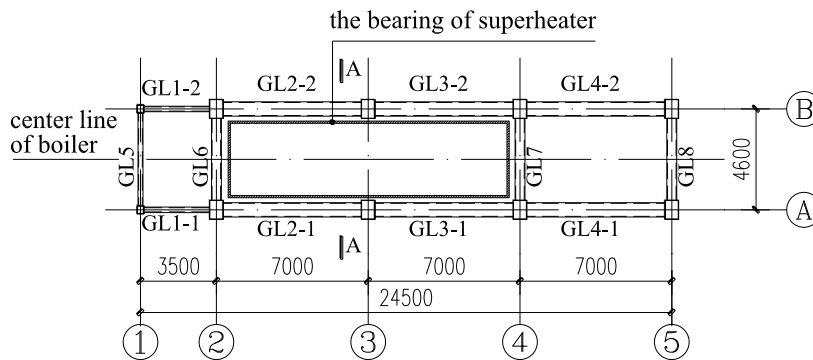
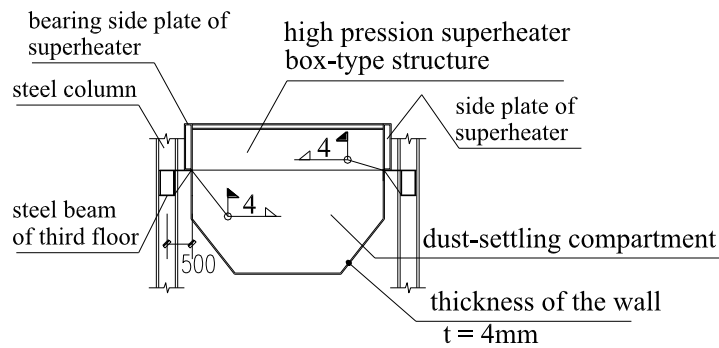
Fig. (1). Structure layout of the boiler steel structure.

As can be seen from Fig. (1), the dust-settling compartment and super-heater tube chamber was connected into a whole through 4 mm fillet weld. The composite unit was hung onto the steel beams of the third floor. Meanwhile, considering the off-center of the mass centre and the point of

bearing reaction resultant, the combination was actually in a state of cantilever.

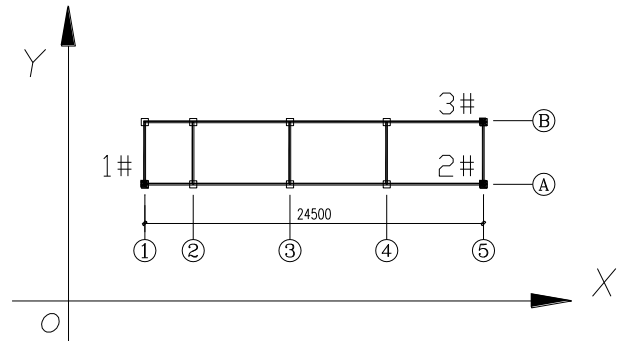
Fig. (8). Verticality Observation Measure Point Arrangements.

Topcon GTS332N-type total station is adopted to inspect the structure’s verticality situation on spot. The measure point arrangement is shown in Fig. (8), and Table 1 shows the inspection results. The results indicate that the maximum relative displacement of measure point is 40mm (the value of measure point 2 #), which exceeds the value of 35, but does not exceed 45(a limit value prescribed by GB50144-2008 [5]). The value has exceeded the prescribed limits of GBT22395-2008 (specification for design of boiler steel structures) ( $H/500=16000/500=32\text{mm}$ ) [4]. According to the item 7.3.9 of Standard for appraisal of reliability of industrial buildings and structures (GB50144- 2008) [6], the ratings of frame displacement is graded as B-degree, which has a limited impact on the normal application of the structure.

Measuring point	The height of measuring point to ground/m	Offset in X direction/mm	Offset in Y direction/mm
1#	30	22	—
2#	16	—	40
3#	16	—	30

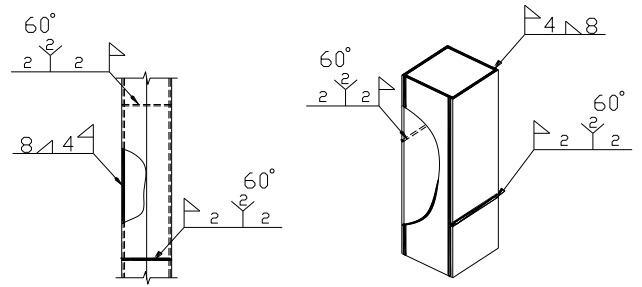
Fig. (10). Splice detail of the column section.

Checking the design drawing of the dust-settling compartment, the self-weight ( $N_{GK}$ ) of this equipment is 38.835 tons. As mentioned above, the total weight of the deposition ( $N_{QK}$ ) in the dust-settling compartment is 198.8 tons. So, we can get the design value of actual load ( $N$ ) about

$$N = \gamma_G N_{GK} + \gamma_Q N_{QK} = 1.2 \times 388.35 + 1.4 \times 1989 \text{kN} = 3250.62 \text{kN} \quad (1)$$

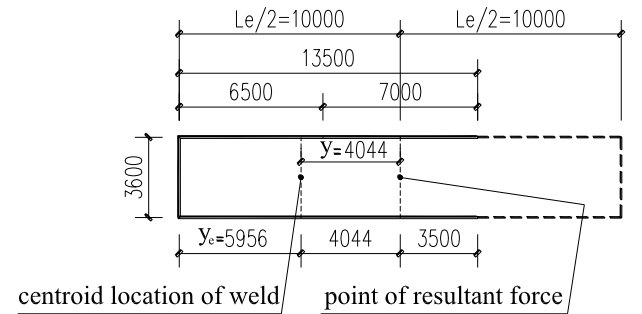
Fig. (11). Arrangement of the weld.

The checked weld is transverse fillet weld, and its centroid location is shown in Fig. (11). Ignoring the uneven distribution of the deposition and the construction error and defect, we can regard that the resultant point of load get through the centroid of dust-settling compartment. Obviously, the two centroids are not coincidence, and the checked section of weld is under the situation of eccentric tension.

From the above calculation, we can see that, without considering the construction error and defect, the connection weld between dust-settling compartment and super-heater tube chamber is safety. Weld stress is less than the standard limit.

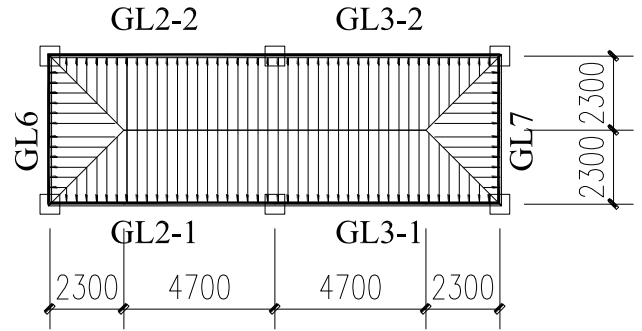
Fig. (12). Distribution diagram of load for bearing beam.

According to structure arrangement of the third floor, we can get the distribution diagram of load for the bearing beam of super-heater tube chamber as shown in Fig. (12). All bearing beams have the same section (See Fig. 13). In the

site of accident, we can see that the bearing beams twisted seriously while the columns have little damage. So, it is necessary to re-check the carrying capacity of bearing beam.

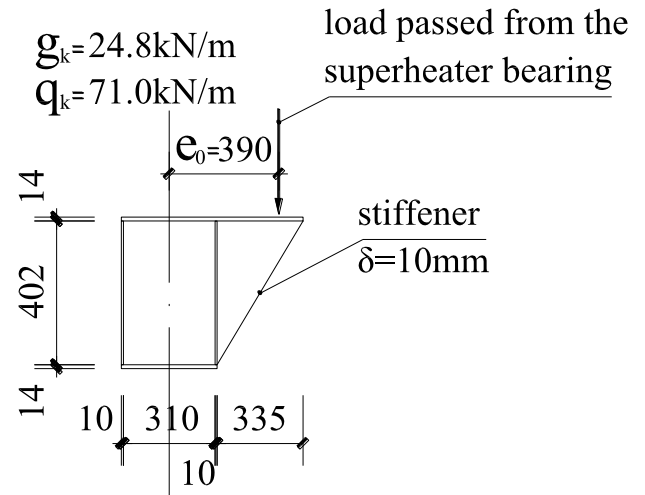
Fig. (13). The section of bearing beam and its bearing load.

The weight of dust in the dust-settling compartment is 198.8 tons, the self-weight of the dust-settling compartment and super-heater tube chamber are 38.835 tons and 30.587 tons respectively. All loads were passed to the bearing beam through the super-heater supports (See Fig. 13), so, we can get the characteristic value of the uniformly distributed load for the bearing beam: dead load 24.8 kN/m, live load 71 kN/m. At the same time, a uniformly distributed twisted moment is also loaded on it, considering eccentric effect of the loading.

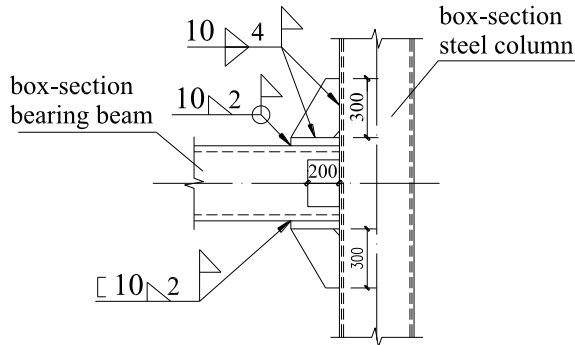
**Fig. (14).** Design details of beam-column connection.

3D3S 3 dimension steel structure system (developed by Tongji University) was used to check the bearing beam GL3, which is under the most unfavorable load. Fig. (14) shows the design details of beam-column connection, it can be regarded as a rigid connection. Table 2 gives the basic section geometrical parameter, and the sketch of load distribution and structure analysis can be seen in Fig. (15).

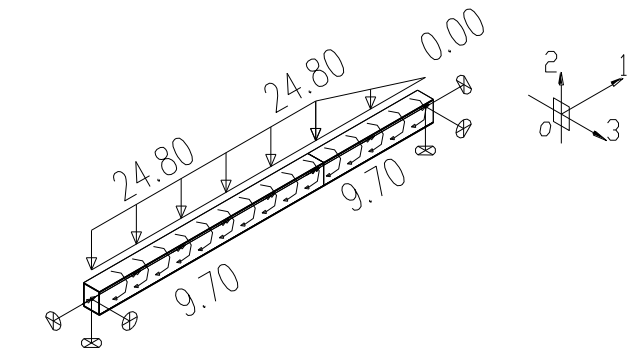
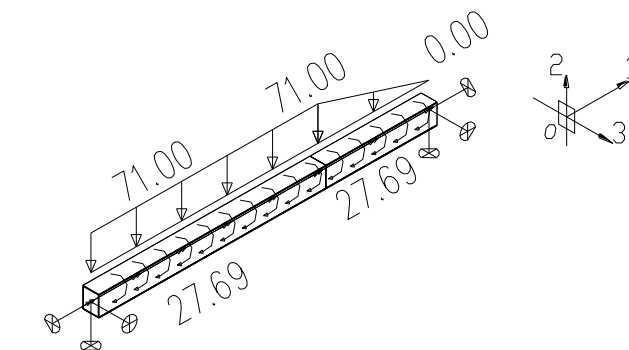
**Fig. (15).** Sketch of load for GL3.

Bending strength	Shear strength	Overall stability turning around axis 2	Overall stability turning around axis 3	Mid-span deflection
0.97	0.42	0.97	0.97	1/1384
