Analysis of Fault Lines in the City of Manado

Abstract:

Aim: This study aimed to identify the Manado fault line. The Geoelectric PQWT-TC 300 tool was utilized, which can detect up to a depth of 300 meters vertically.

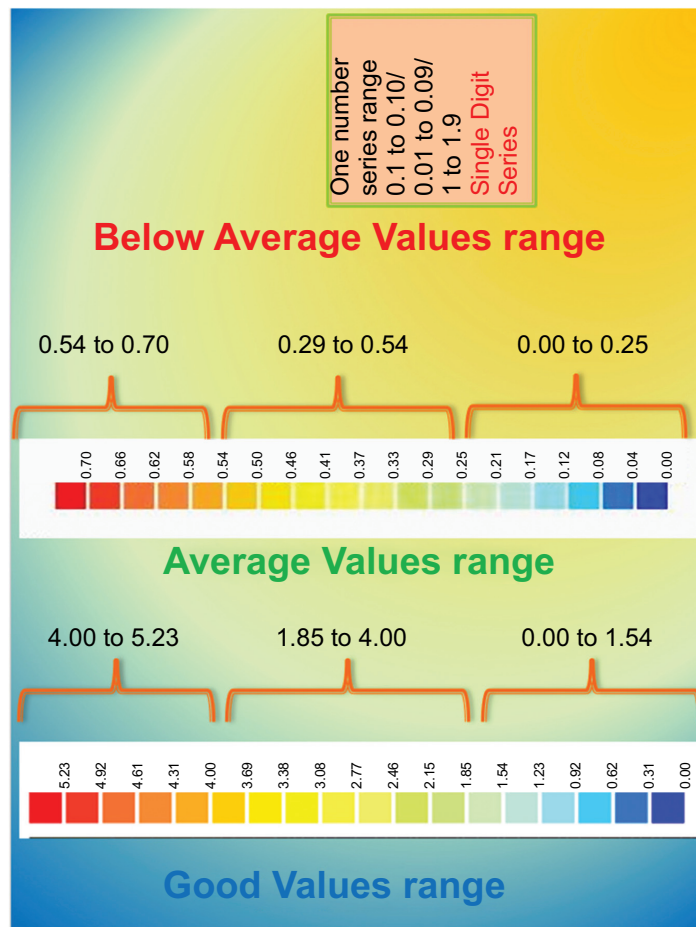
Fig. (5). Resistivity value represented the color.

Red Color represents **highly** strengthen/ high resistivity of rock formation, and the color indicate danger symbol, we don't get water in this zones/ getting in limited areas

Orange Color represents **less than the highly** strengthen rock formation, this color also indicates some of danger zone, here we don't get water in this zones / getting in the limited areas

Yellow Color represents **medium** strengthen rock formation, this color also indicates warning to getting water in this zones

Green Color represents the **less-than medium** strengthen rock formation, this color also indicates starting of water zones

Light Blue Color represents the **soft rock formation** / water bearing rock formation, this color indicates wealthy chances of getting water in the zone

Blue Color represents the **soft rock** formation / water bearing rock formation, this color indicates wealthy chances of getting water in the zone

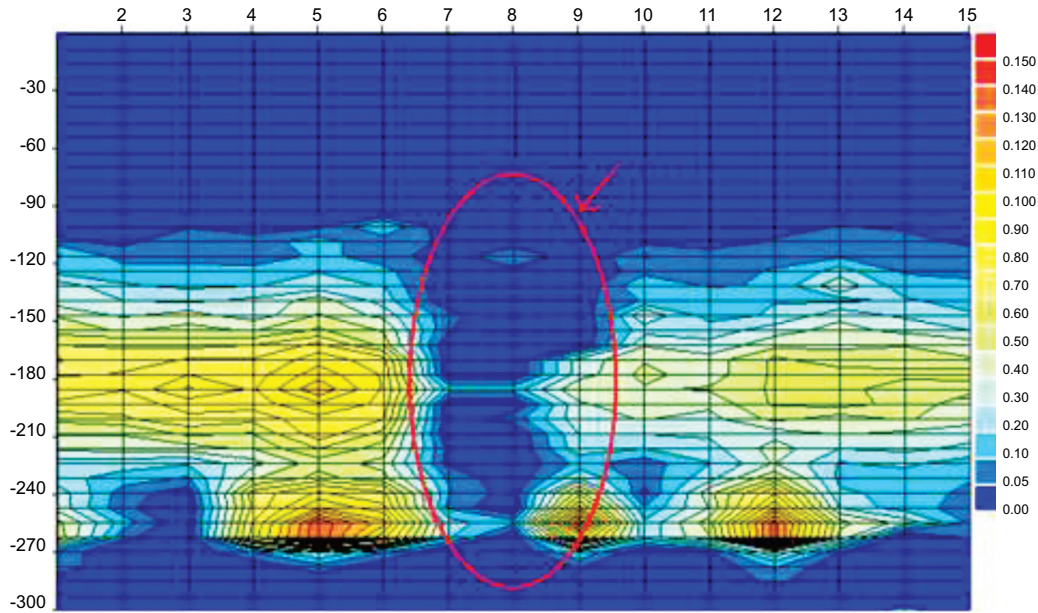
Line 23 Kairagi-1, Manado city, at the coordinates 1°30'3.72" N, 124°52'34.92" E, showed a weak zone area with high water potential from 0 to 120m. There was found fault from a depth of 120m to 270m, as shown in Fig. (9).

Fig. (9). Line 23 kairagi - 1 Manado city.

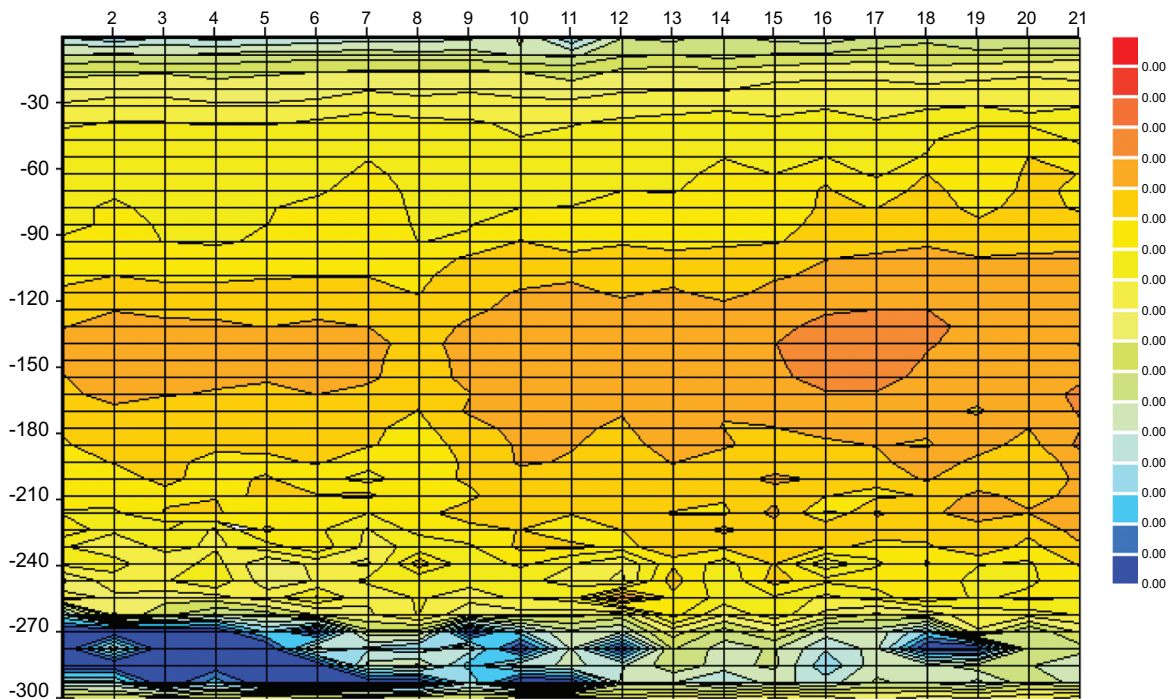
Fig. (12). Line 66 Kairagi - 3 Manado city.

Line 66 Kairagi-3, Manado city at the coordinates $1^{\circ}29'36.67''\text{N}$, $124^{\circ}52'59.84''\text{E}$ showed a strong zone area with no water potential. There was no fault, as shown in Fig. (12).

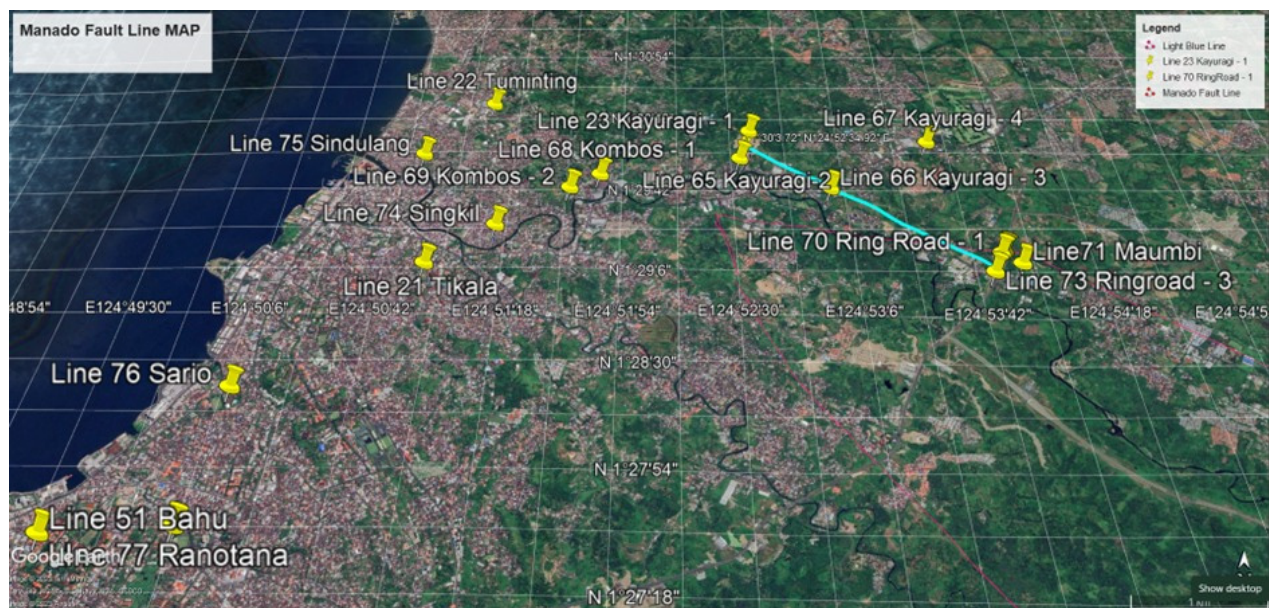
The identification of the Manado Fault line resulted in 17 identified lines spread across Manado City. Among these 17 lines, only two lines, line 23 (Kayuragi-1) and line 70 (Ring Road, Manado City), showed faults starting from 30m to 270m, with resistivity values of 0Ω . The Manado fault line was drawn from line 23 to line 70, as shown in Fig. (24).

Fig. (24). Result of manado fault line.

The map of the Manado fault line was found at line 23 Kayuragi -1, line 70 Ring Road – 1 Manado City, by using the PQWT T300 instrument. The Manado fault was found at 30m to 270m with a resistivity of 0 Ω. The current study of the Manado fault line closely parallels previous analyses. Despite not detected activity since the 1800s., the present method has yielded superior results for identifying the Manado fault line compared to the previous methods.
